SUBJECT: Trowbridge Dam, Dam ID No. 604; Allegan County

**DAM SAFETY INSPECTION REPORT  
TROWBRIDGE DAM – DAM ID NO. 604  
KALAMAZOO RIVER  
ALLEGAN COUNTY – SECTION 12, T 01N, R 13W**

**INSPECTION DATE:** August 18, 2023

**REPORT DATE:** September 19, 2023

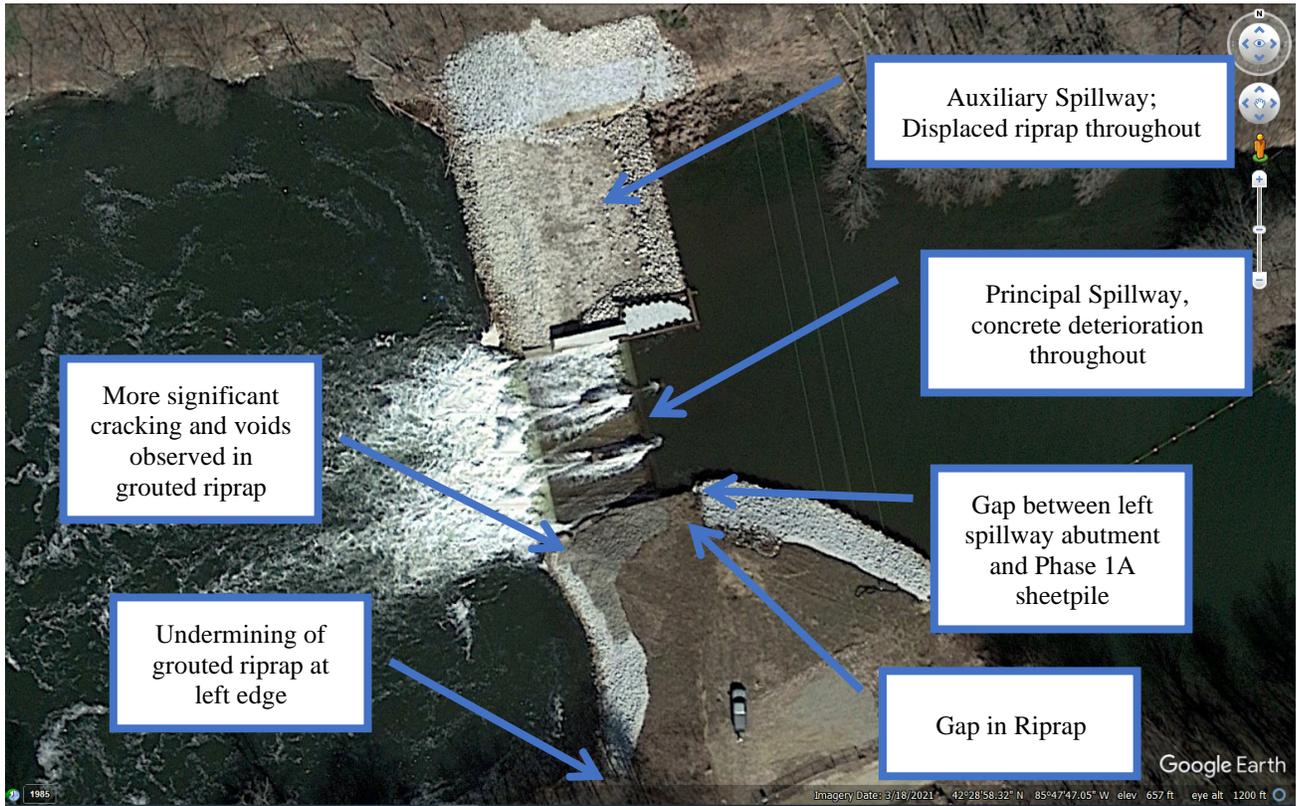
**Photo #1 – Aerial imagery of dam after Phase 1A repairs. More significant deficiencies and their locations are identified**

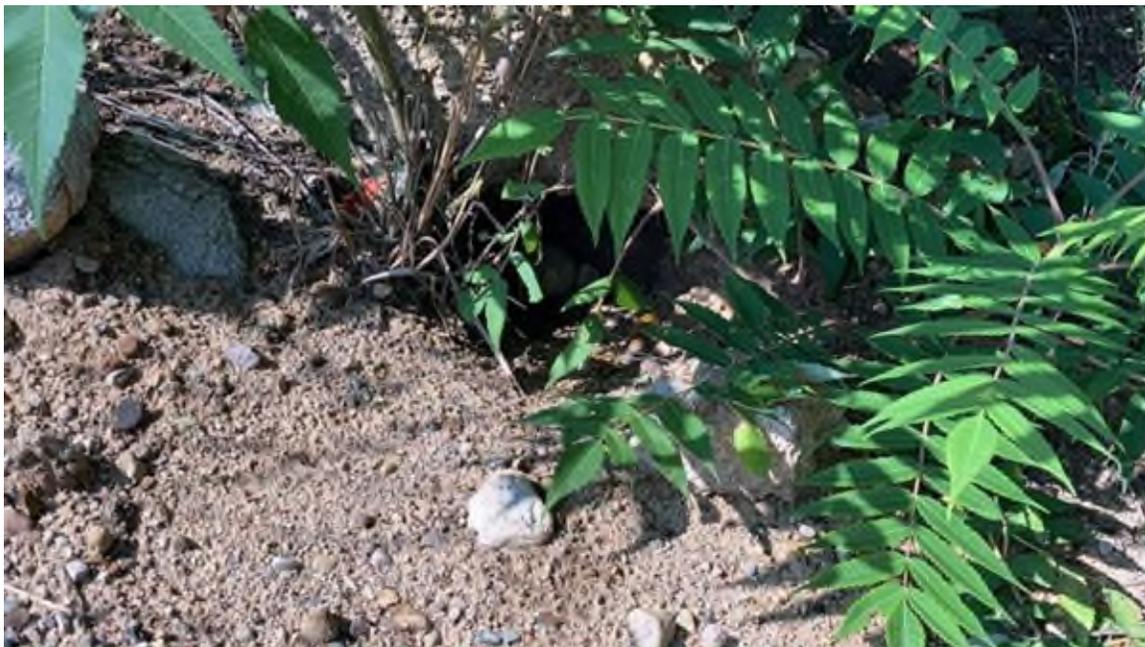
8. One animal burrow was observed on the crest of the left embankment near the principal spillway. Fill/repair this animal burrow and any other burrows as they are observed with suitable, compacted fill.

**Photo #2 - Burrow on left embankment near spillway**

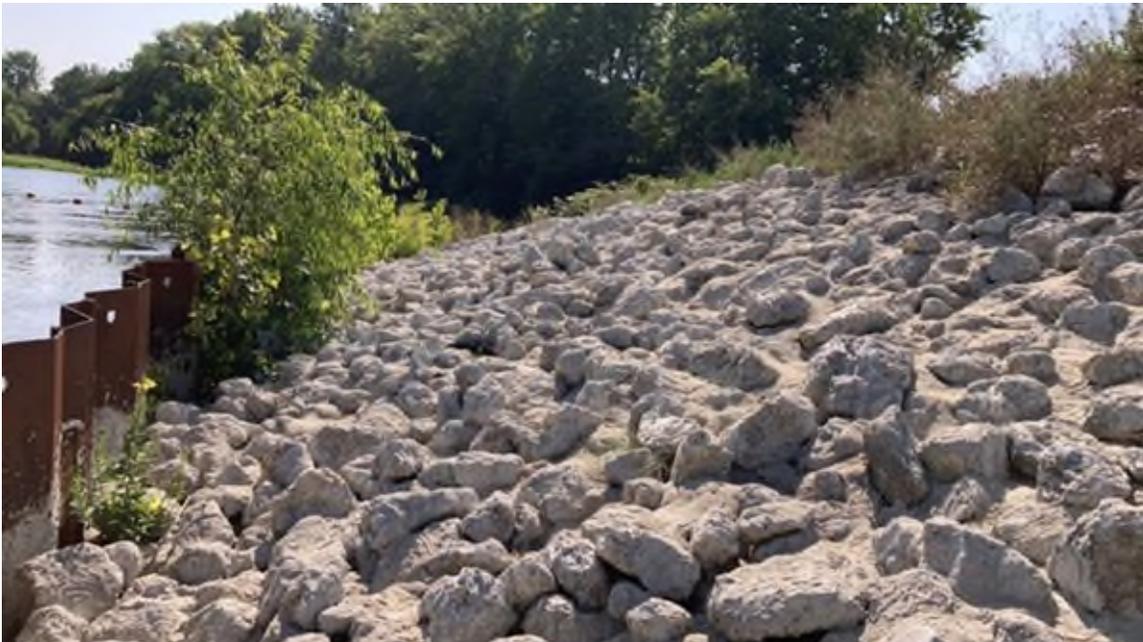
**Photo #4 - Upstream slope of left embankment, Phase 1A sheetpile wall, grouted riprap armoring. Note some brush growing in grouted riprap**

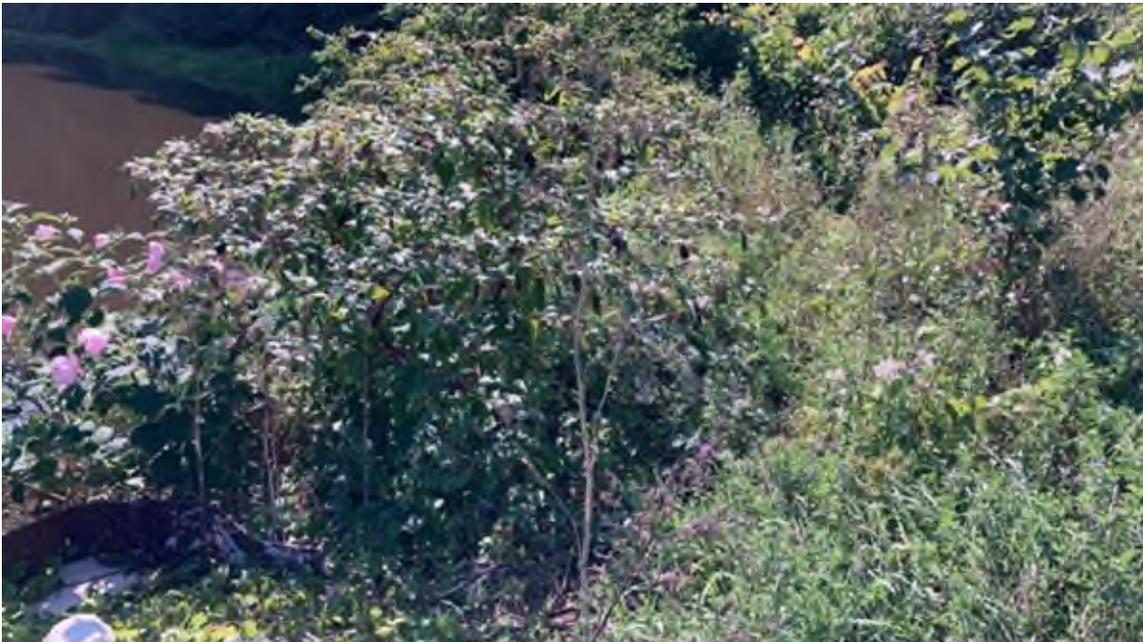
**Photo #8 - Upstream slope of left embankment left of sheetpile wall extent. Note brush**

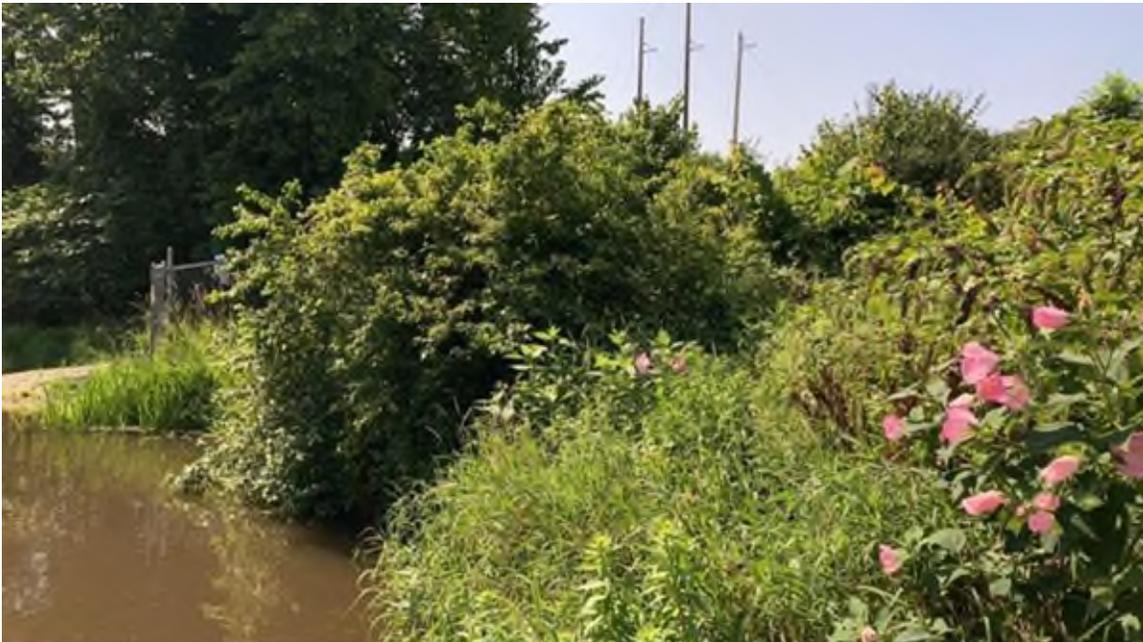
**Photo #10 - Upstream slope of left embankment left of sheetpile wall extent. Note some brush growth**

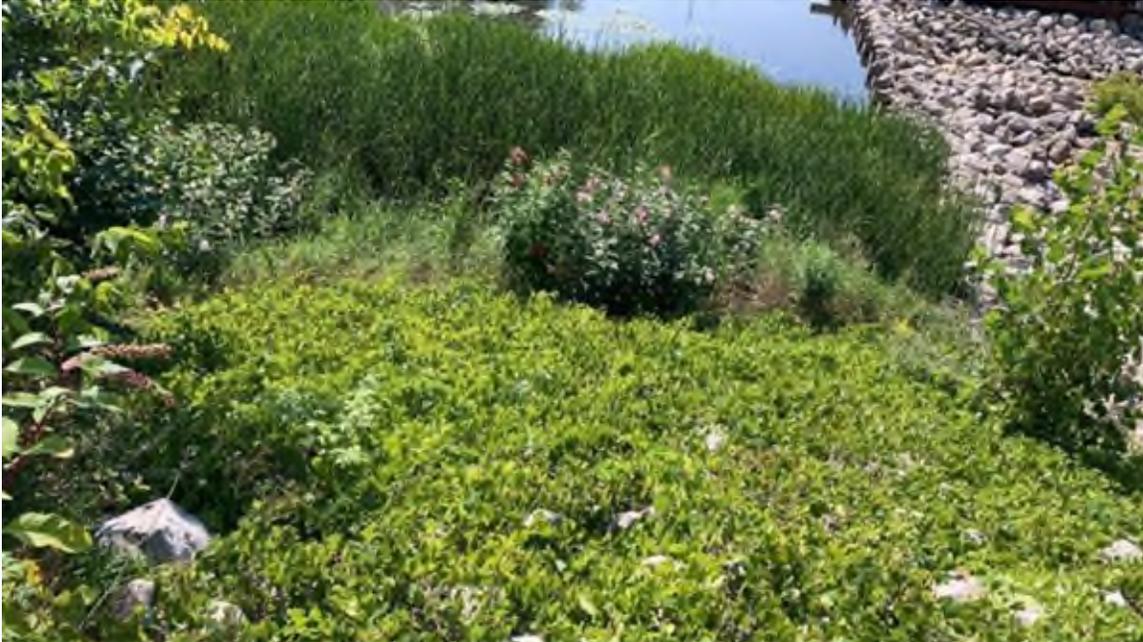
**Photo #11 - Upstream slope of right abutment at edge of auxiliary spillway. Note overgrown riprap**

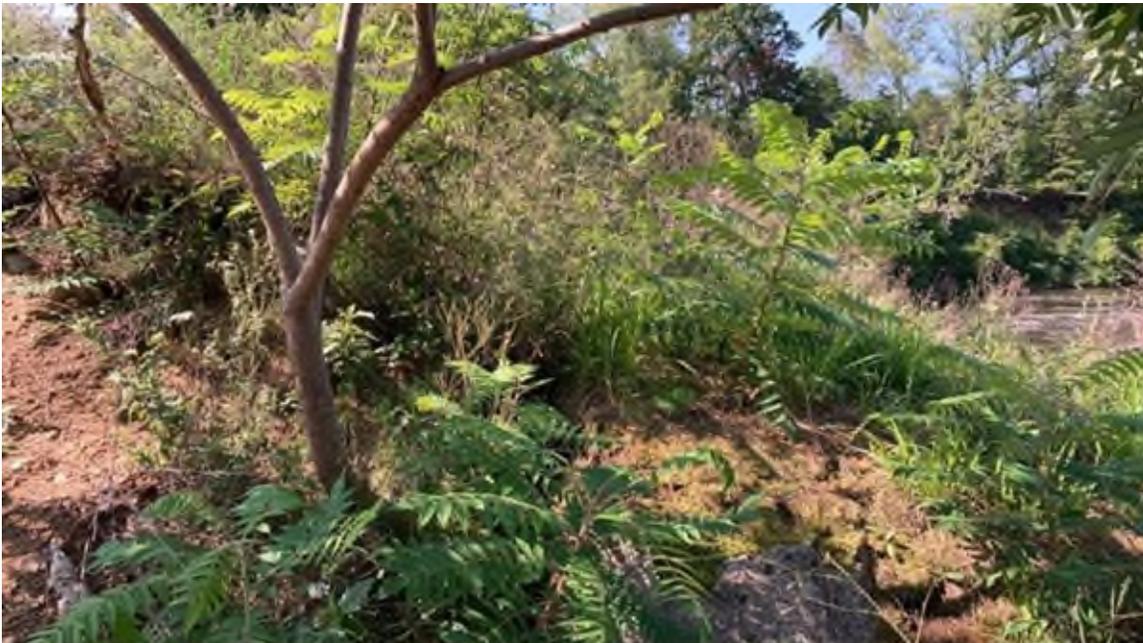
**Photo #16 - Crest of left embankment near spillway abutment. Note tree growing**

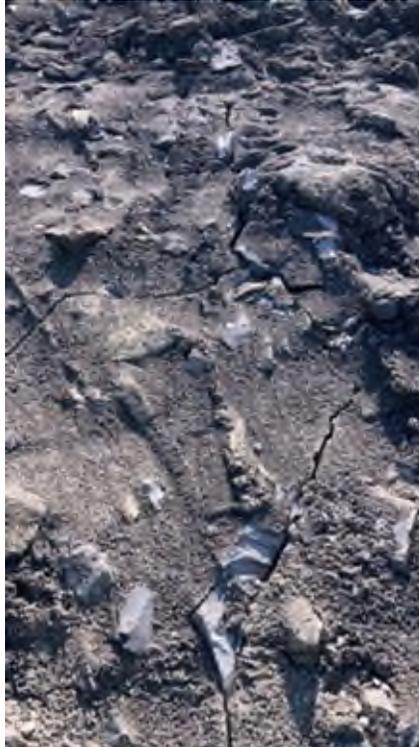
3. Significant voids and cracks in the old grouted riprap on the left embankment downstream slope were observed throughout, especially near the principal spillway outlet. Some brush was growing within larger voids. Flow over the grouted riprap raises concerns of instability during large floods. Also, the left end of the downstream riprap has undermining occurring from tailwater conditions during some flow events. Continued undermining could cause instability of the embankment slope. Monitor grouted riprap areas on a monthly basis for further deterioration. Fill/repair any deteriorated areas as they are observed.

**Photo #19 - Downstream slope of left embankment, old grouted riprap. Crack present from top to bottom.**

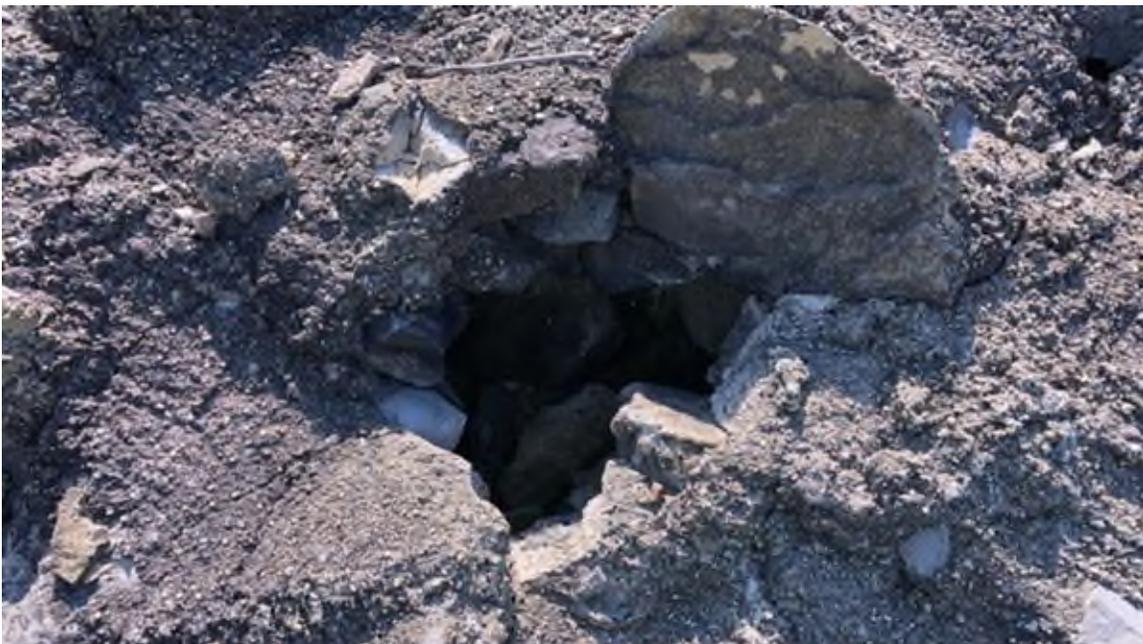
**Photo #20 - Downstream slope of left embankment. Void in old grouted riprap**

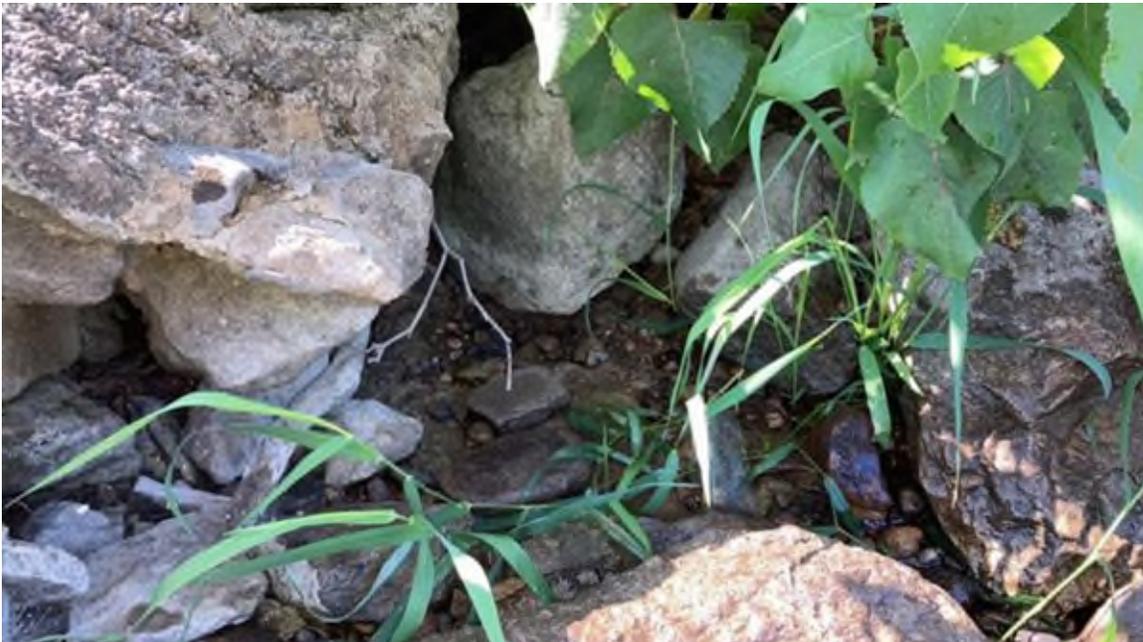
**Photo #22 - Void in grouted riprap on downstream slope of left embankment near  
where brush is growing (see previous photo)**

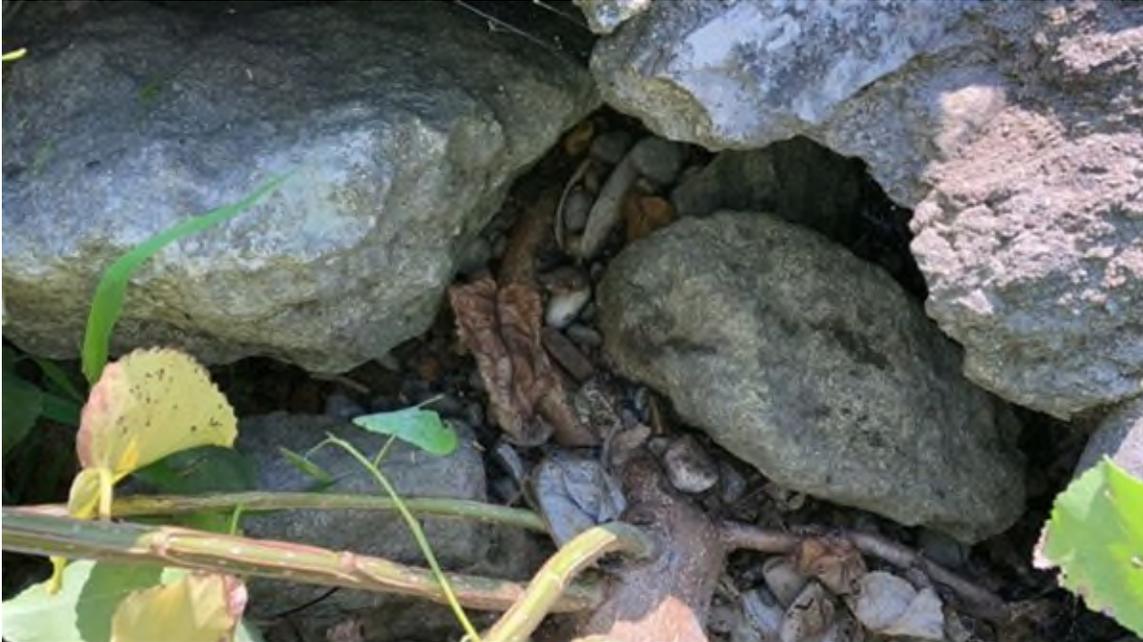
**Photo #23 - Void in grouted riprap on downstream slope of left embankment near where brush is growing (see previous photos)**

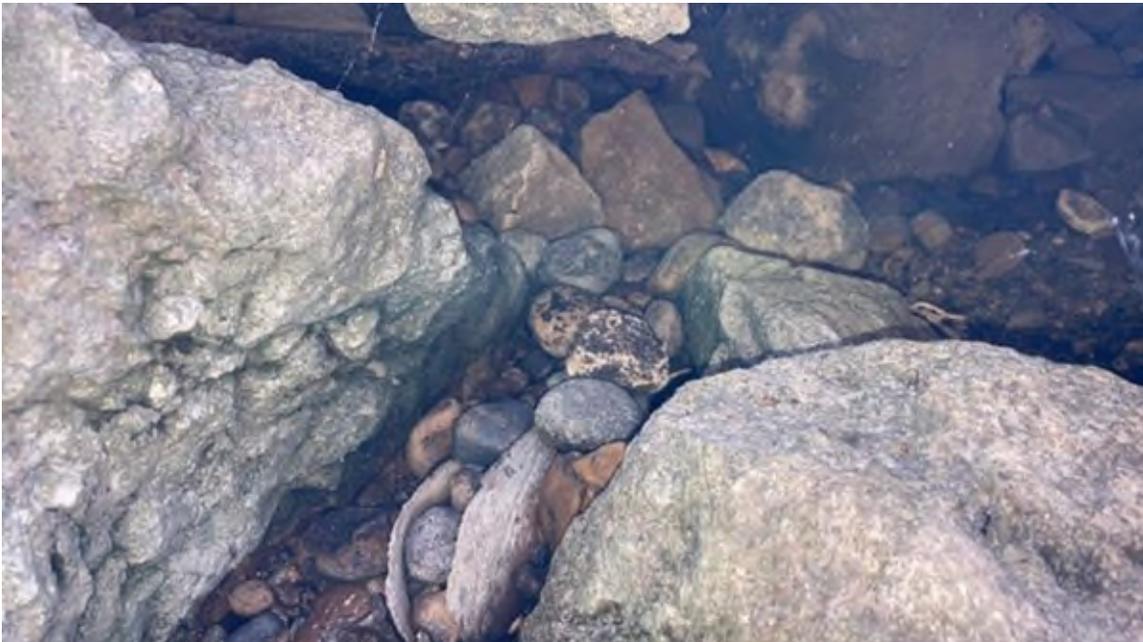
**Photo #24 - Void under grouted riprap on downstream slope of left embankment near spillway outlet**

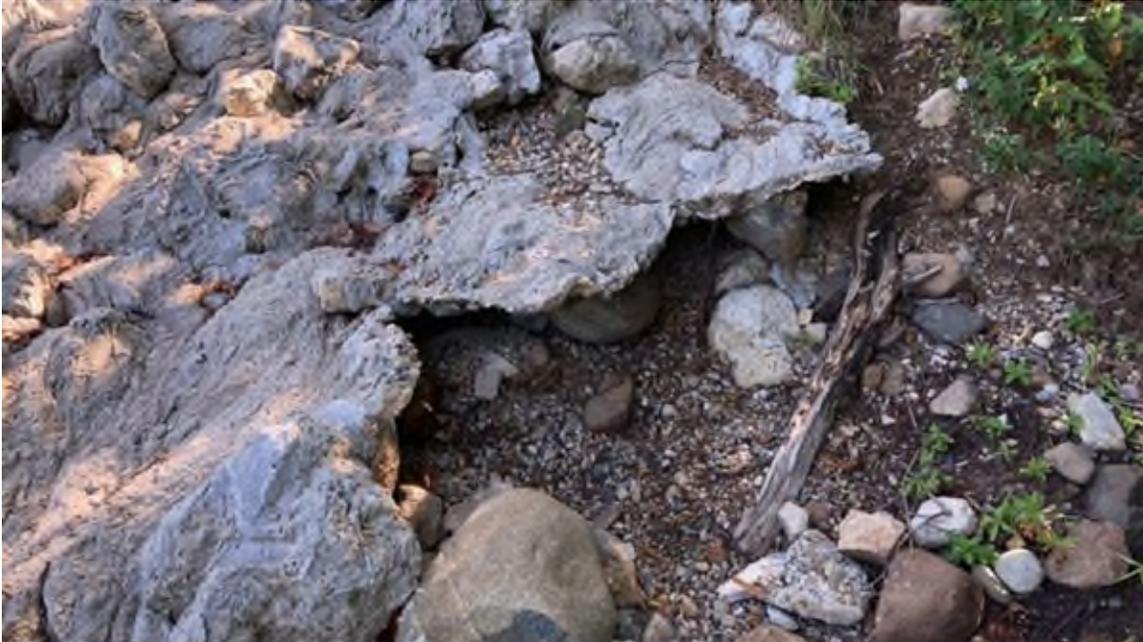
**Photo #29 - Undermining at left end of Phase 1A grouted riprap armoring on left embankment downstream slope**

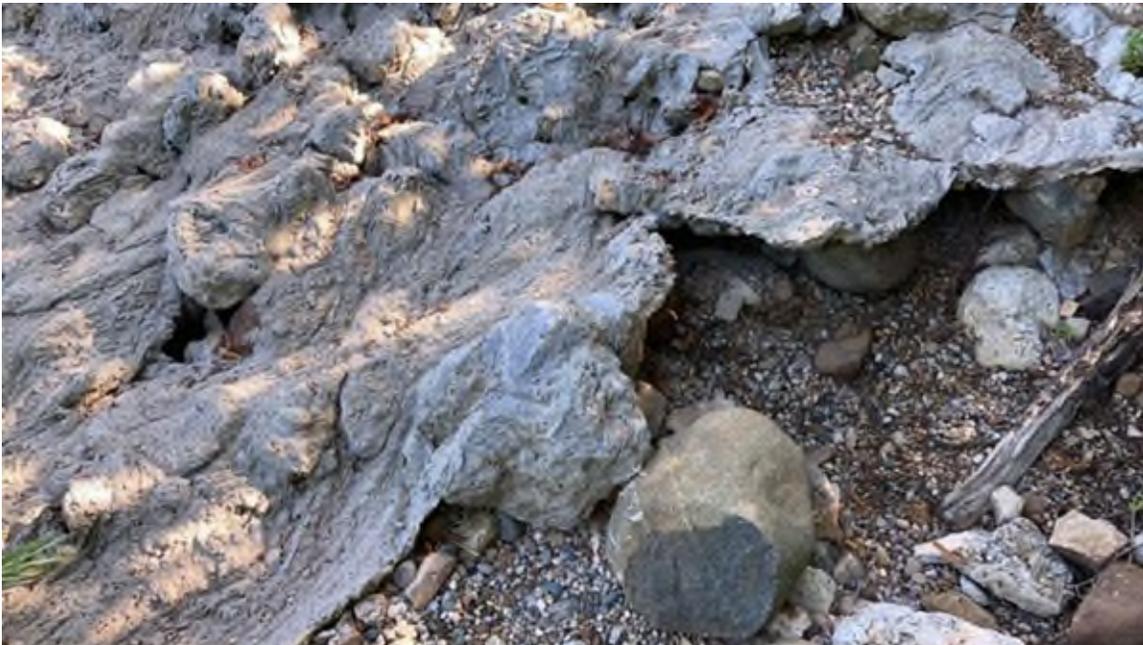
**Photo #30 - Undermining at left end of Phase 1A grouted riprap armoring on left embankment downstream slope**

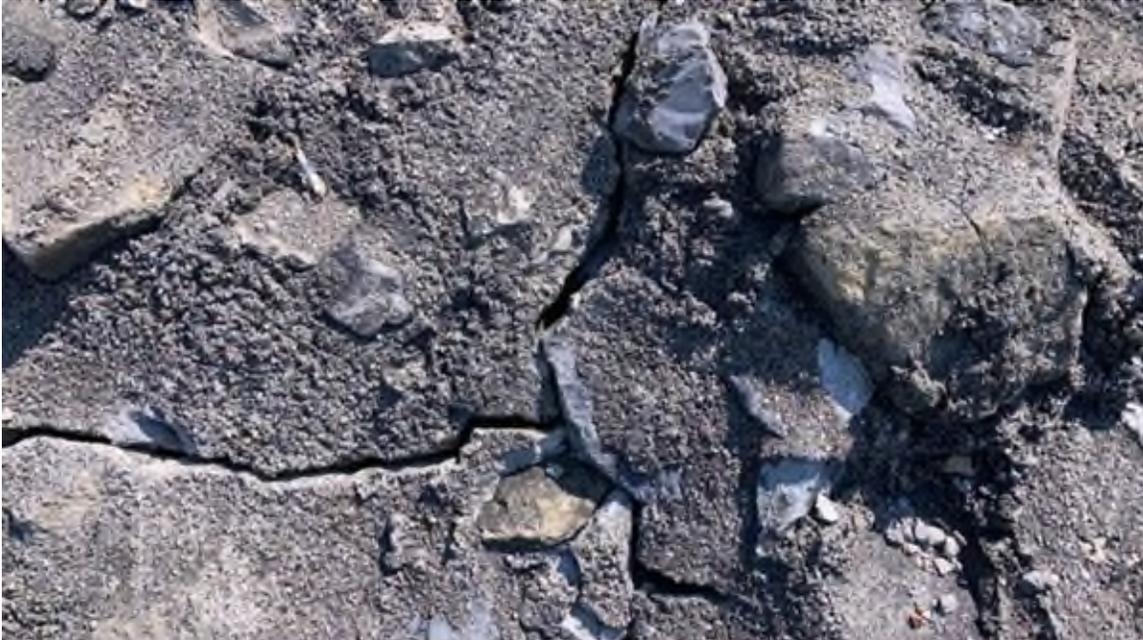
**Photo #33 - Typical crack in old grouted riprap on downstream slope of left embankment**

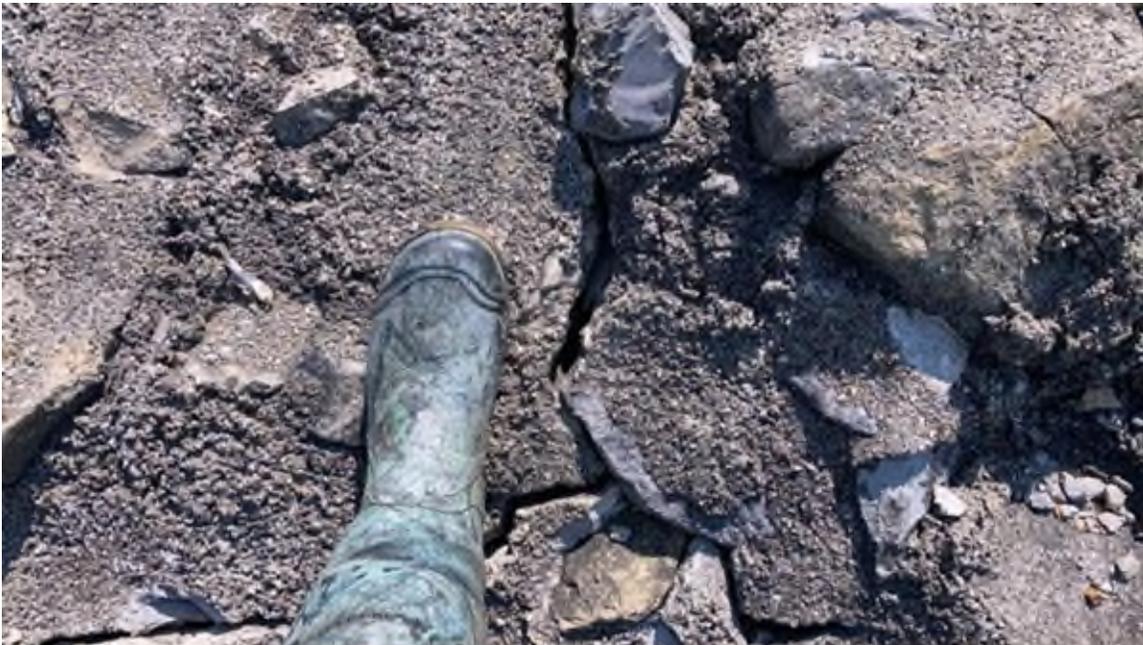
Approximate crack length (ft)	<i>Varies up to the complete transverse length of the older grouted riprap</i>
Approximate crack width (ft)	<i>See photo #34 for size reference. Cracks varied in width from hairline to open voids from the cracks</i>
Approximate crack depth (ft)	<i>Though top grout layer. Voids were also found to exist near under some cracks. Some voids have vegetation and brush growth within them. Cracking and voids could be an indication of the presence of seepage and piping below the grouted riprap that has caused the displacement</i>
Location of cracks	<i>Downstream slope of left embankment</i>
Action required for cracks	<i>Monitor, Maintenance</i>
Describe action required	<i>Repair the grouted riprap cracks and fill voids with suitable fill in the areas that would be overtopped during the 200-year storm. Monitor after the repair for further</i>
<b>Embankment / Internal Drains</b>

**Photo #34 - Typical crack in old grouted riprap on downstream slope of left embankment, boot in shot for size reference**

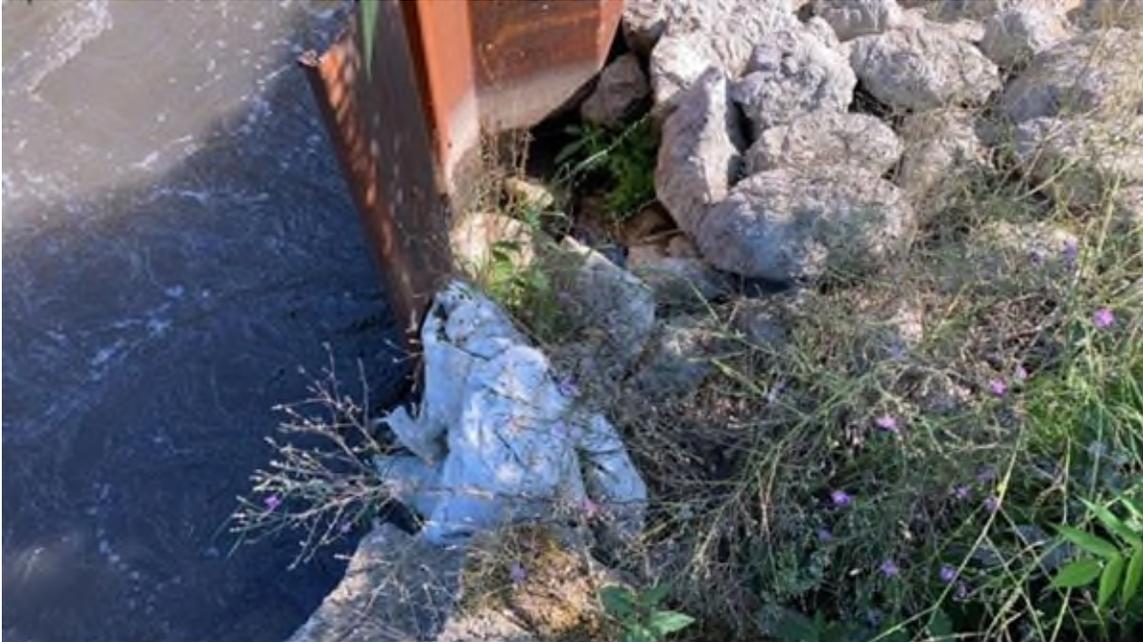
added this location to match the elevation of the Phase 1A grouted riprap. There is also a gap between the principal spillway left abutment and Phase 1A sheetpile wall where the gap in grouted riprap exists. Sandbags are stacked in the gap, but flow through or over the sandbags could still cause erosion of the embankment behind the abutment wall and sheet piling. This should also be sealed and armored to protect against erosion. These repairs should be completed by July 1, 2024.

**Photo #37 - Gap between principal spillway left upstream abutment and Phase 1A sheetpile. Note stacked sandbags and lack of riprap at gap**

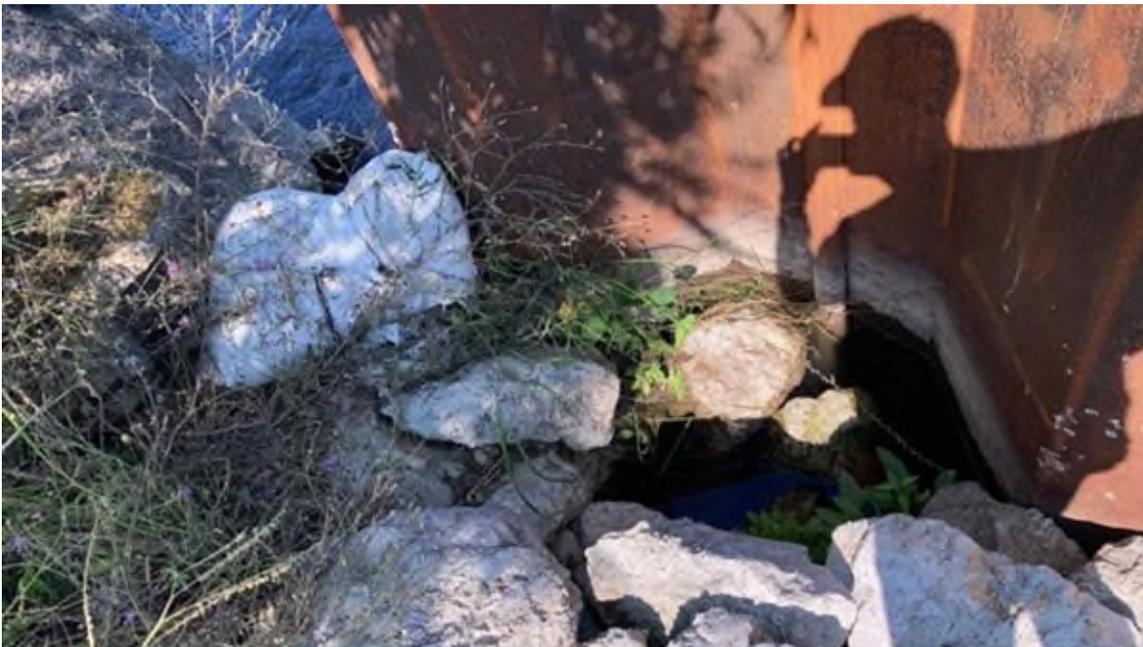
**Photo #38 - Gap between principal spillway left upstream abutment and Phase 1A sheetpile wall**

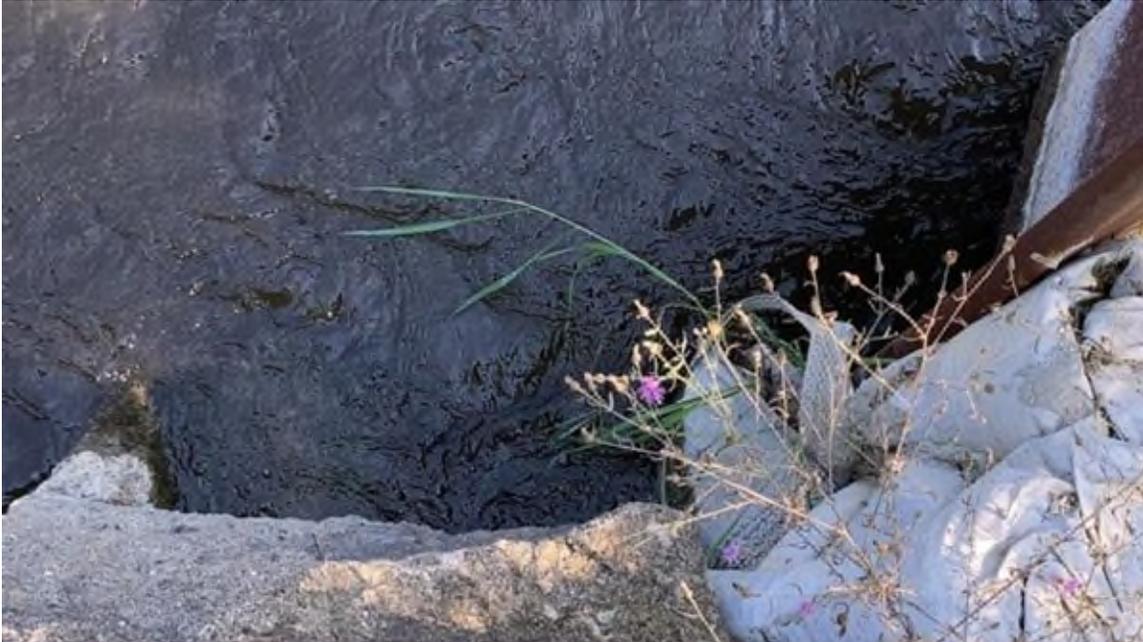
**Photo #39 - Gap between principal spillway left embankment and newer sheetpile**

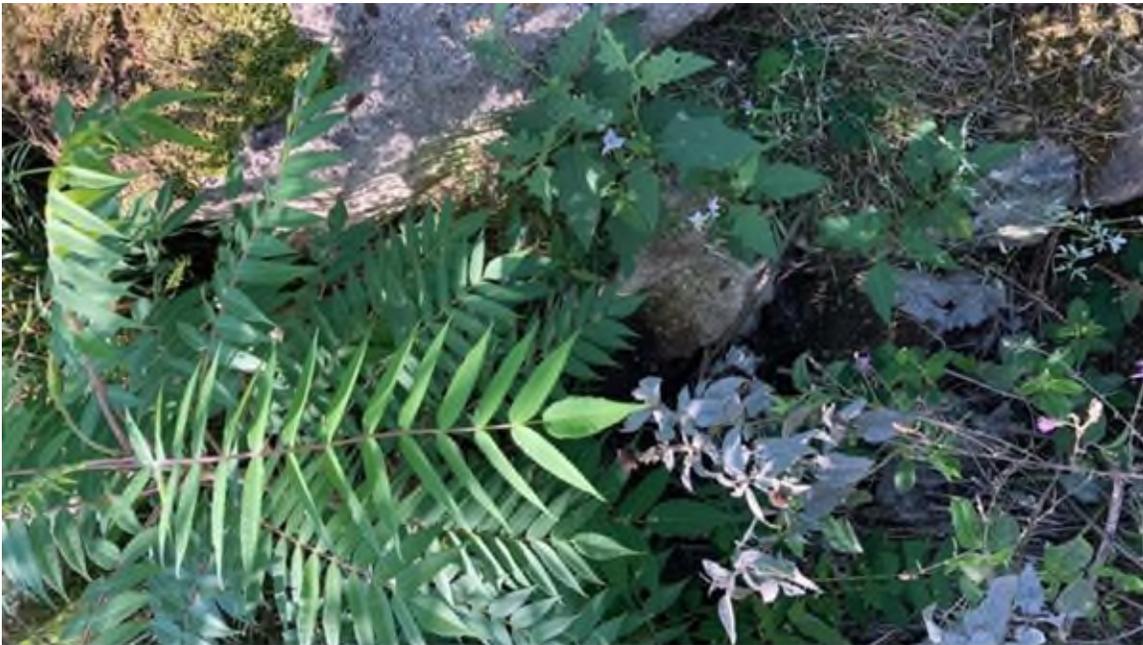
**Photo #40 - Some erosion observed at principal spillway left upstream abutment wall by gap**

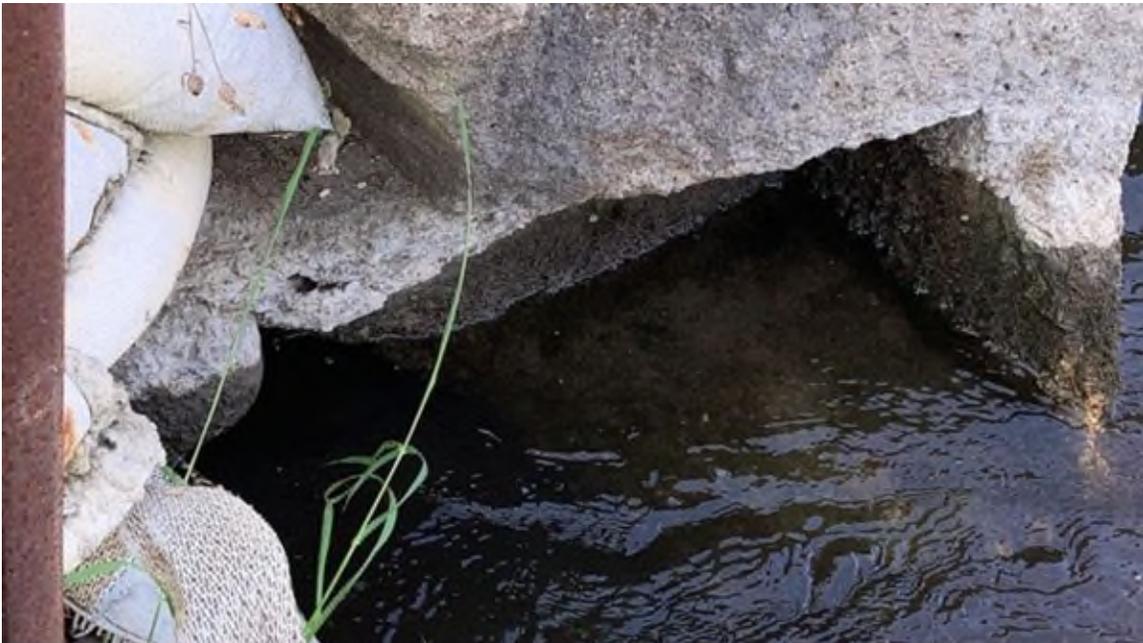
**Photo #42 - Left upstream principal spillway abutment wall at gap to Phase 1A sheetpile wall. See sandbags at left end of photo. Concrete shows some loss and undermining**

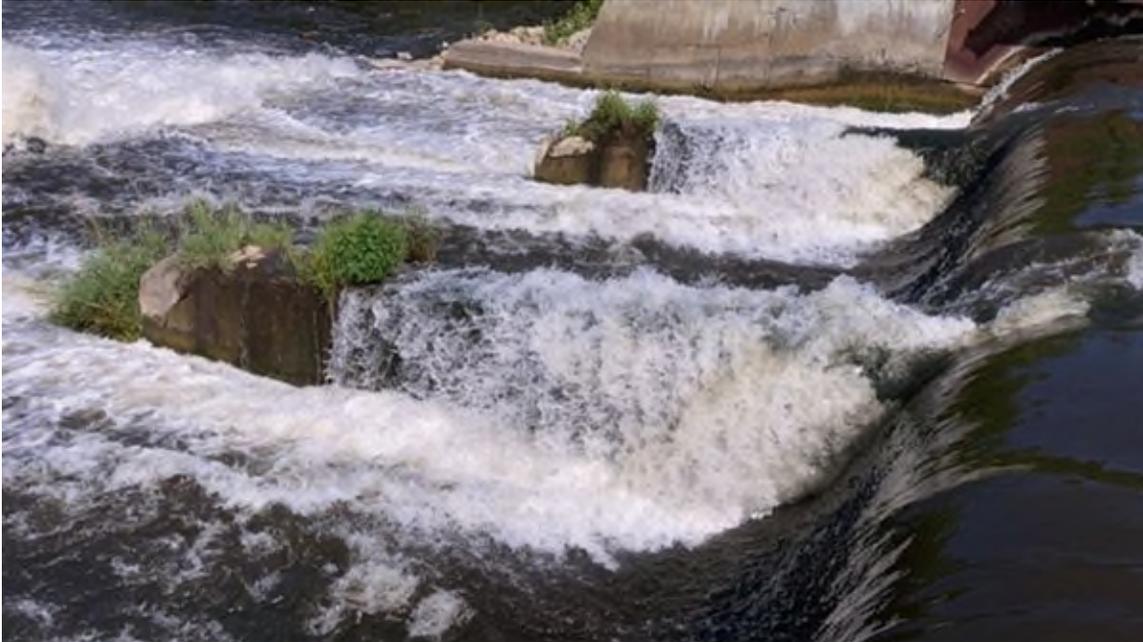
**Photo #47 - Left pier within principal spillway. Note concrete deterioration and vegetation growth**

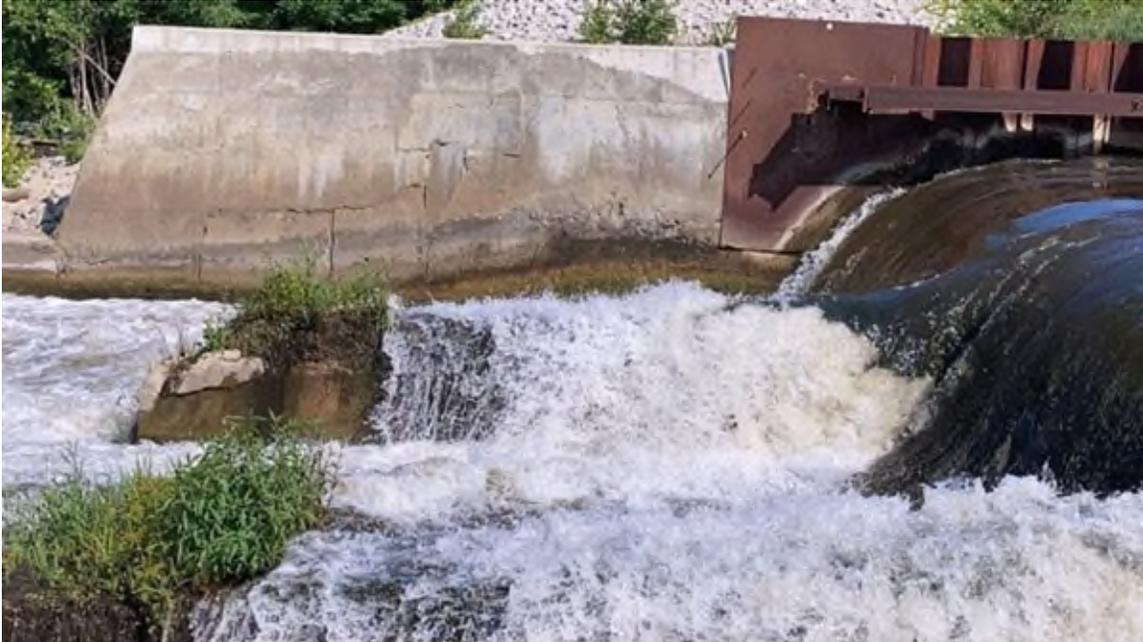
**Photo #49 - Right pier within principal spillway. Note concrete deterioration and vegetation growth**

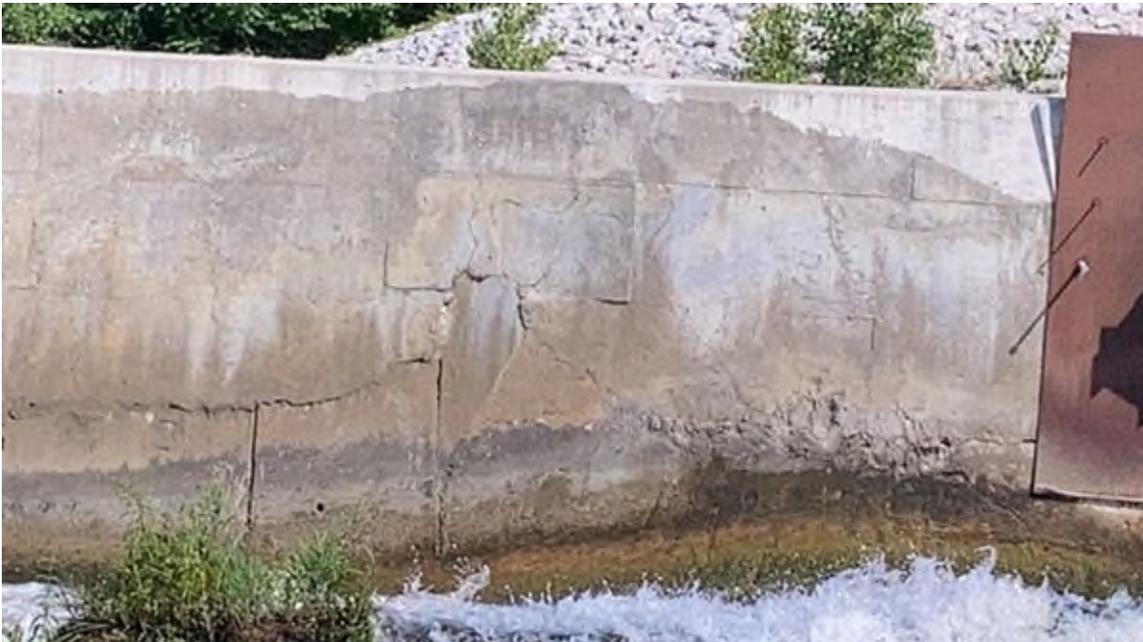
**Photo #50 - Principal spillway right downstream abutment wall. Note minor concrete deterioration**

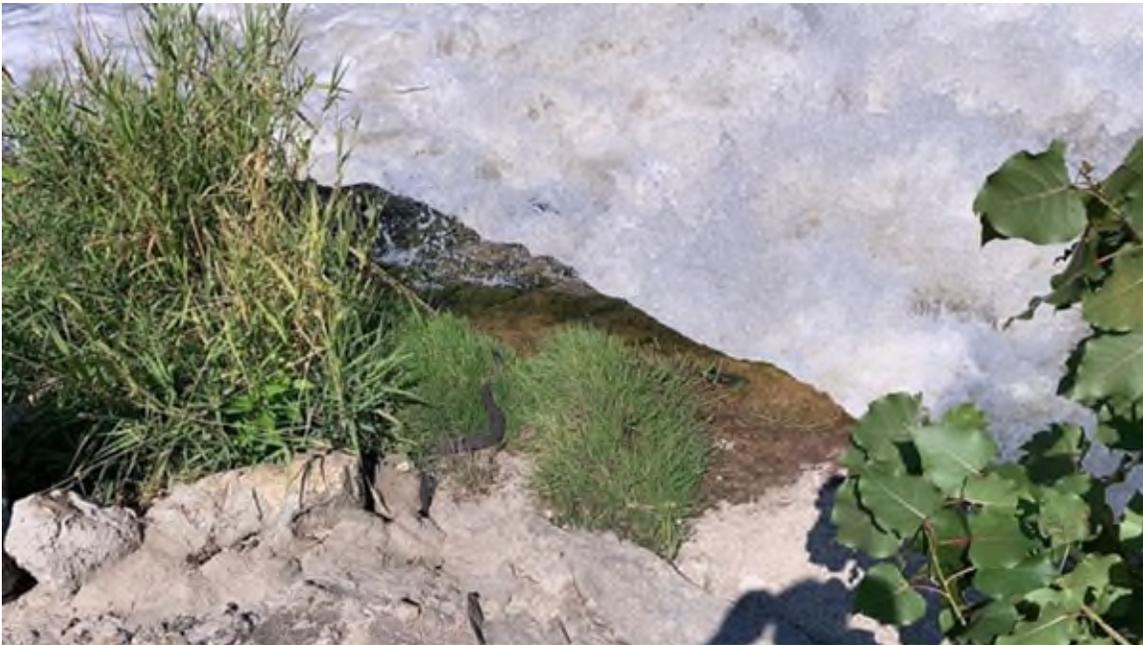
**Photo #52 - Principal spillway left downstream abutment/training wall. Note vegetation growth**

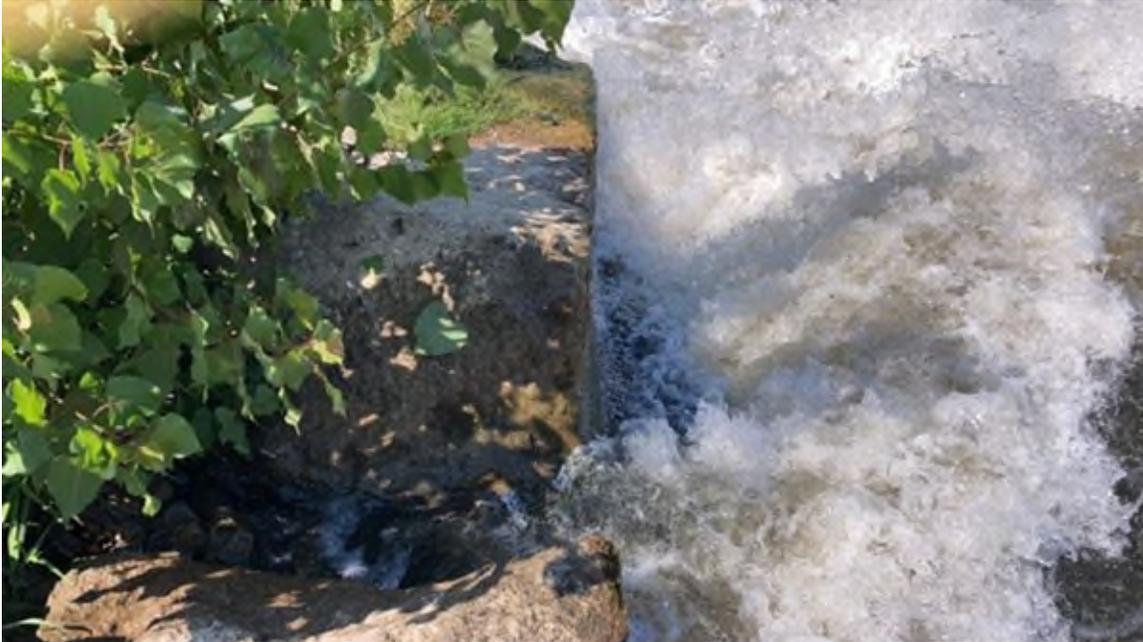
4. Monitor the concrete components of the principal spillway for further deterioration and movement, especially along the left spillway abutment wall, including the downstream training wall that is significant misaligned. Remove all brush and vegetation growing within cracks in the concrete walls and piers of the principal spillway by December 31, 2024.

**Photo #55 - Principal spillway left downstream abutment wall at downstream end.  
Note concrete deterioration, misalignment of downstream left training wall**

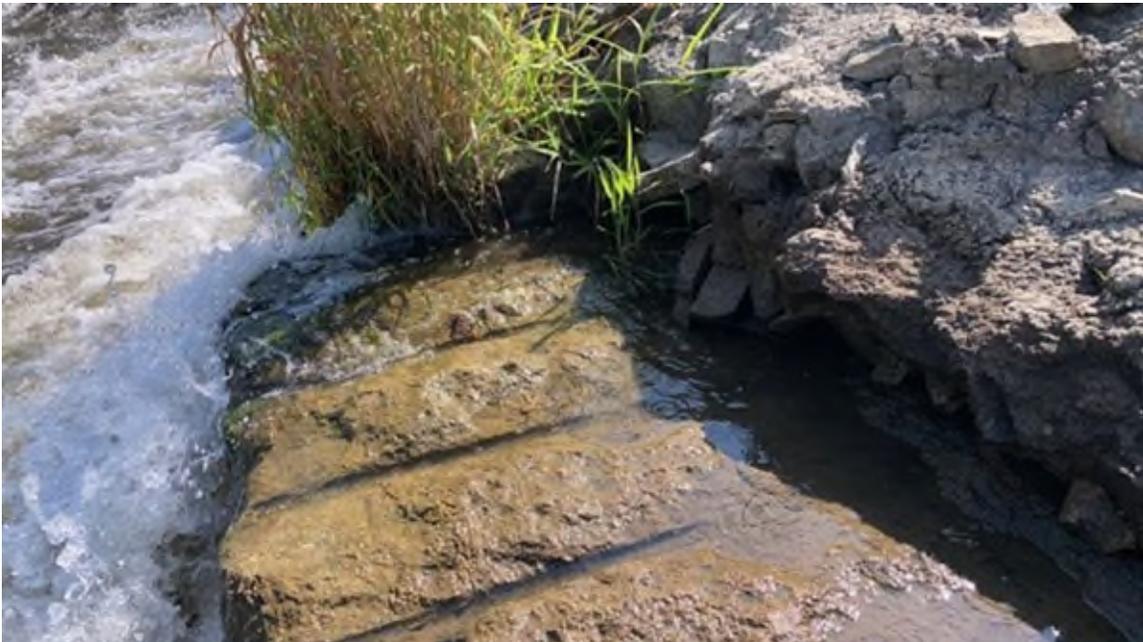
**Photo #56 - Principal spillway left downstream abutment wall at downstream end.  
Note concrete deterioration, misalignment of downstream left training wall**

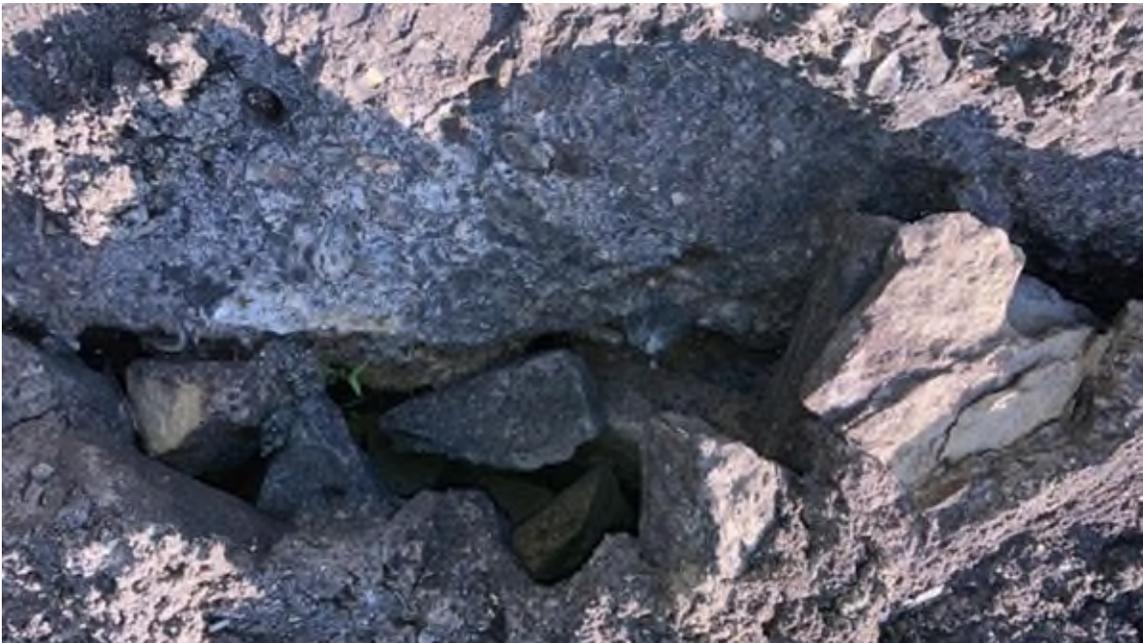
**Photo #58 - Riprap abutment with left spillway downstream wall. Note voids**

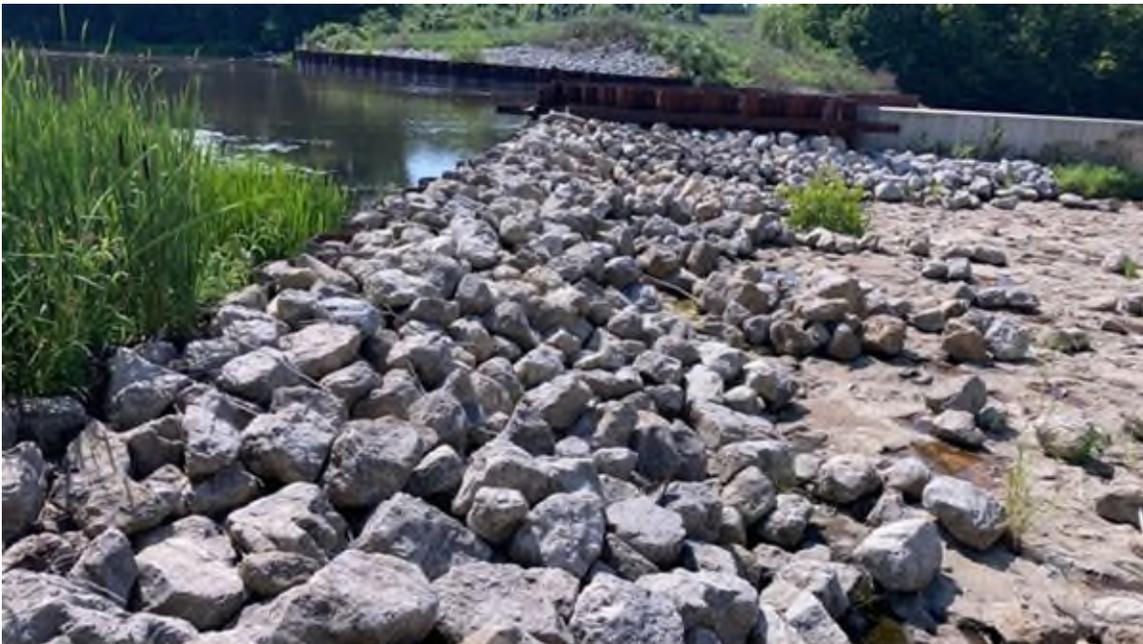
**Photo #78 - Riprap armoring on auxiliary spillway downstream of sheetpile crest, some displacement**
