SUBJECT: Trowbridge Dam, Dam ID No. 604; Allegan County

**DAM SAFETY INSPECTION REPORT  
TROWBRIDGE DAM – DAM ID NO. 604  
KALAMAZOO RIVER  
ALLEGAN COUNTY – SECTION 12, T 01N, R 13W**

**INSPECTION DATE:** August 18, 2023

**REPORT DATE:** September 19, 2023

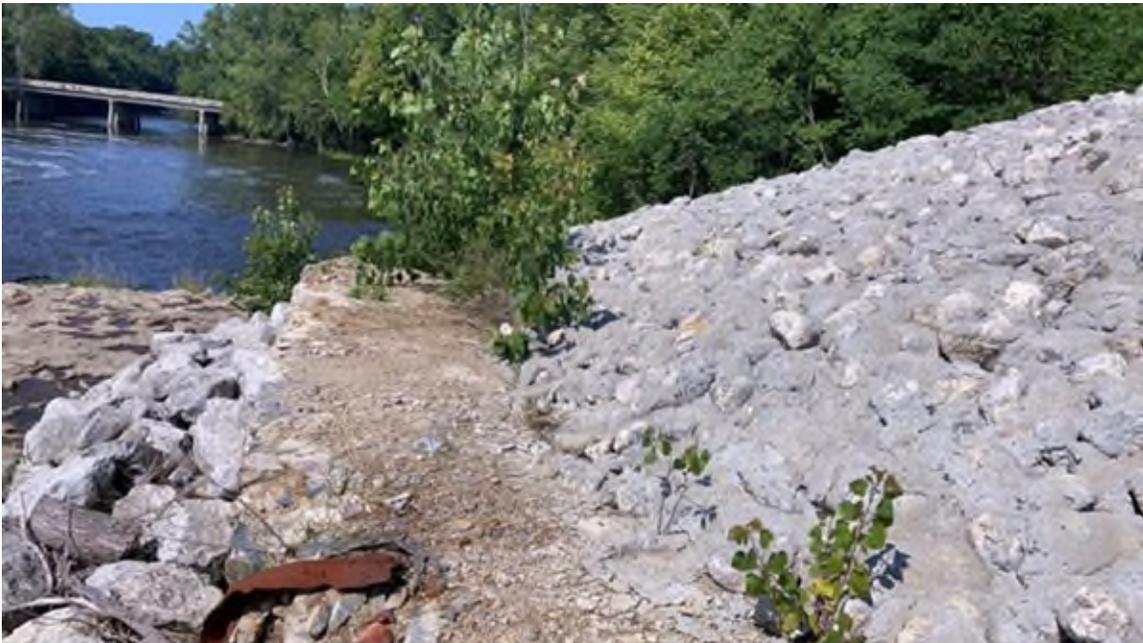
**Photo #80 - Right armored slope of auxiliary spillway above previous powerhouse wall. Note brush growth**

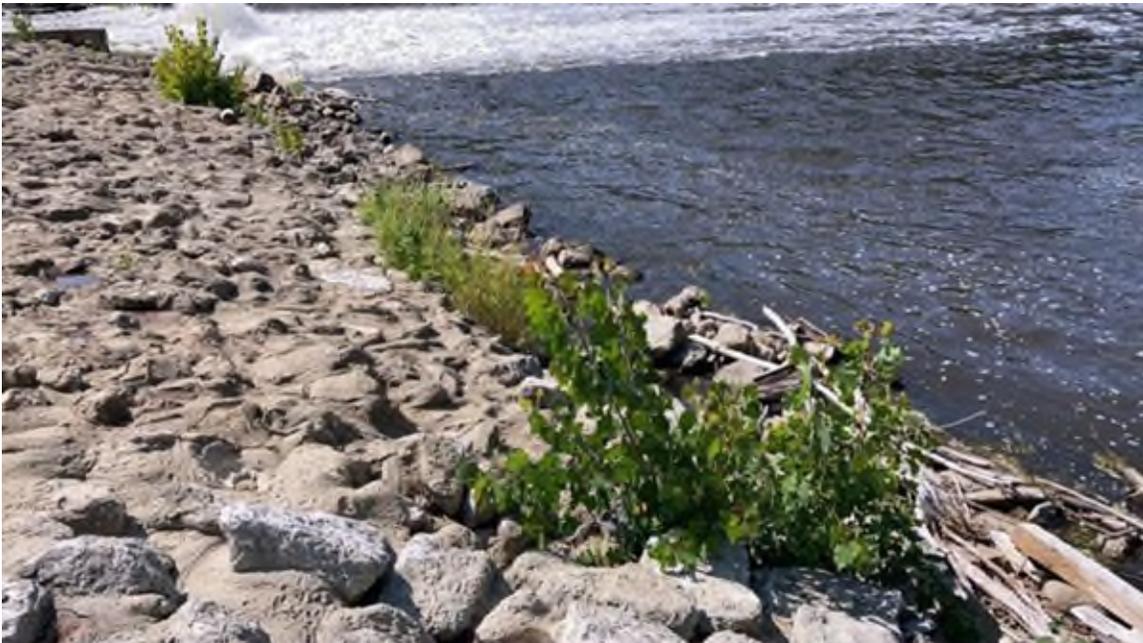
**Photo #84 - Downstream end of auxiliary spillway. Minor vegetation growth starting**

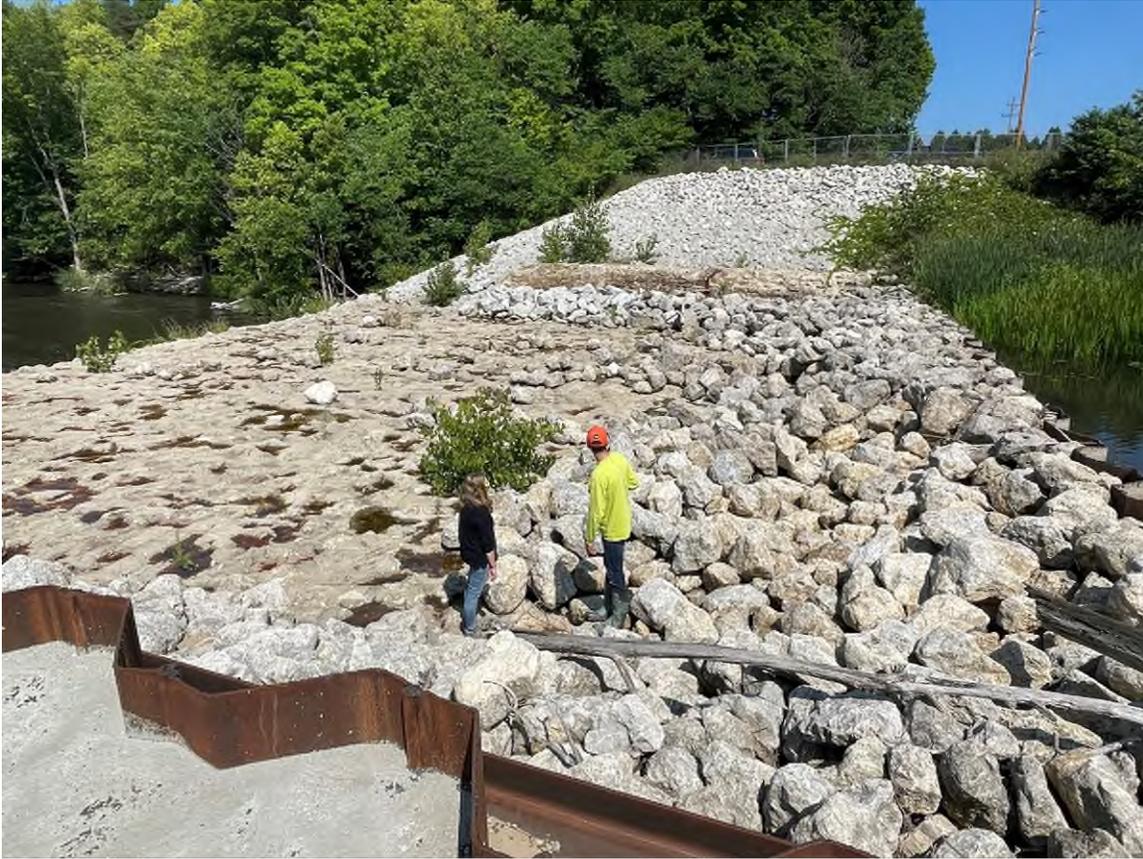
5. Since the 2022 Dam Safety Inspection, riprap within the auxiliary spillway apron has become displaced from the downstream face of the steel sheet pile spillway crest. It is unclear whether this riprap is crucial to the stability of the steel sheet piling or if it serves as scour protection and energy dissipation only. Consult with your engineer to determine the function and criticality of this displaced riprap. Implement repairs as directed by your engineer. This consultation should occur before December 31, 2023, and repairs should be implemented as directed by your engineer.

**Photo #91 - Displaced riprap downstream of auxiliary spillway crest**
