**Subject: Sawmill, AZ Asbestos Removal Assessment
Sawmill Chapter, Navajo Nation, Arizona
Task Order (TO) No.: 68HE0919F0081-20
Document Control No.: 0145-08-AAXL**

PHOTOGRAPH LOG

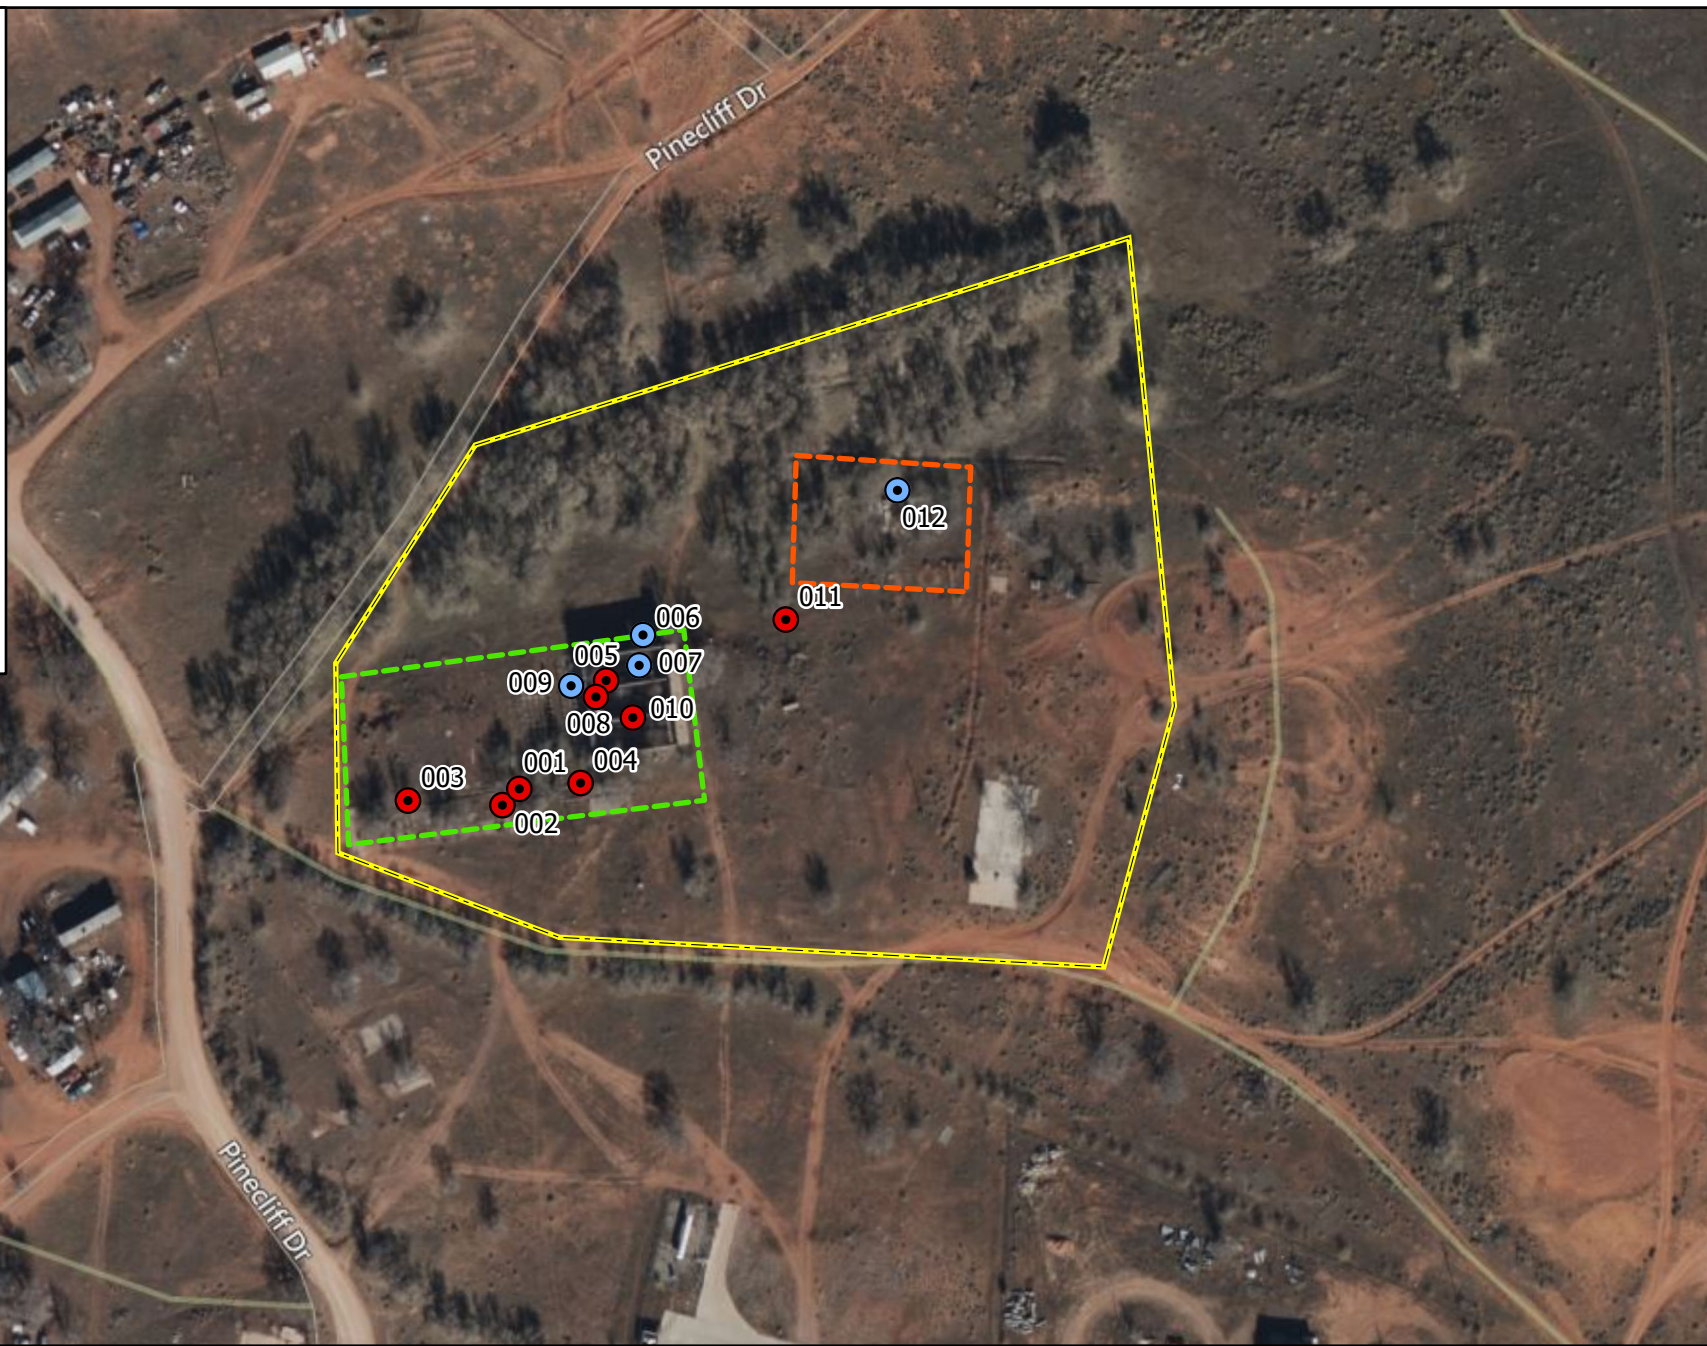
FIGURE 3
Bulk Asbestos Sample Locations
Sawmill, Arizona Asbestos
Removal Assessment
Sawmill Chapter, Navajo Nation
Sawmill, Apache County, AZ

Twelve bulk samples were collected, and 13 separate layers were analyzed. Of the 13 bulk samples collected, nine samples contained asbestos at concentrations ranging from 3% to 80% chrysotile. Sample results are shown below in **Table 1**. **Figure 3** shows the location of the asbestos bulk samples collected at the Site.

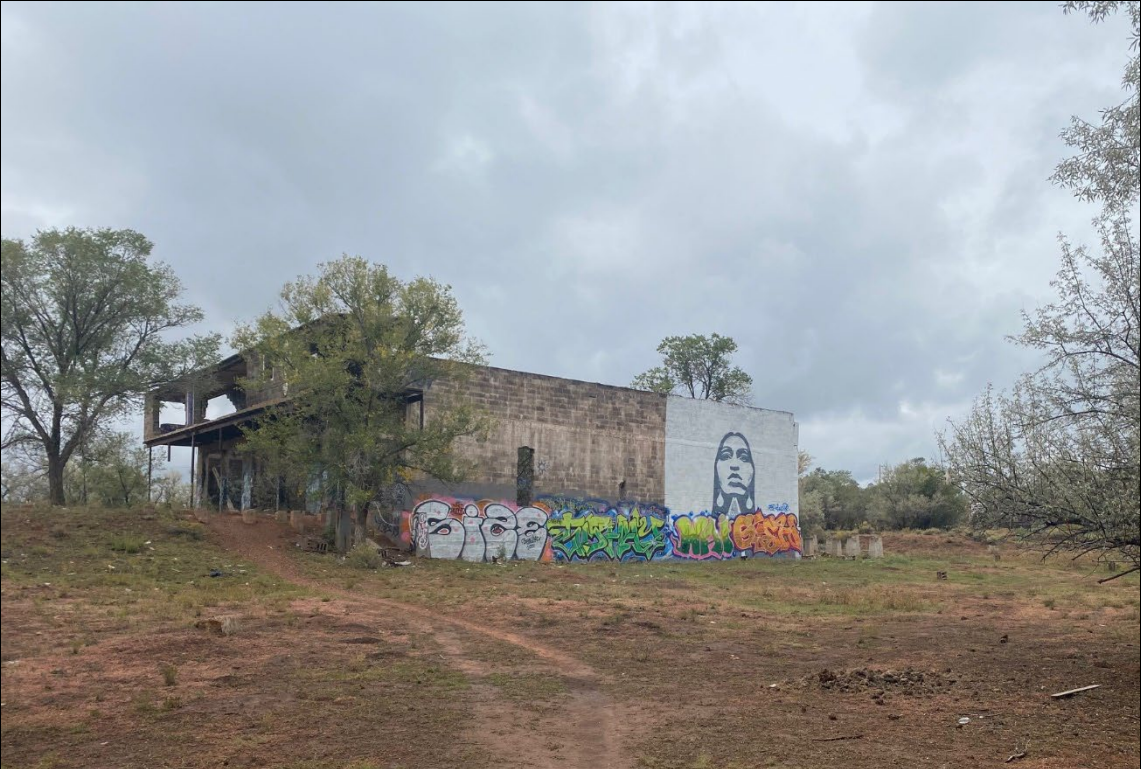
Project Name: Sawmill, AZ Asbestos		Site Location: Sawmill Chapter, Navajo Nation Sawmill, Apache County, Arizona	TO No.: 68HE0919F0081-20
Photo No. 1	Date: 9/30/2021

Direction Photo Taken: Southwest			
Description: Overview of the former Drying Kiln Building

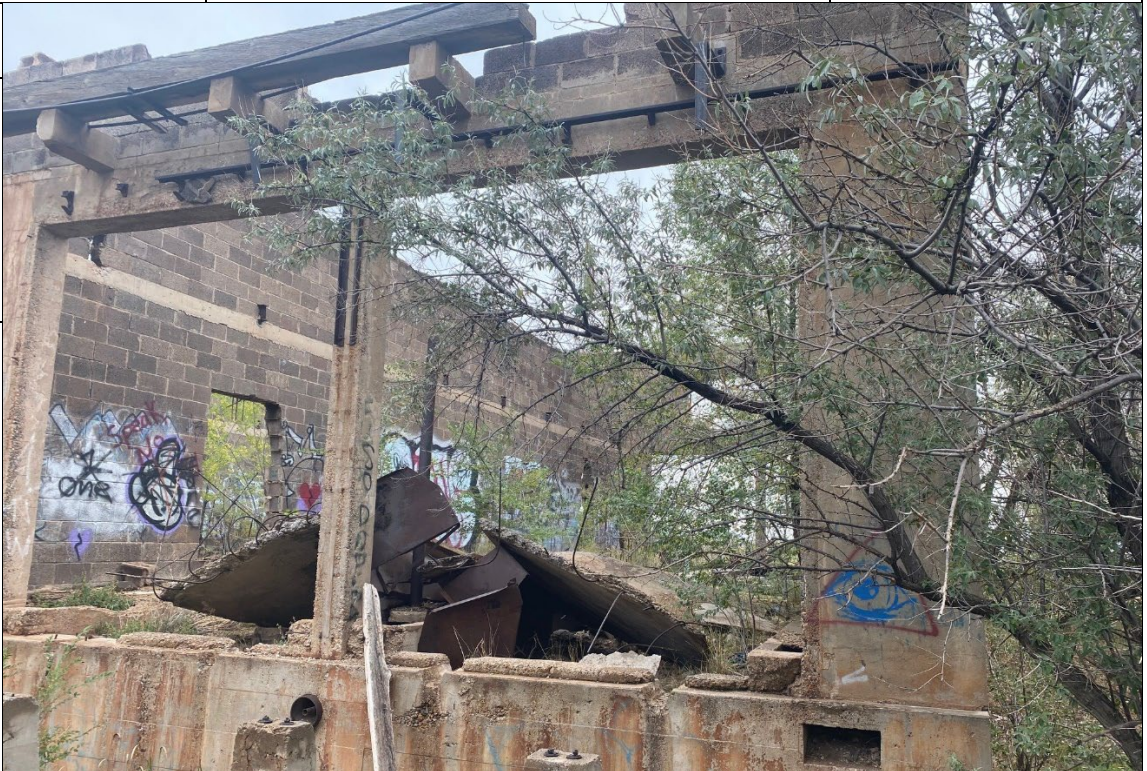
Project Name: Sawmill, AZ Asbestos		Site Location: Sawmill Chapter, Navajo Nation Sawmill, Apache County, Arizona	TO No.: 68HE0919F0081-20
Photo No. 3	Date: 9/30/2021

Direction Photo Taken: West			
Description: View inside the former Drying Kiln Building showing collapsed roof
