MEMORANDUM

SUBJECT: Request for Approval of a Time-Critical Removal Action, Ceiling Increase and 12-Month Exemption at the Allied Textile Printing Site, Passaic County, Paterson, New Jersey

Attachment B
Photographic Documentation
Allied Textile Printing Site
Paterson, Passaic County, New Jersey

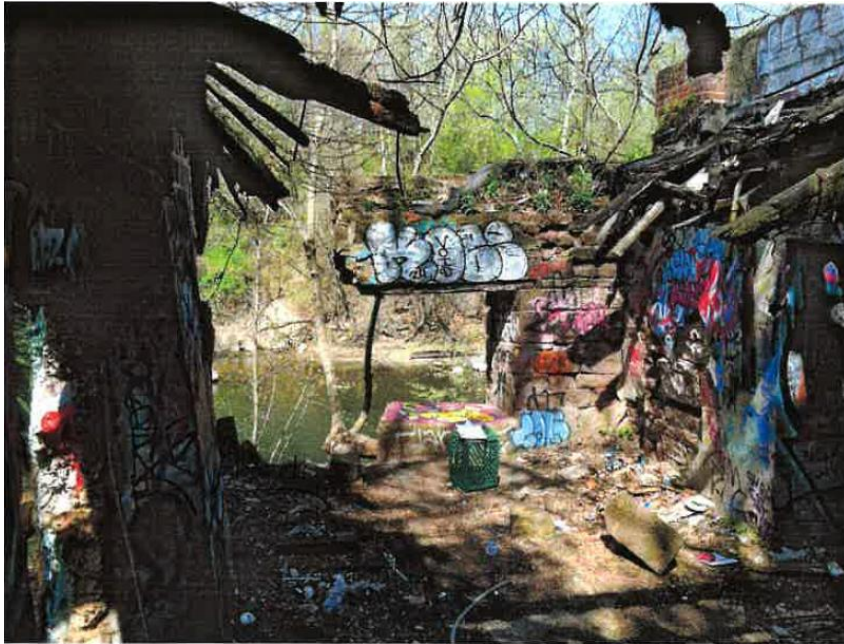
Photograph 1: A 2015 view of a room south of Building No. 14A, looking west with the Passaic River in the background.

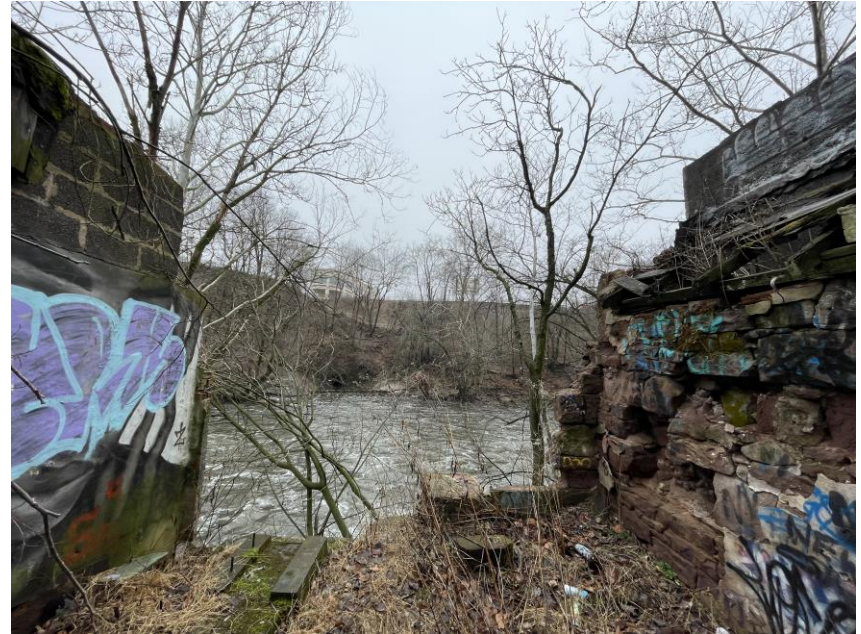
Photograph 2: A 2024 view of a room south of Building No. 14A, looking west with the Passaic River in the background.

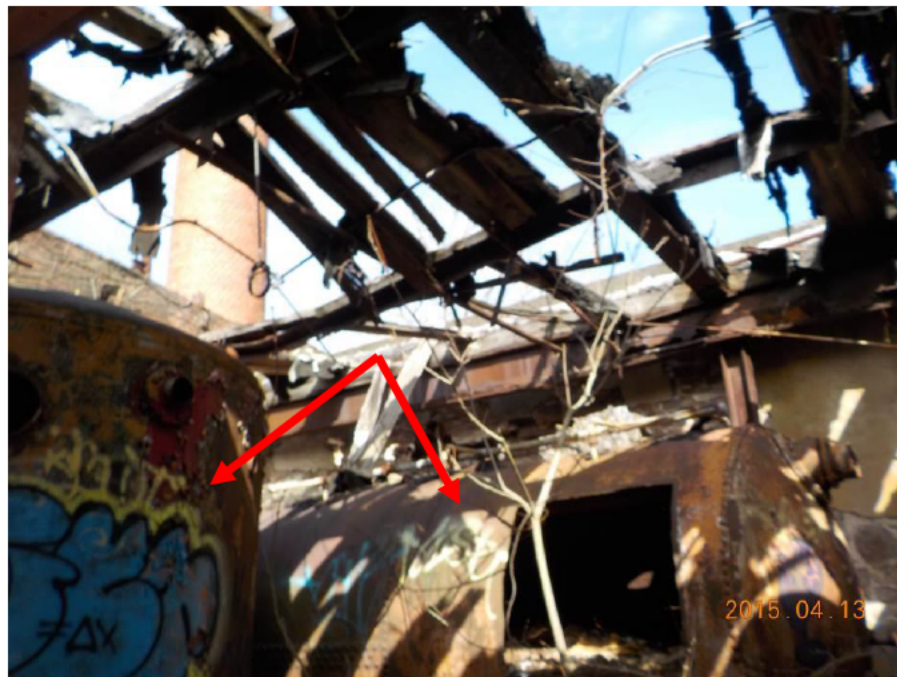
Building 16 contained five above ground storage tanks ("AST"s). At least two of these tanks had been cut open, exposing their interiors. Suspected asbestos containing material ("SACM") was observed on the floor of the west wall between two of the tanks and on an overhead pipe.

Photograph 6: A view of the interior of Building No. 16. The building roof had collapsed with debris covering the floor. There were five abandoned ASTs located inside the building.

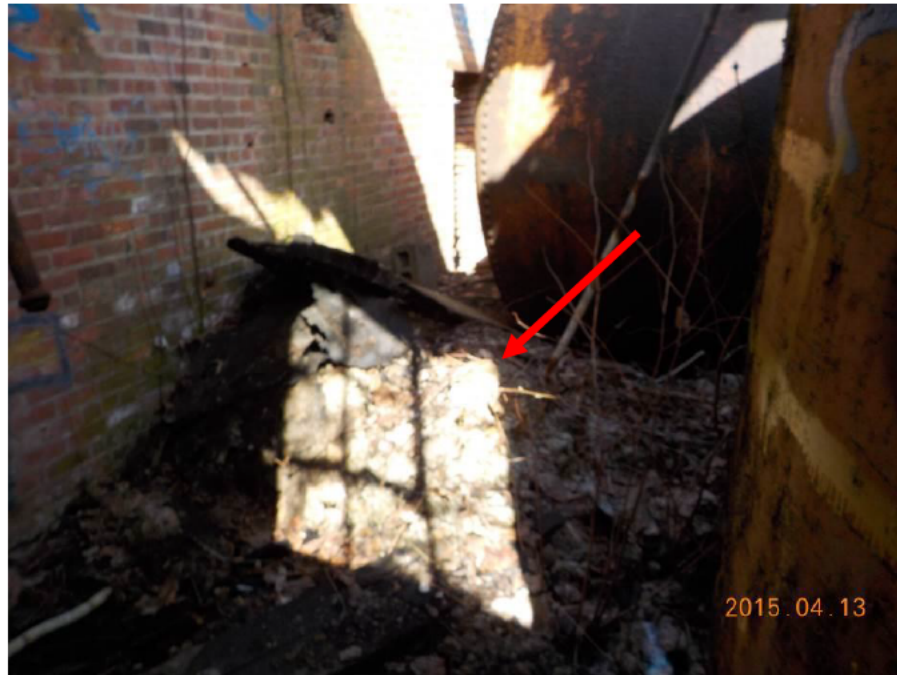
Photograph 7: SACM was observed on the floor of the west wall between two tanks inside Building No. 16.

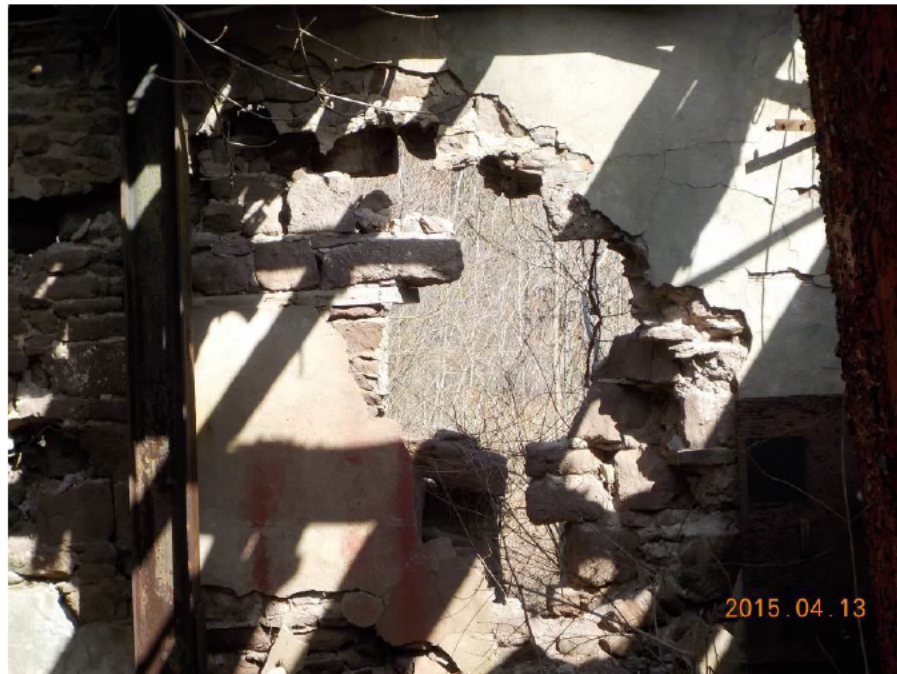
Photograph 8: The north wall of Building No. 16 was broken at two locations.

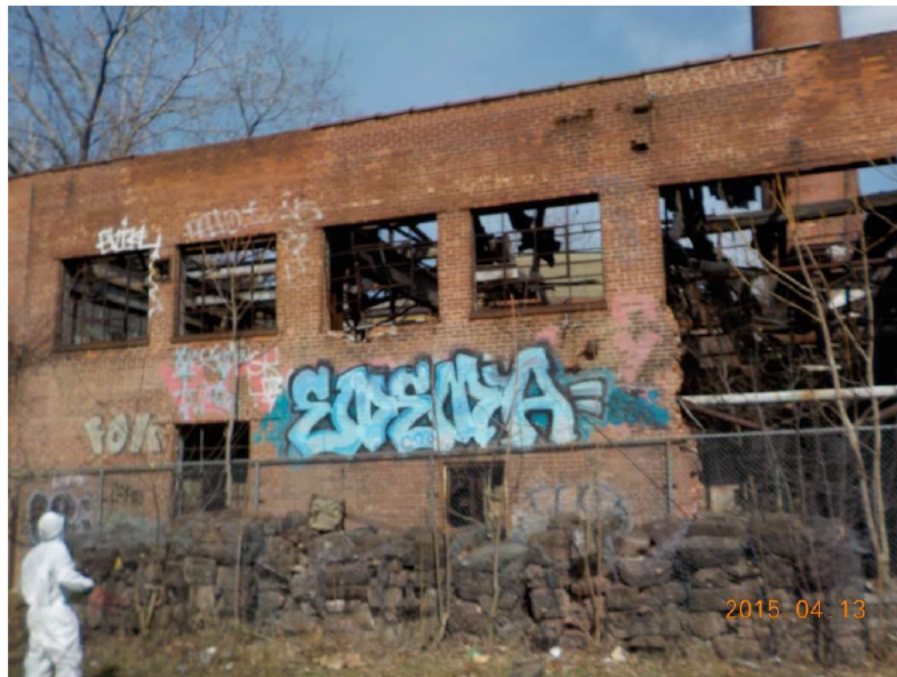
The Building 14 windows on the south and west sides were missing and the remaining portions were badly deteriorated. The wall on the east side of the building north of Building 16 was almost completely gone from the floor to the roof. The building roof had collapsed and debris including trash, clothes, ash, pipes, machine parts and remnants of the roofing material were observed throughout the building floor. SACM was observed mixed with the floor debris. Three boilers observed in Building 14 were identified from east to west as boilers 1 through 3. A tank and associated piping was observed on top of each boiler. SACM was observed on top of each of these tanks and affiliated piping and on top of each boiler. SACM was also observed within corroded sections of the boiler's metal jacket. Ash was observed falling out of the three boilers at cleanout ports and through damaged portions of the boiler and on the surrounding ground at the base of each boiler. Ladders and catwalks servicing the areas above the boilers were dilapidated and appeared unsafe for use. SACM was observed on the floor around the three blower motors that were associated with each boiler. The SACM observed on the floor was suspected to have sloughed from overhead piping. SACM was also observed on the floor next to boiler 1 at the southeast corner of the building.

Photograph 9: A view of the south wall of Building No. 14. The building roof had collapsed, the windows are all broken and some of the walls have holes.

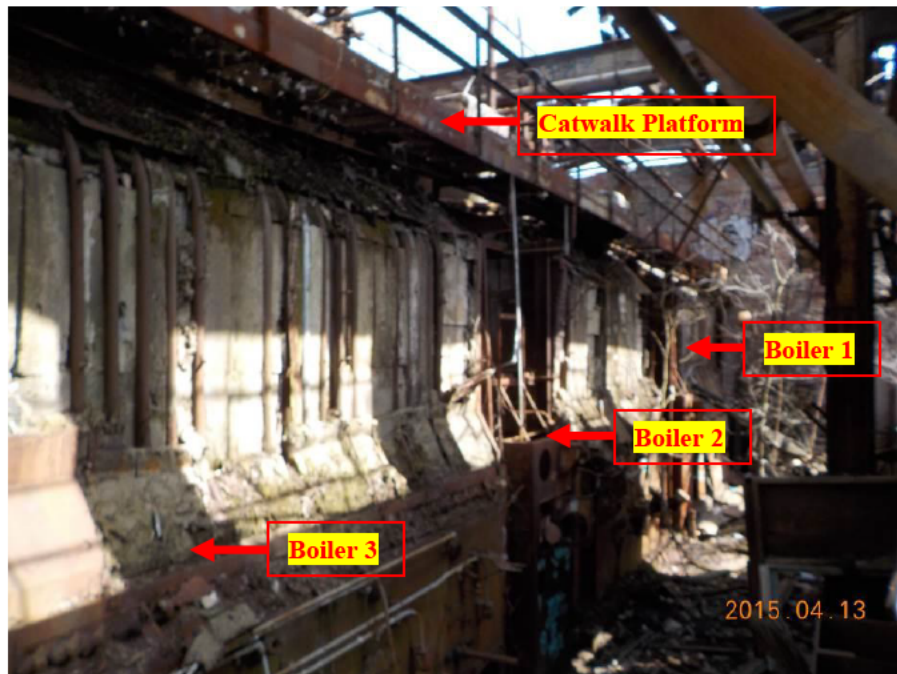
Photograph 10: A view of the interior of Building No. 14. The catwalk which provides access to the boilers via ladders appeared unsafe with rusty spots observed along sections of the platform.

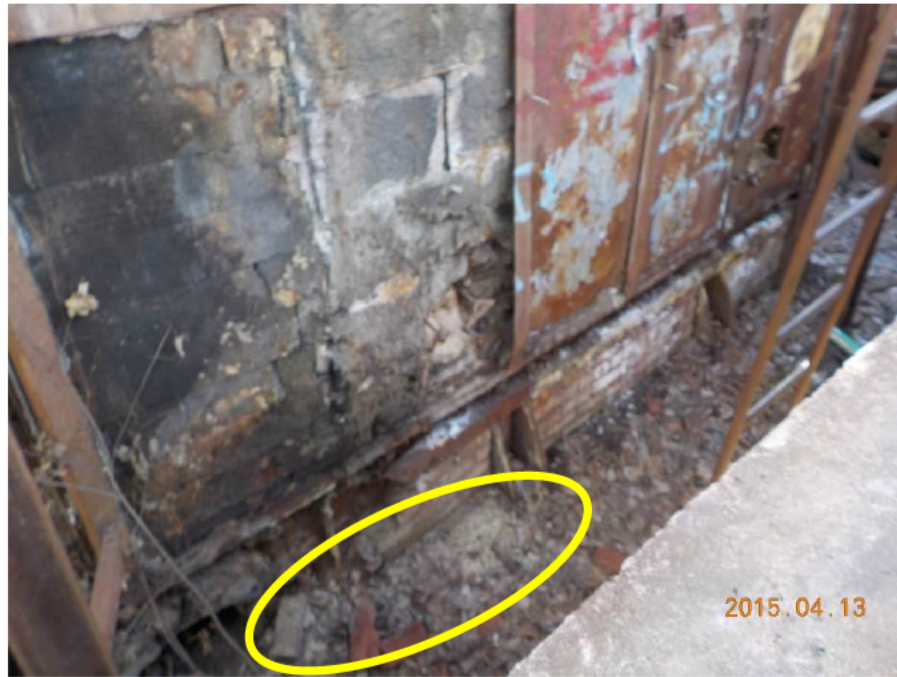
Three decrepit boilers in Building 14 are deteriorating, exposing the inner portions of the boilers including insulation, heat exchange pipes and ash. The ash of these boilers is falling out of the rusted openings as well as from maintenance and observation ports on different parts of each boiler. This ash was sampled and TCLP lead results evidenced lead at levels exceeding the Resource Conservation and Recovery Act ("RCRA") TCLP threshold value of 5 mg/L.

Photograph 11: Ash material was observed at the base of each boiler inside Building No. 14.

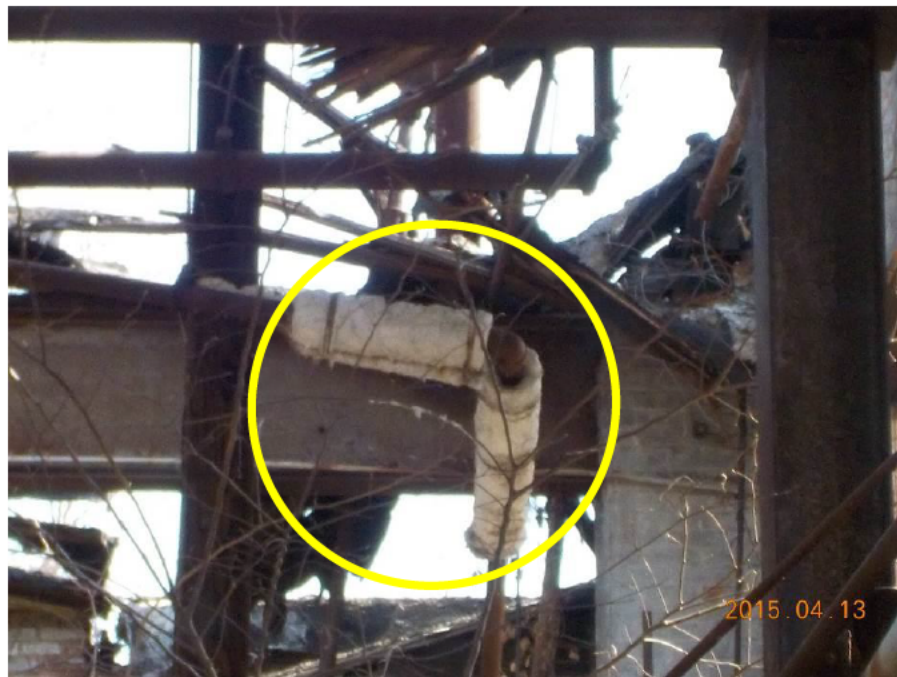
Deteriorated SACM was observed on overhead piping throughout Building 14. SACM was observed on an overhead duct connecting the boiler's exhaust to the smokestack. Ash was also observed in the smokestack cleanout. Dislodged bricks appeared to have been displaced around the top rim of the smokestack. SACM was also observed on the ground adjacent to the exterior Building 14 west wall.

Photograph 12: SACM was identified on one overhead pipe, opposite Boiler 1 inside Building No. 14.

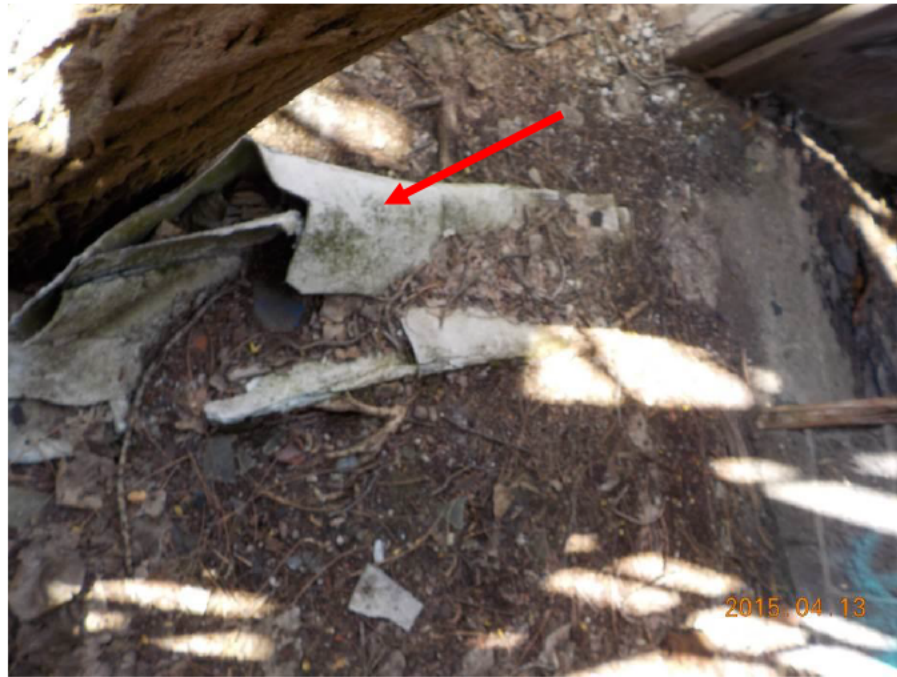
Photograph 13: A sheet of SACM was observed at the point of entry into the 1st Open Room which is located by the west wall of Building No. 14.

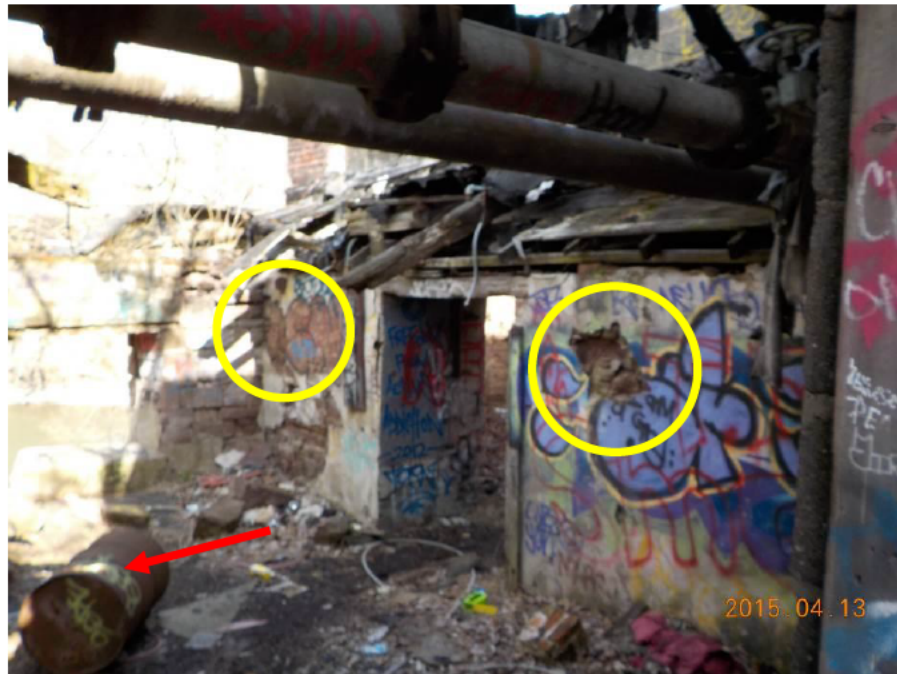
Also, on the west side of Building 14 an open doorway provided access to a room with a collapsed roof, designated by EPA as Open Room 1. Inside an unmarked corroded 55-gallon steel drum was found lying on its side. Pin-holes were observed on one end of the drum.

Photograph 14: A drum containing residual quantity of material was observed in the 1st Open Room (indicated by the red arrow). The drum was rusty with signs of deterioration in the form of pin-hole leaks on the top and bottom. The east wall was cracked at two locations exposing SACM within the wall (yellow circle).

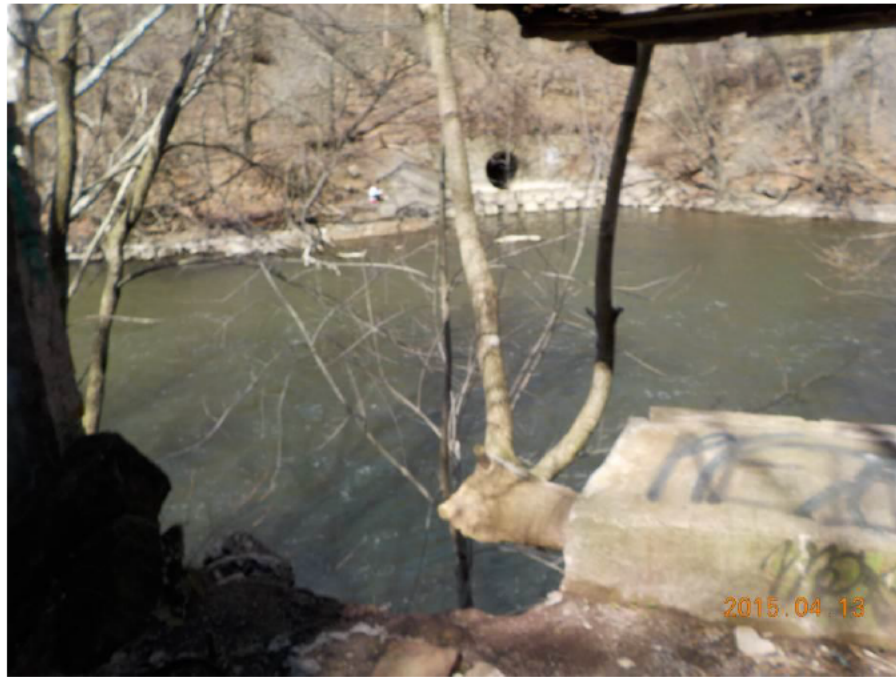
Photograph 15: The north wall of the 1st Open Room was broken and it exposed a view of the Passaic River.

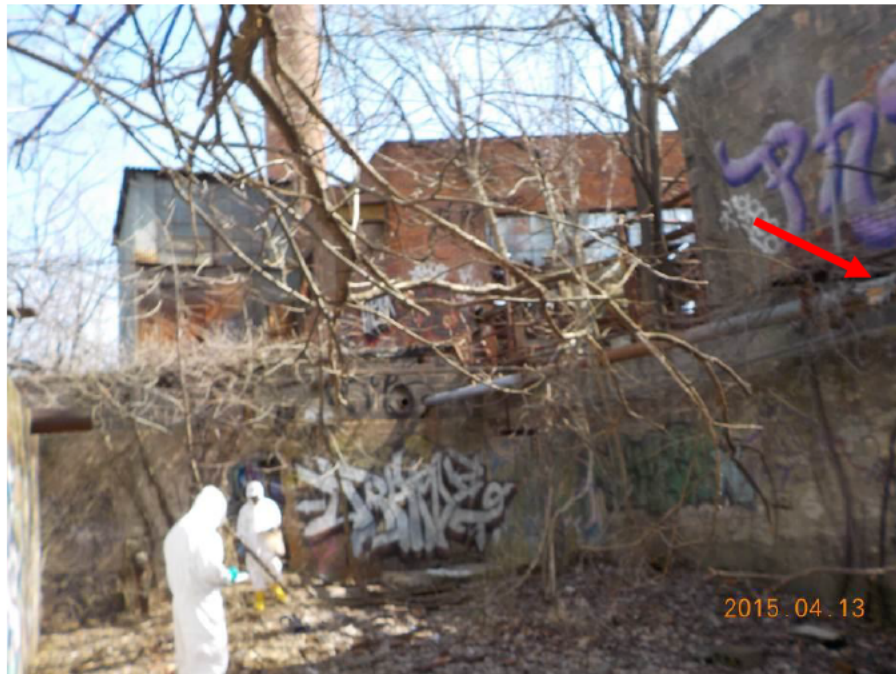
To the west of Open Room 1 was another room also with a totally collapsed roof. This room was designated Open Room 2. SACM was observed on piping approximately ten feet from the ground along the south wall of the building and on the ground mixed with debris.

Photograph 16: A view of the 2nd Open Room. Debris observed throughout the floor. SACM was observed on piping approximately 10 feet from the ground along the south wall of the building. There were no pre-existing roofing structures in this room.

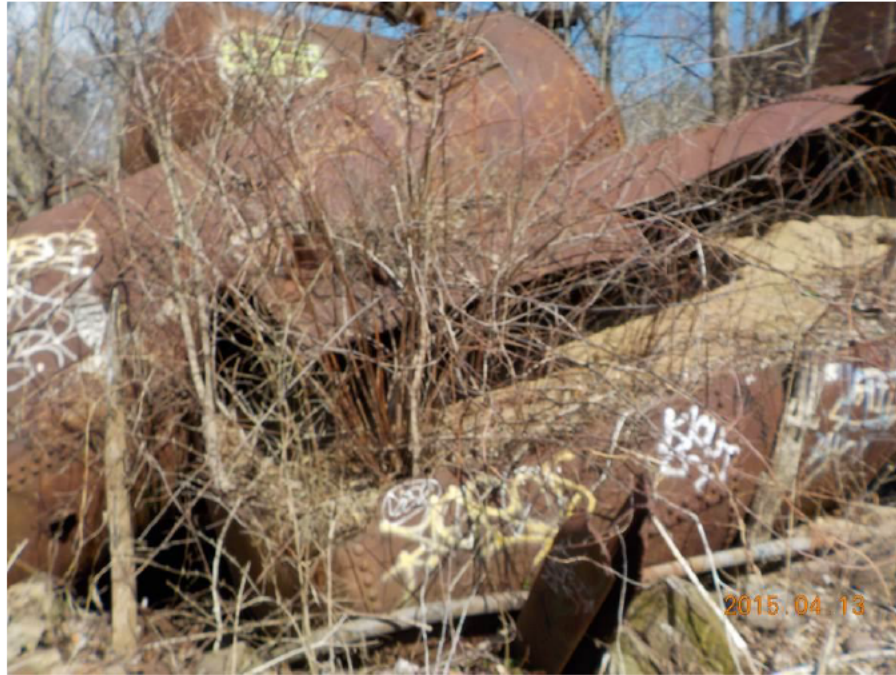
Photograph 17: Abandoned ASTs observed at the Western Building Tank Room.

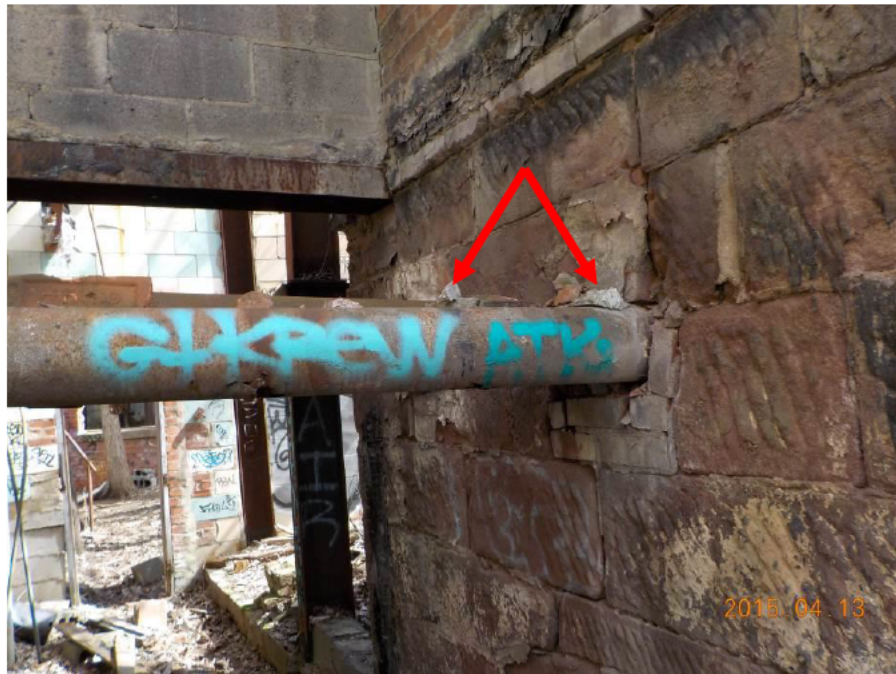
Photograph 18: SACM was identified on piping (indicated by the red arrows) approximately 5 feet from the ground on the east side of the access corridor to the Western Building Tank Room.

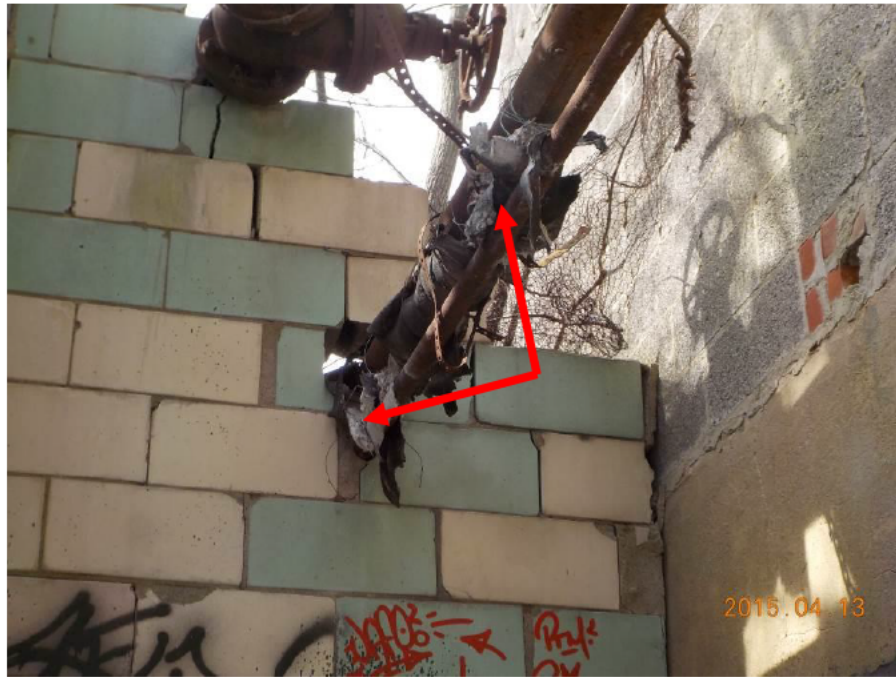
Photograph 19: SACM was identified on piping (indicated by the red arrows) approximately 9 feet from the ground on the west side of the access corridor to the Western Building Tank Room.

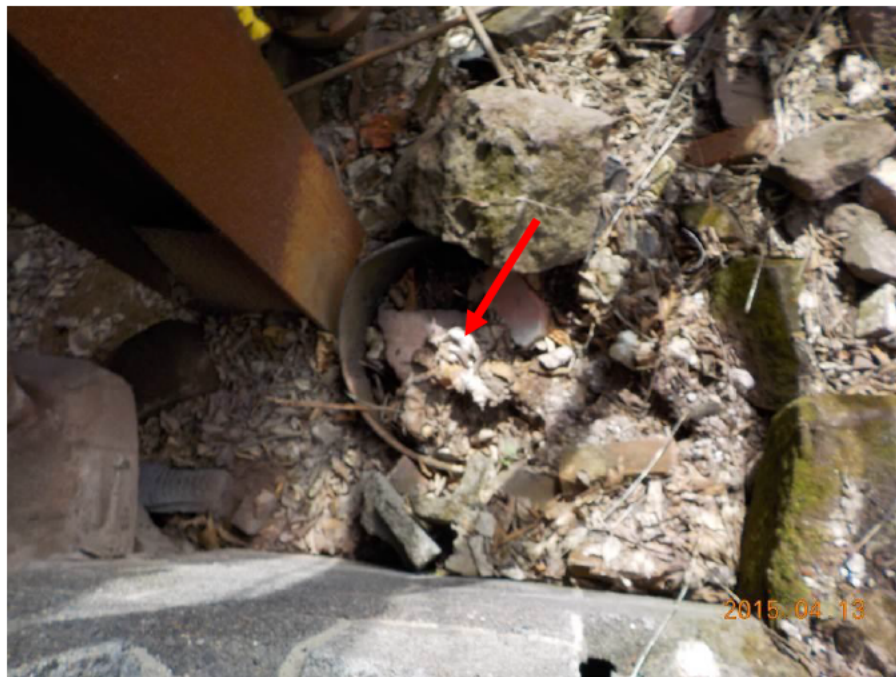
On the east side of the alleyway formed by the south wall of Open Room 2 and the north wall of the remains of a building field designated as the Western Building Tank Room on the exterior northern wall of the Western Building Tank Room, SACM was observed on an overhead pipe approximately nine feet from the ground and on another overhead pipe immediately west of the aforementioned pipe approximately five feet from the ground. Several ASTs were observed in the Western Building Tank Room. A partially buried open top 55-gallon steel drum without a lid in the northwest corner of this room was observed to contain SACM.

Photograph 20: A partially buried drum containing SACM was observed at the northwest corner of the Western Building Tank Room (indicated by the red arrow).

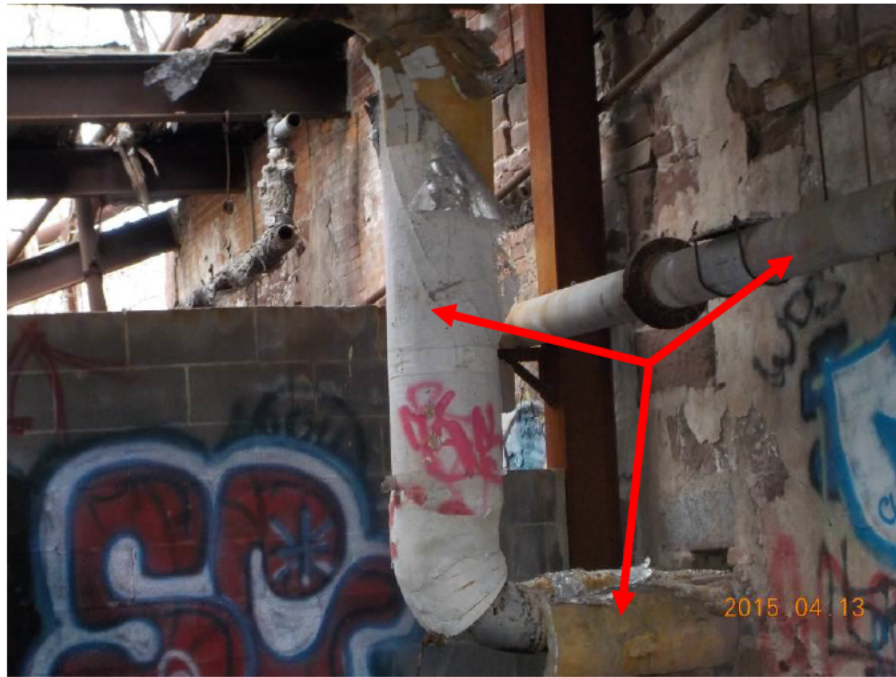
Photograph 21: SACM was observed on overhead piping (indicated by the red arrows) along the south wall inside a Sub Room located within Building No. 14A.

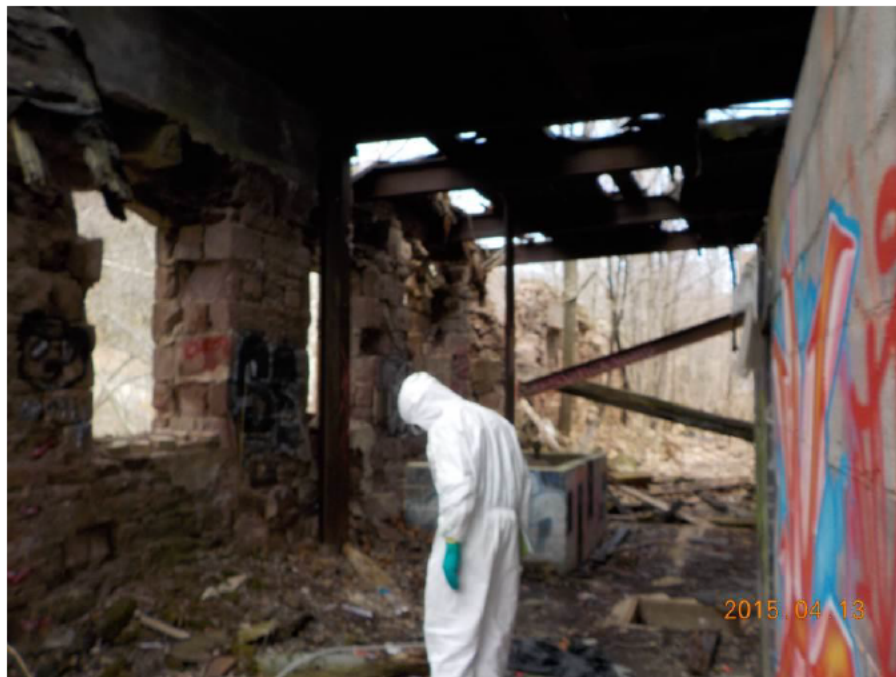
The roof of Building 14A was severely damaged and large holes were present in the walls. The floor was covered with debris, some of which was fallen roof material. A partially walled sub-room with a precariously collapsed roof was present in the building. SACM was observed on overhead piping along the south wall inside the sub-room. SACM was observed mixed with the debris on the floor. A vessel adjacent the north wall surrounded by a half wall also contained SACM in the interstitial space.

Photograph 22: A view of Building No. 14A showing broken walls, damaged roof, and debris throughout the floor.

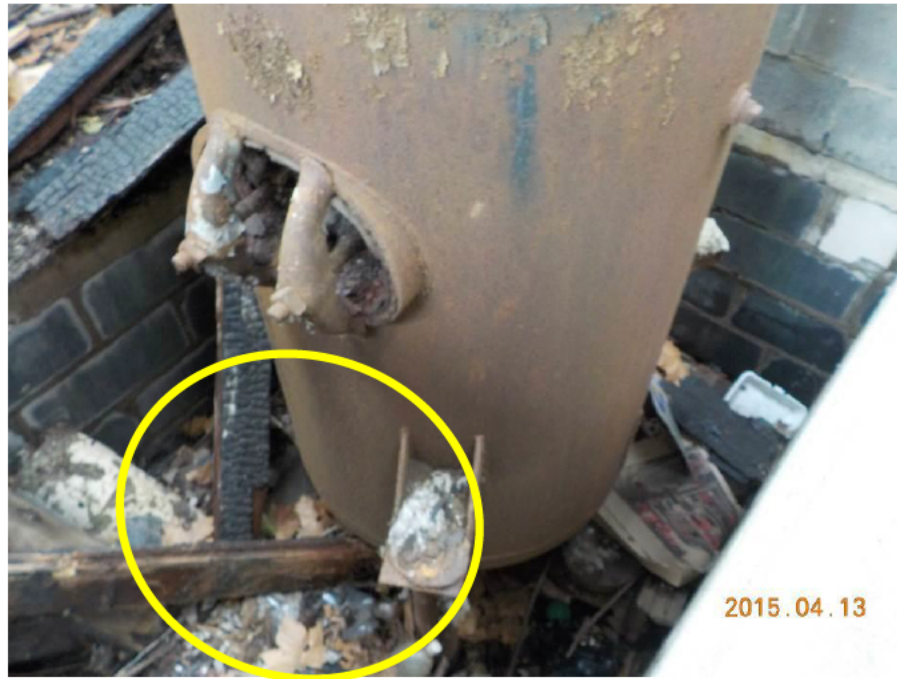
Photograph 23: Inside Building No. 14A, SACM was observed on the floor near a walled tank and within the walled space around the tank.

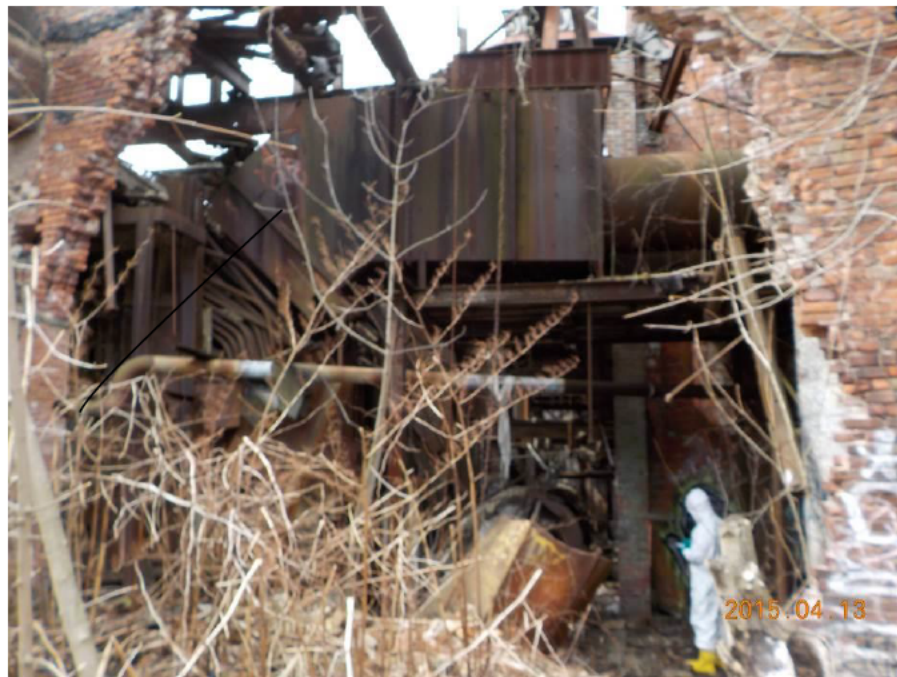
Photograph 24: The southwest wall of Building No. 12 was broken and it exposed the northeast portion of Building No. 14.

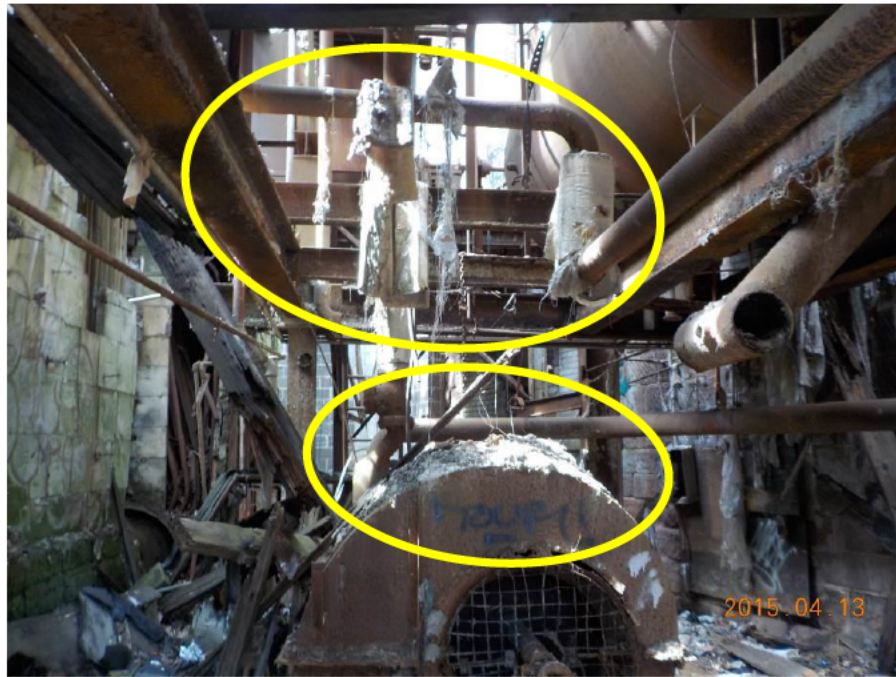
Photograph 25: SACM was observed on the floor around the three blowers that were associated with each of the boilers inside Building No. 14. The SACM observed on the floor was suspected to be slough from overhead piping associated with the blowers.

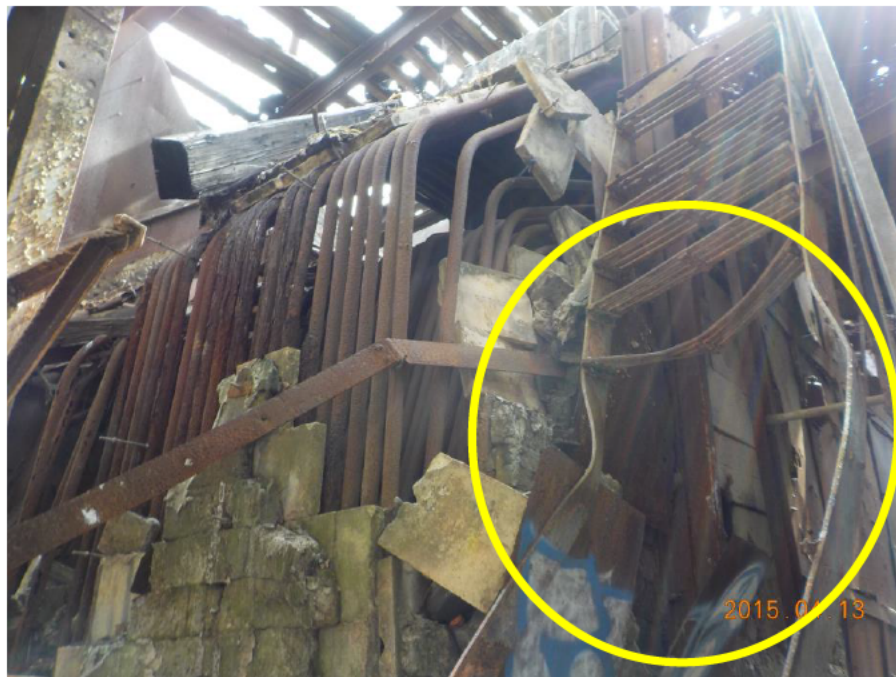
Photograph 26: View of intricate ducts associated with the boilers, blowers and the exhaust stack within Building No. 14. The yellow circle shows the extent of damage to one of the several ladders used to access the catwalk platform.

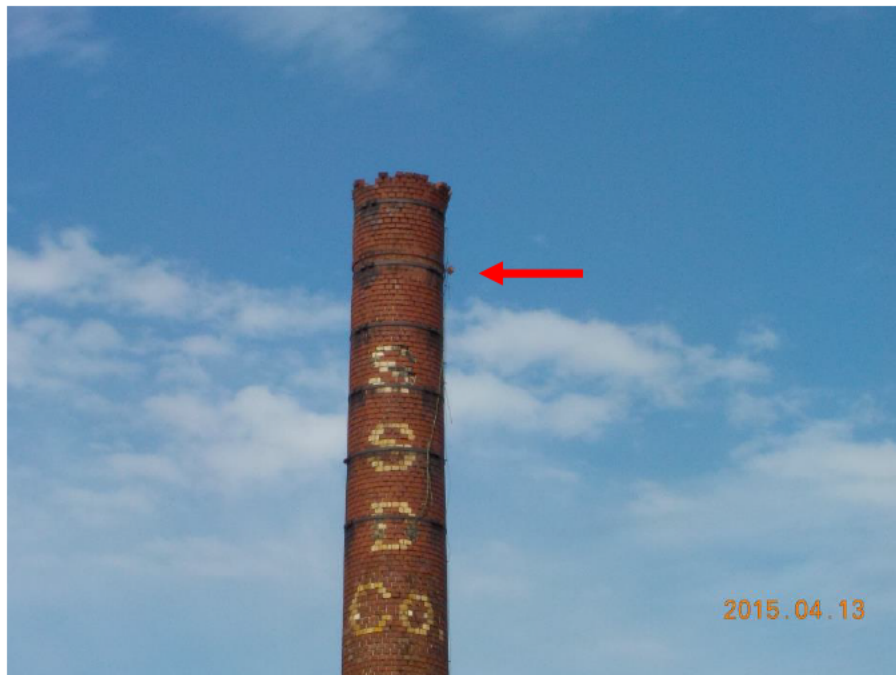
Photograph 28: Dislodged bricks, indicated by the red arrow, were observed to be hanging around the rim of the exhaust stack which was located inside Building No. 14.
