September 24, 2024

Scott Owens  
R.A.I., Inc.  
1390 13<sup>th</sup> Street  
PO Box 776124  
Steamboat Springs, CO 80477  
NWCC Project No: 24-13440

Subject: Inspection for Asbestos Containing  
Building Materials, 62 West Acres  
Drive, Steamboat Springs, Colorado

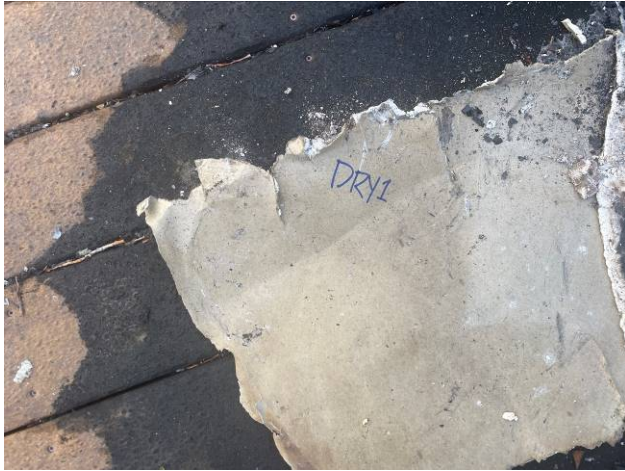
- *White, Drywall*: Two samples (*DRY1 and DRY2*) including associated components (e.g., tape and joint compound) were collected from approximately 3,025 ft<sup>2</sup> of assumed walls and ceilings in the remaining rubble. The collected samples were classified as friable miscellaneous material observed in significantly damaged condition.

Drywall.

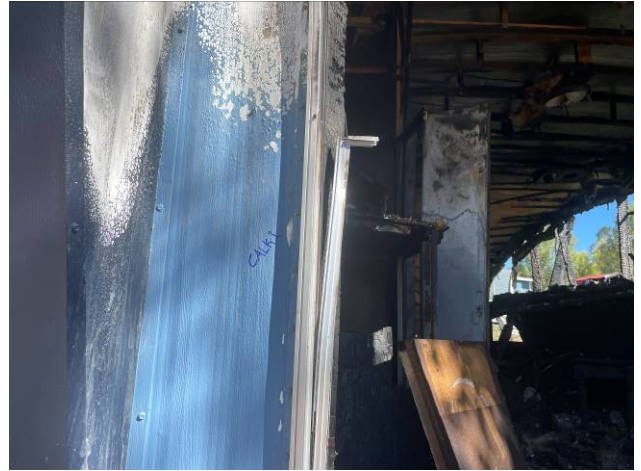
- *White, Caulk*: Two samples (*CALK1 and CALK2*) were collected from approximately 42 linear feet of window trim from the south facing window system. The collected samples were classified as friable miscellaneous material observed in damaged condition. The quantity of this material is estimated at less than 1-gallon.

Calking.

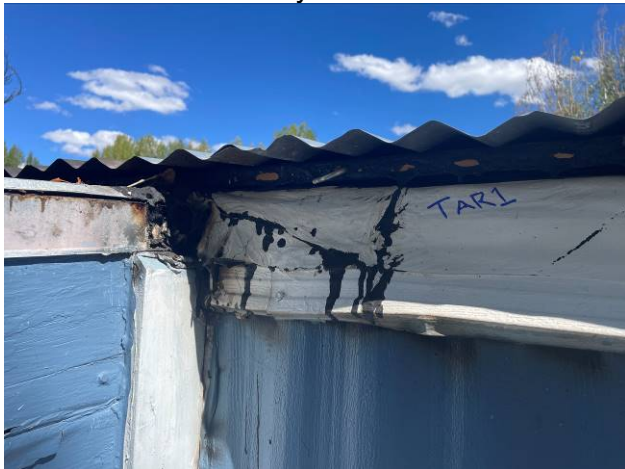
- *Black, Tar Roofing Underlayment*: Two samples (*TAR1 and TAR2*) were collected from approximately 1,300 ft<sup>2</sup> of roofing underlayment on the south portion of the structure. The collected samples were classified as friable miscellaneous material observed in significantly damaged condition. In accordance with Reg. 8 Section IV.F.2. d. this material was classified as damaged or significantly damaged friable miscellaneous ACM.

- Chrysotile asbestos reported at 4% in the silver resinous material (Sample TAR2) component of the tar roofing collected from roofing underlayment on the south portion of the structure. All tar roofing in this homogenous area is considered ACBM.

The black, tar roofing covers the entirety of the approximately 1,300 ft<sup>2</sup> footprint of the structure, which is above the regulatory trigger level. Due to the plane crash and resulting fire, tar roofing is most likely dispersed throughout the rubble and indistinguishable from other building materials.

Tar roofing.

Asbestos was not identified in any other samples. The remaining structure remnant and debris was destroyed by fire. Based on the debris piled in the structure and remaining in the debris field outside the building, it is likely that other ACBM is buried and hidden. Moreover, various building materials have been reduced to ash and are unrecognizable. Because ACBM was identified above the trigger levels and based on the materials condition, NWCC recommends that the entire site be abated by a certified asbestos abatement contractor. Regulation 8 Section III. A, requires that a copy of this inspection report be on-site during deconstruction, demolition, and/or asbestos abatement activities.
