ACTION MEMORANDUM

SUBJECT: Approval and Funding for a Removal Action at the Saints John Mine Site in Montezuma, Summit County, Colorado

Pre-CERCLA Screening Checklist/Decision Document

Sts. John Mine, Montezuma, Colorado

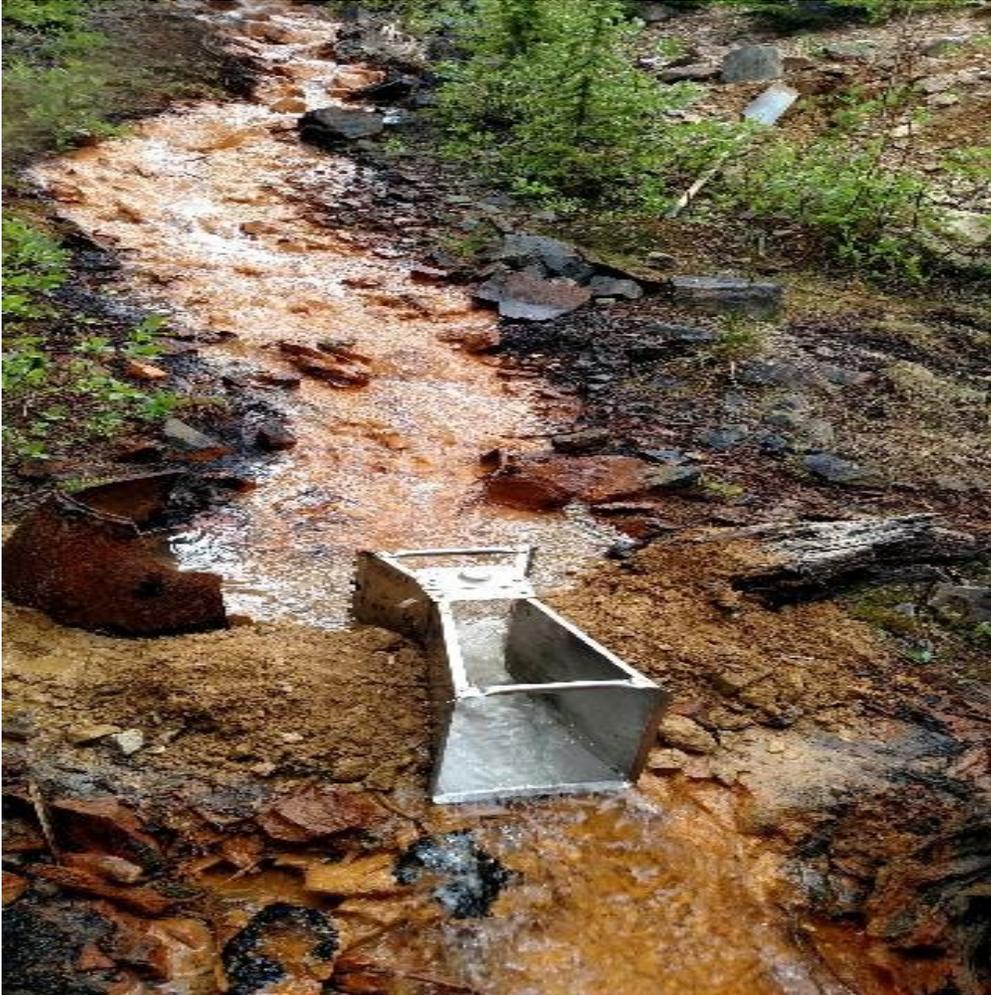
Flume location downstream of STJ-SW-A01-02

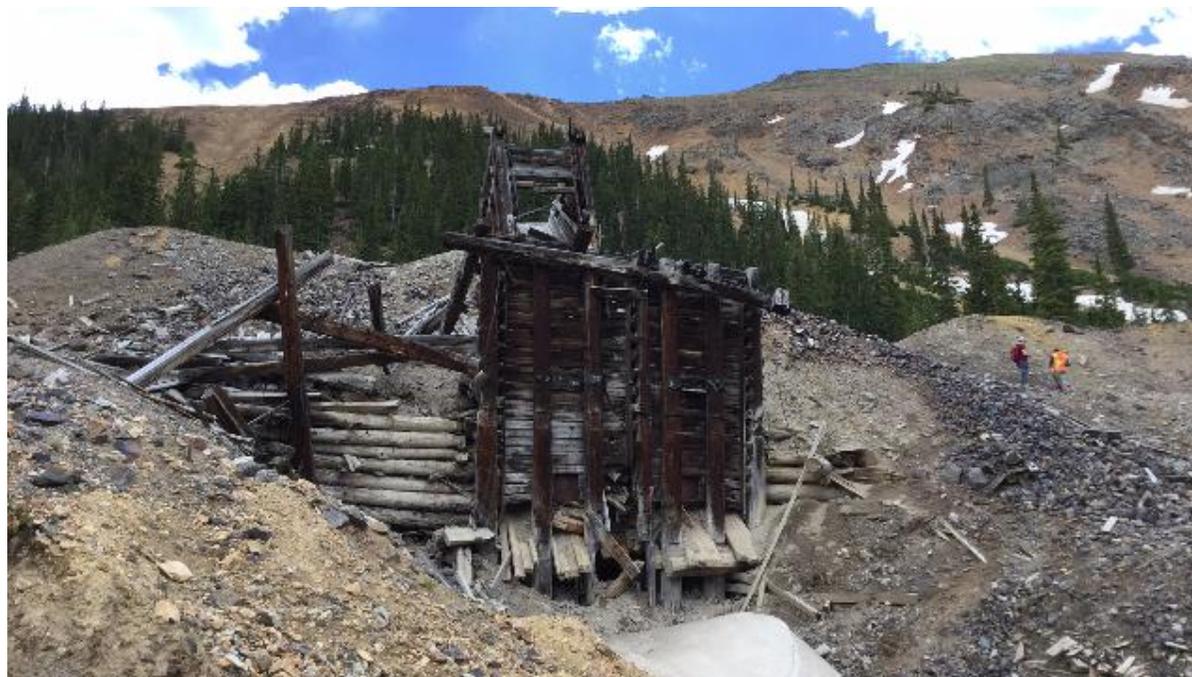
The pile of mine waste at the Site is without vegetation and visibly eroded. The erosion appears to be episodic during stormwater events. Some efforts were made to control stormwater while the mine was active. Contaminated mine waste was used to create a large run-on control berm along the south, uphill perimeter of the mine. This historic drainage control has been overwhelmed by natural mud and debris flows from the mountains above.

STJ waste pile area

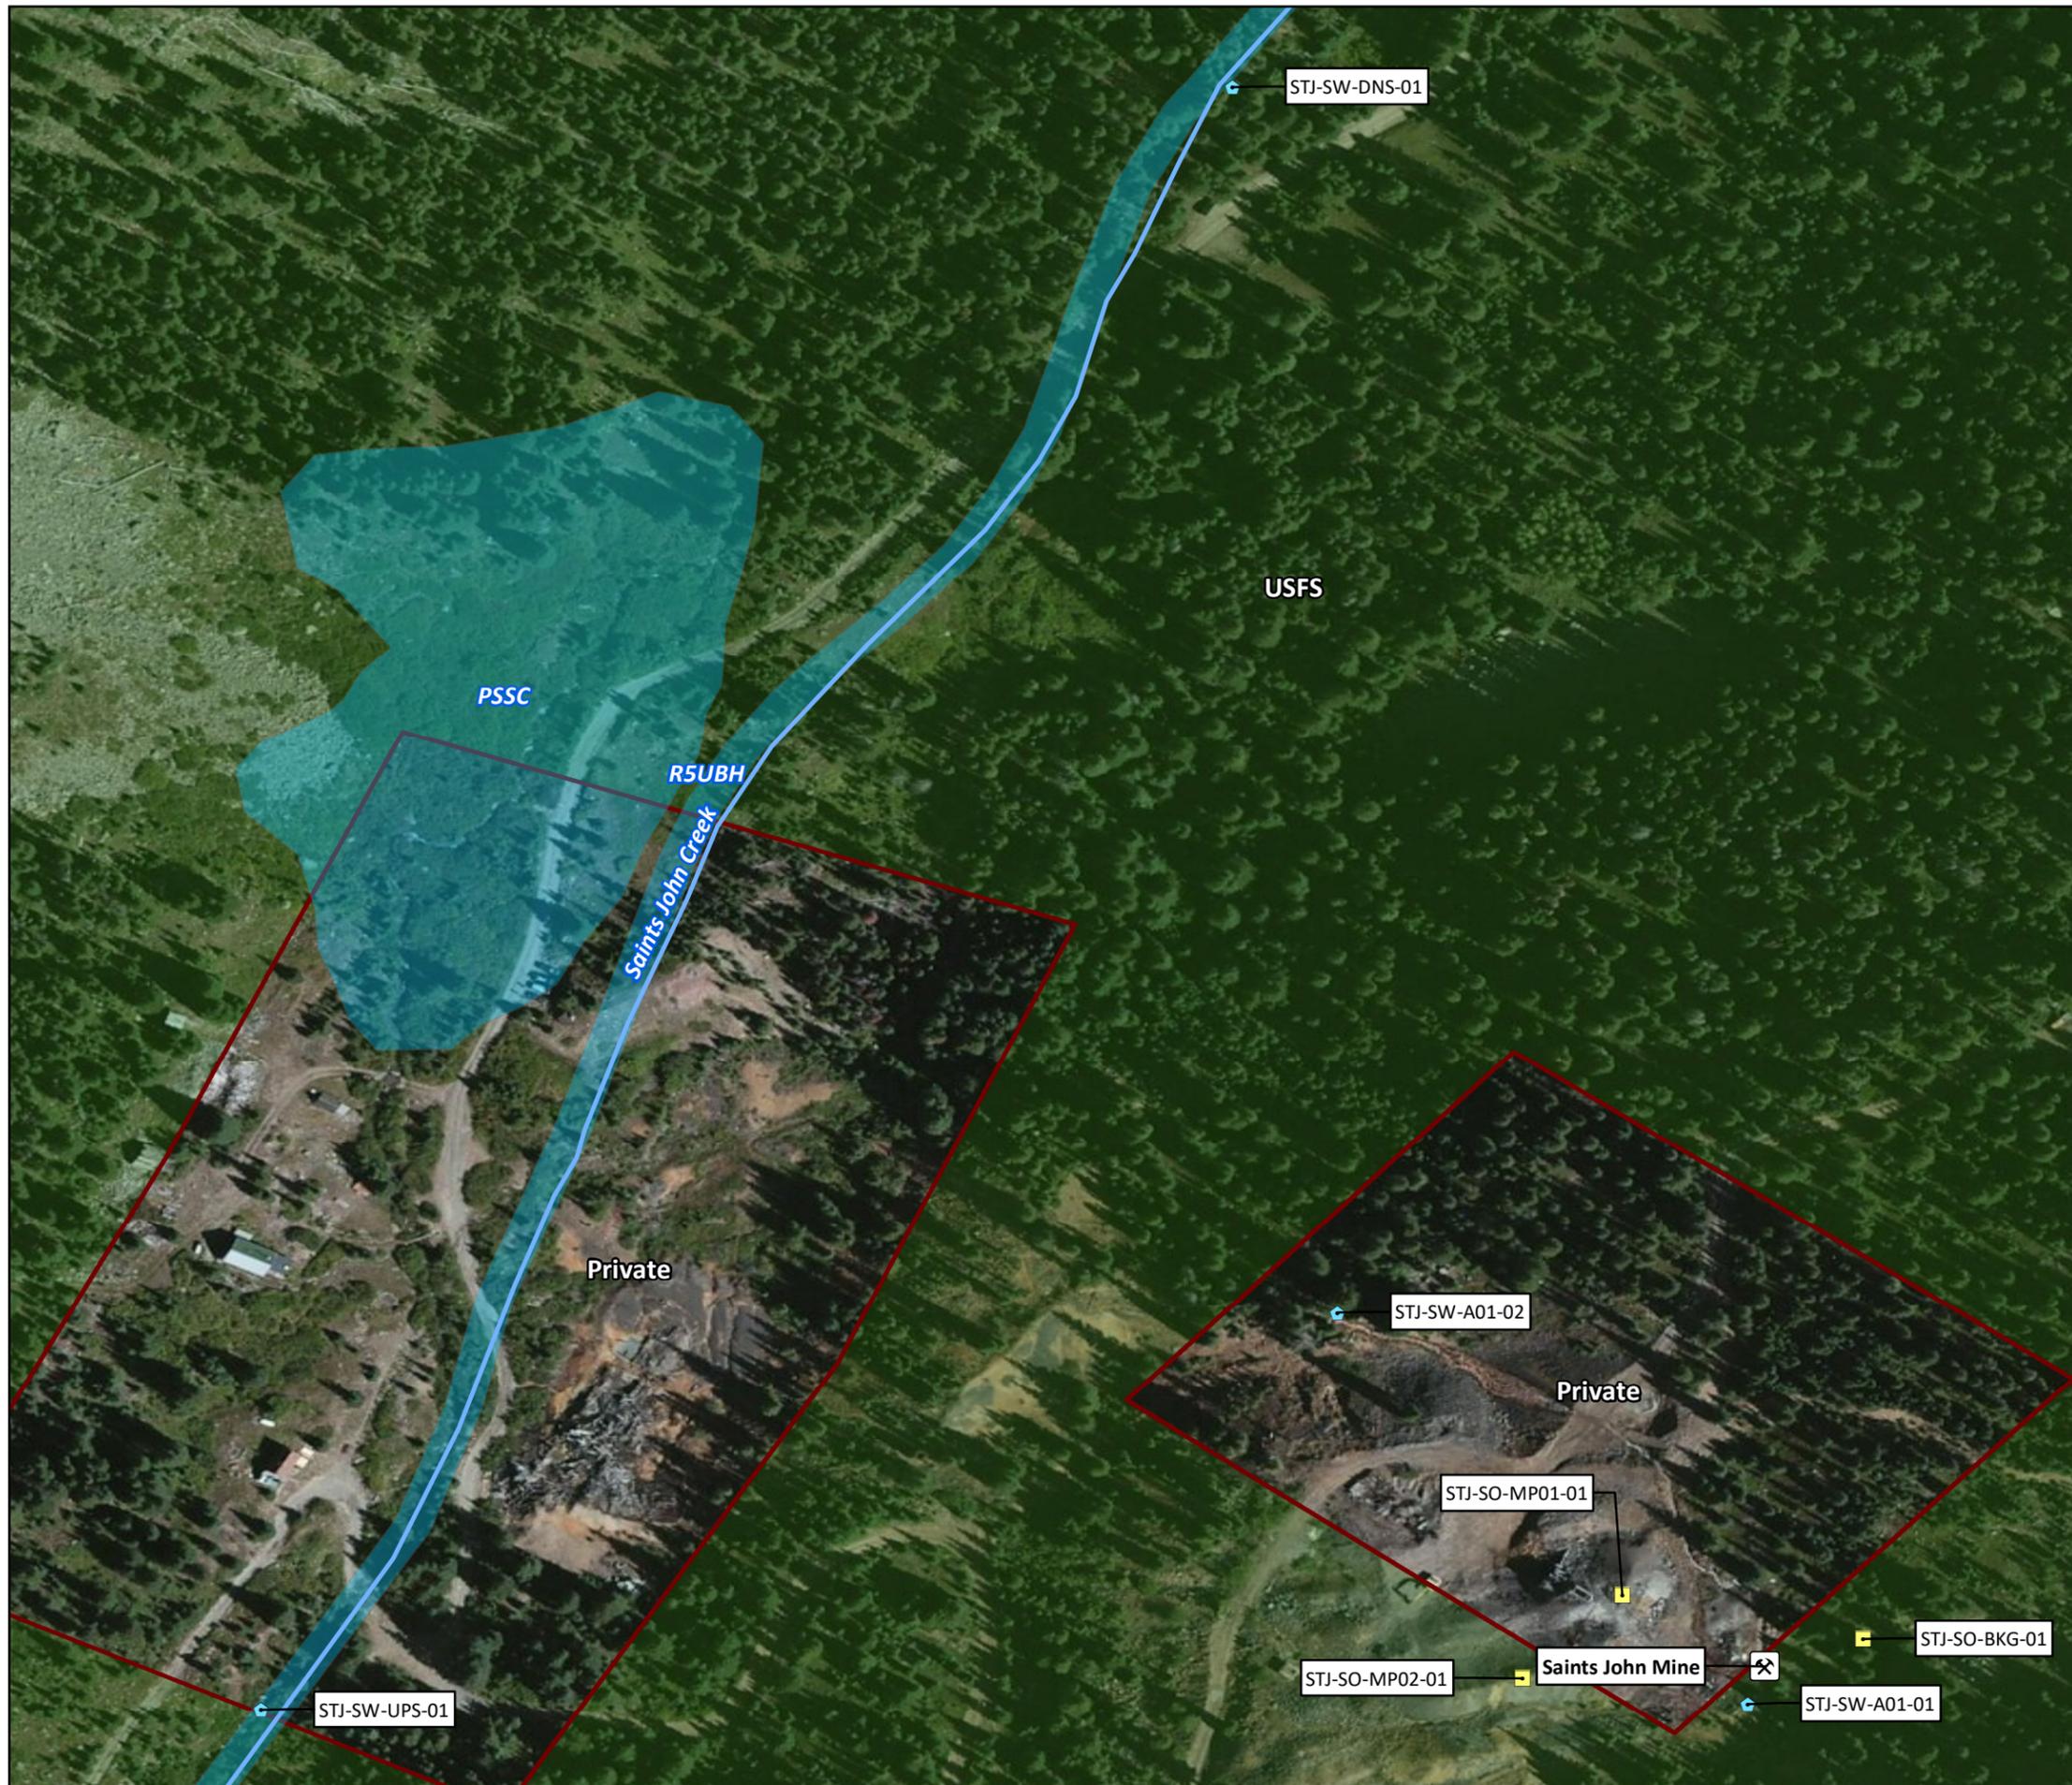
Figure A.1 2018 Colorado Draining Mines Pre-CERCLA Screening Surface Water and Soil Sampling Locations

*DRMS Mine #163
Saints John Mine, Montezuma, CO
Snake River Watershed
Summit County*
