Pre-CERCLA Screening Checklist/Decision Document

Sts. John Mine, Montezuma, Colorado

June 19, 2018

Pre-CERCLA Screening – Sts. John Mine

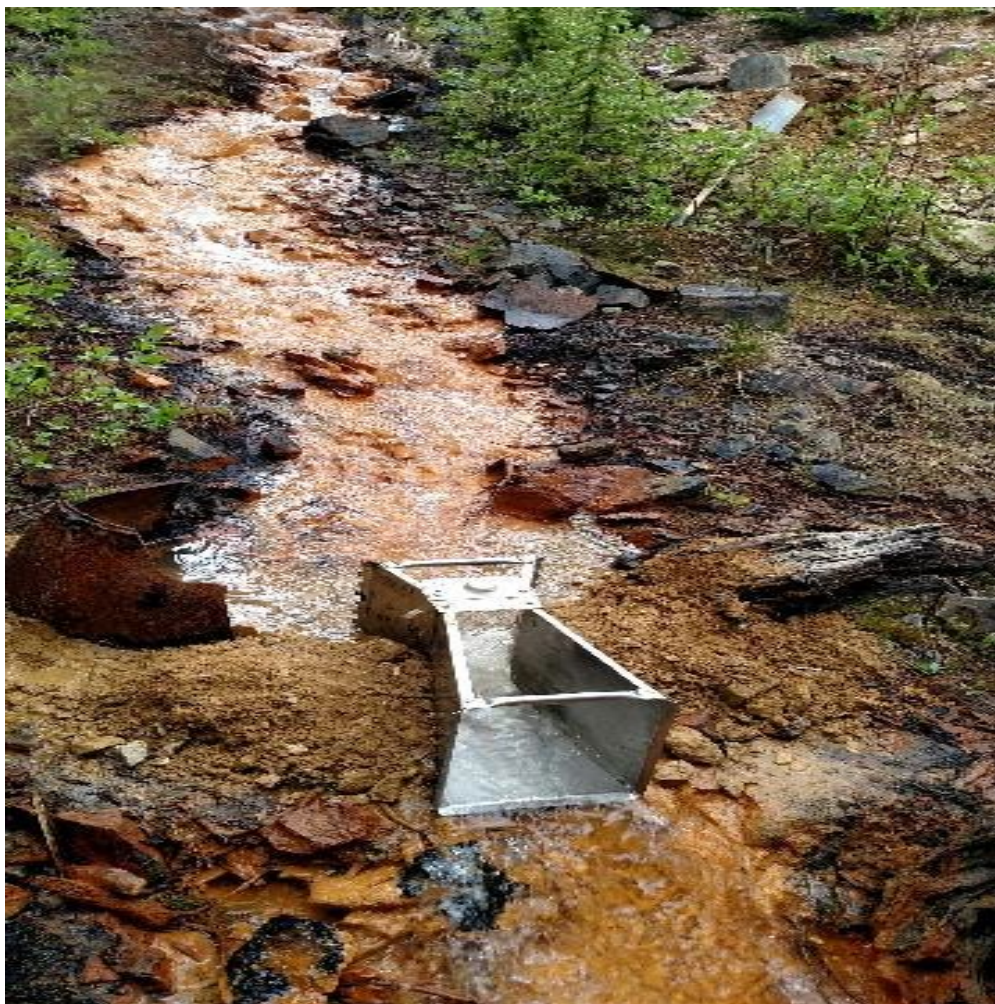
Flume location downstream of STJ-SW-A01-02

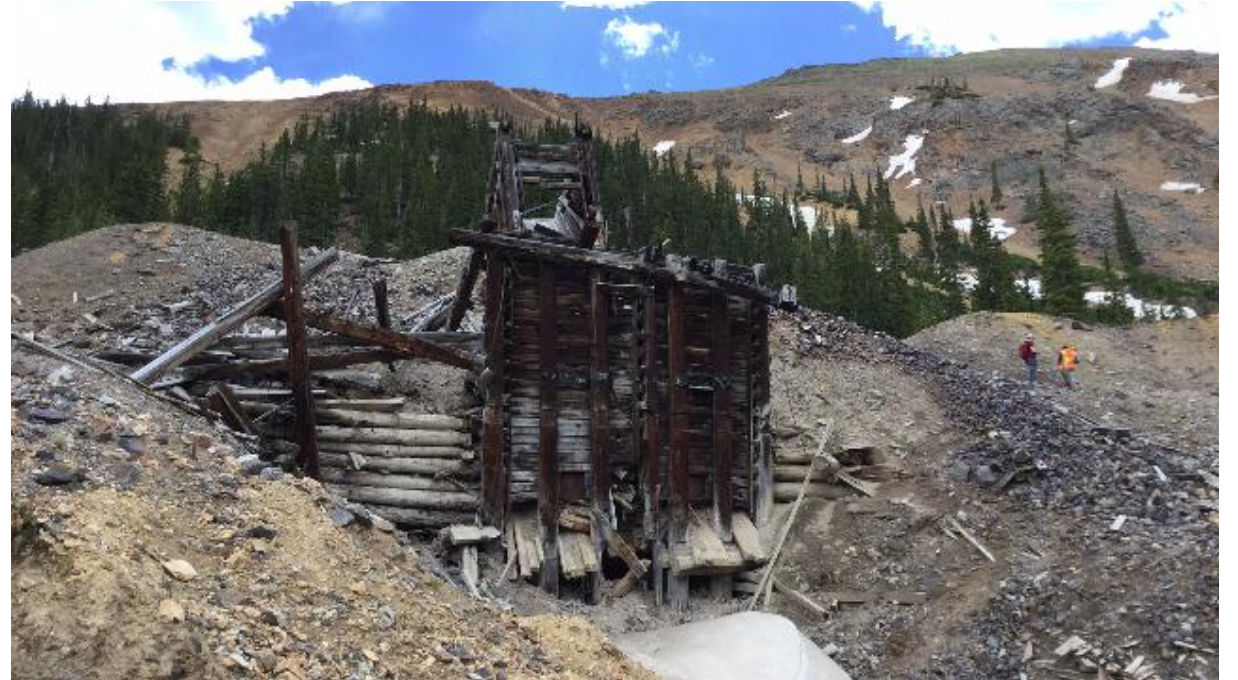
Describe Waste Pile Run Off: waste material is observed in the surrounding vegetation and is included in adit drainage channel.

STJ waste pile area

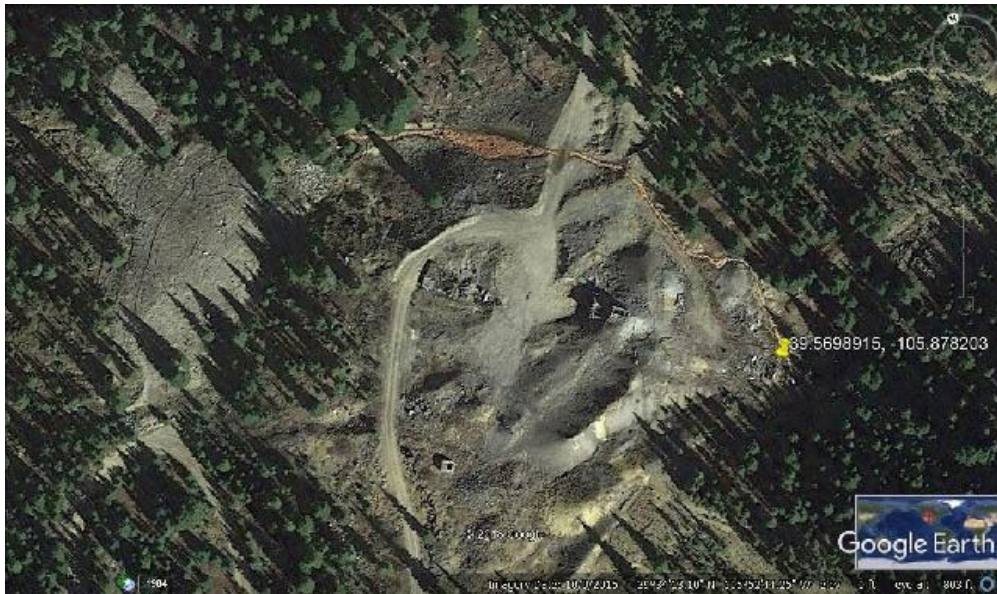
Sts. John Mine - Overview Aerial View

Site Surface (Field Notes): Site is surrounded by forested area, drainage from high flowing adit creates stream that discharges through the waste piles and into the surrounding forested area, ultimately into a forested stream/creek setting.
