STANDARD OPERATING PROCEDURE 201:
**RECONNAISSANCE OF ELECTRIC
VEHICLES**

**2025 SOCAL WILDFIRE RESPONSE
JANUARY 15, 2025**

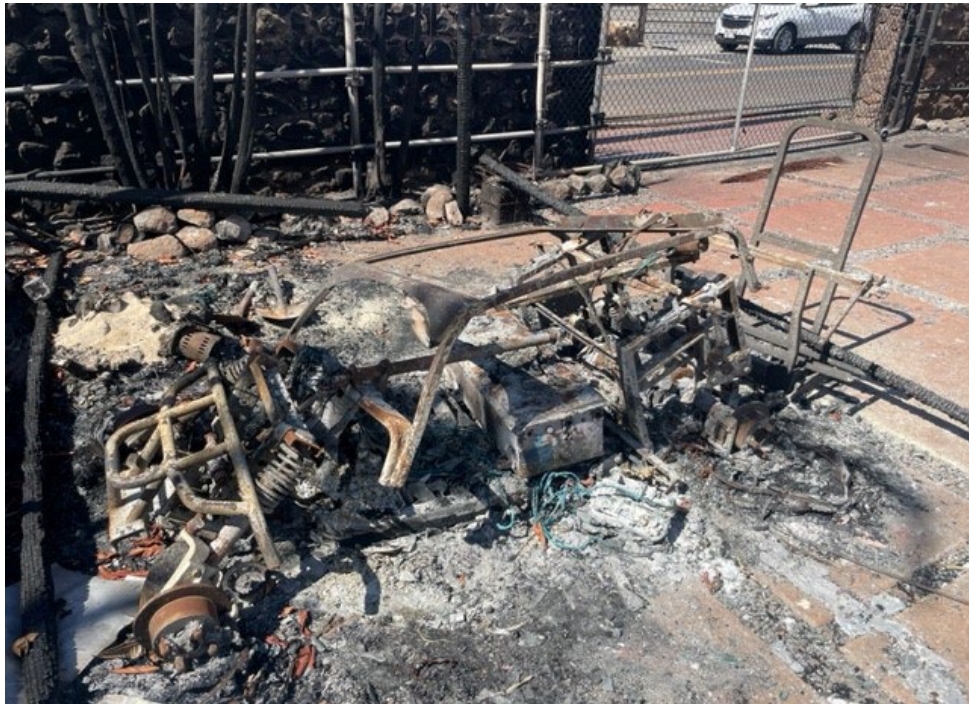
Electric Golf Cart with Lithium-Ion Battery Pack

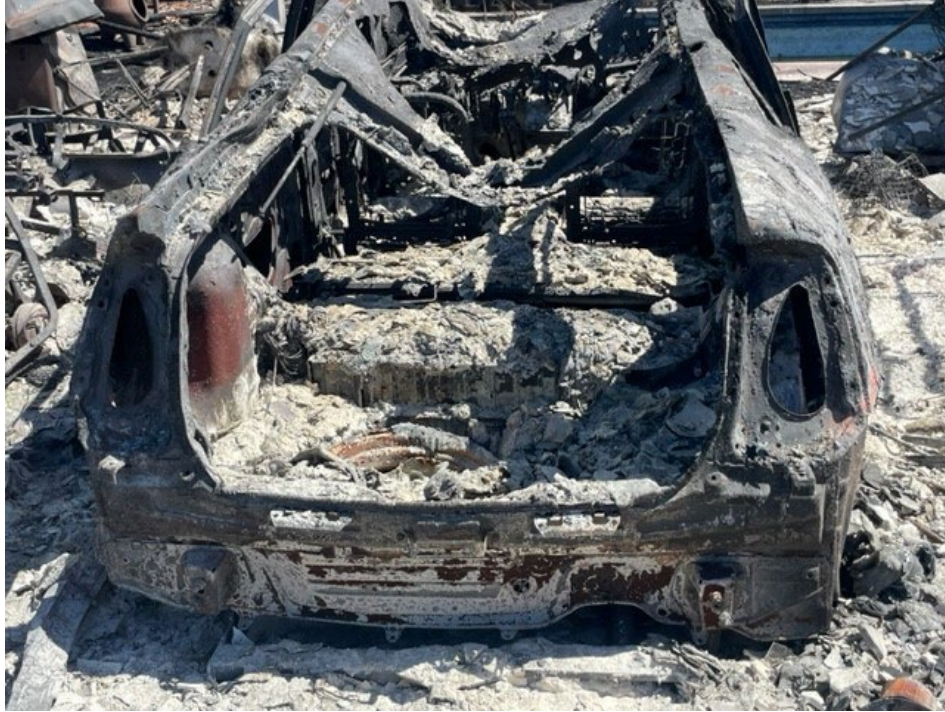
Toyota Prius battery pack located behind rear seat.

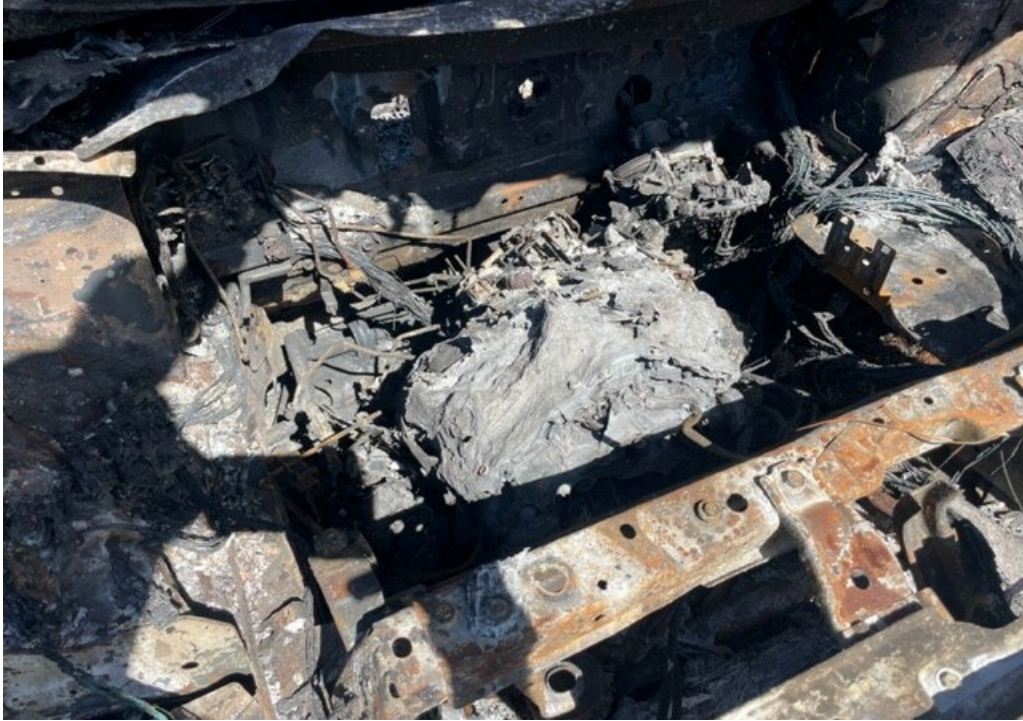
Nissan Leaf full electric vehicle engine bay. Note: none of the components of a gasoline engine can be distinguished.

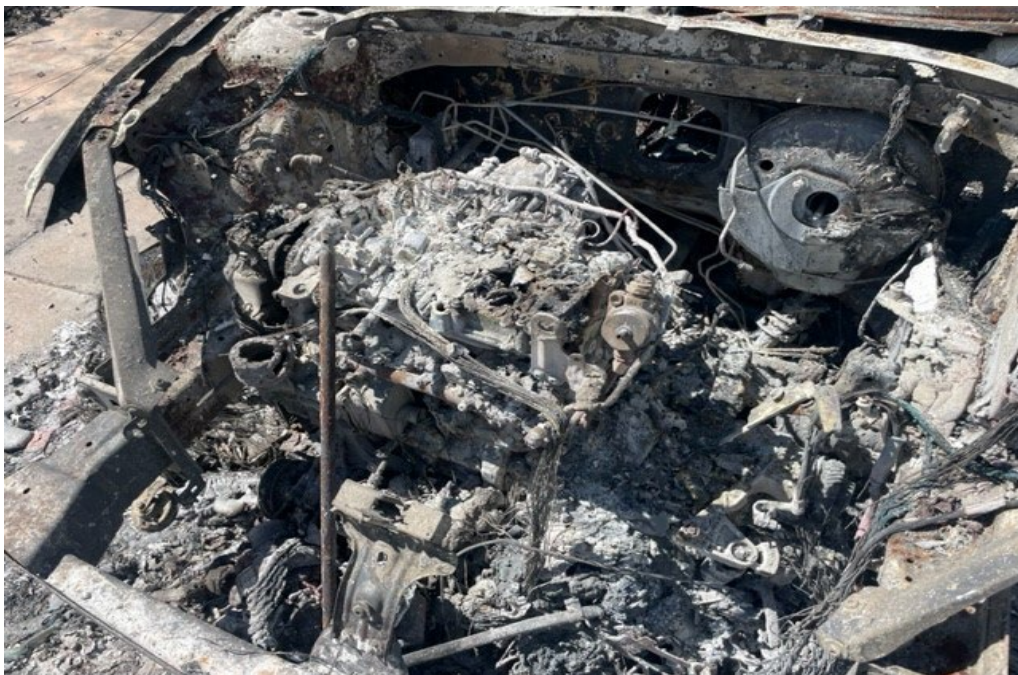
Volkswagen Golf Non-Hybrid Non-Electric engine bay.

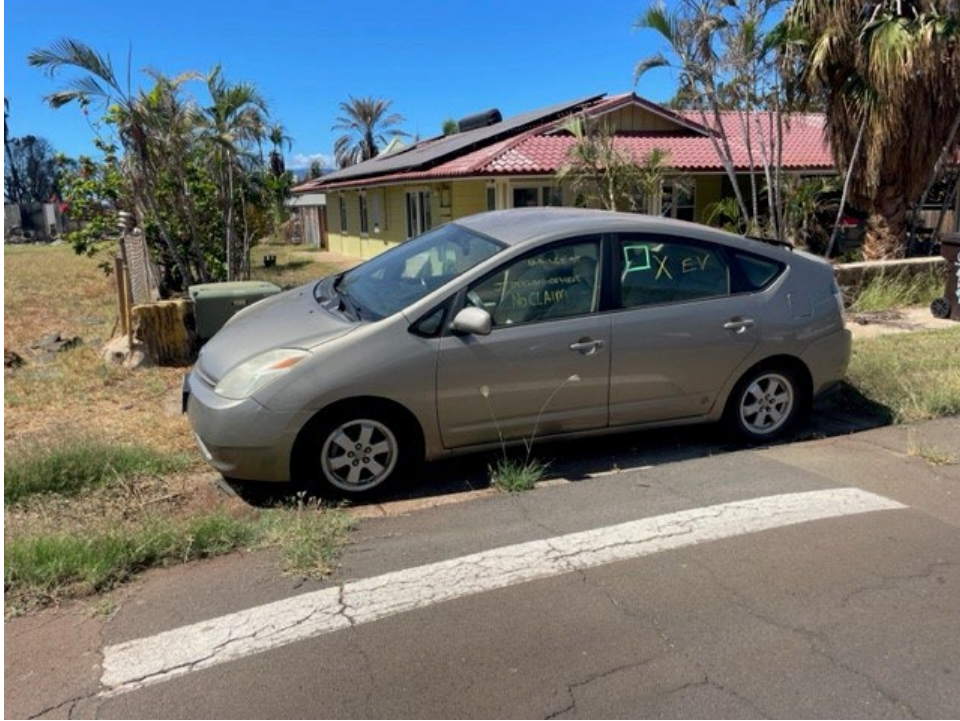
Toyota Prius with no visible burn evidence but located in survey zone. Note: plants and structures unburned nearby.

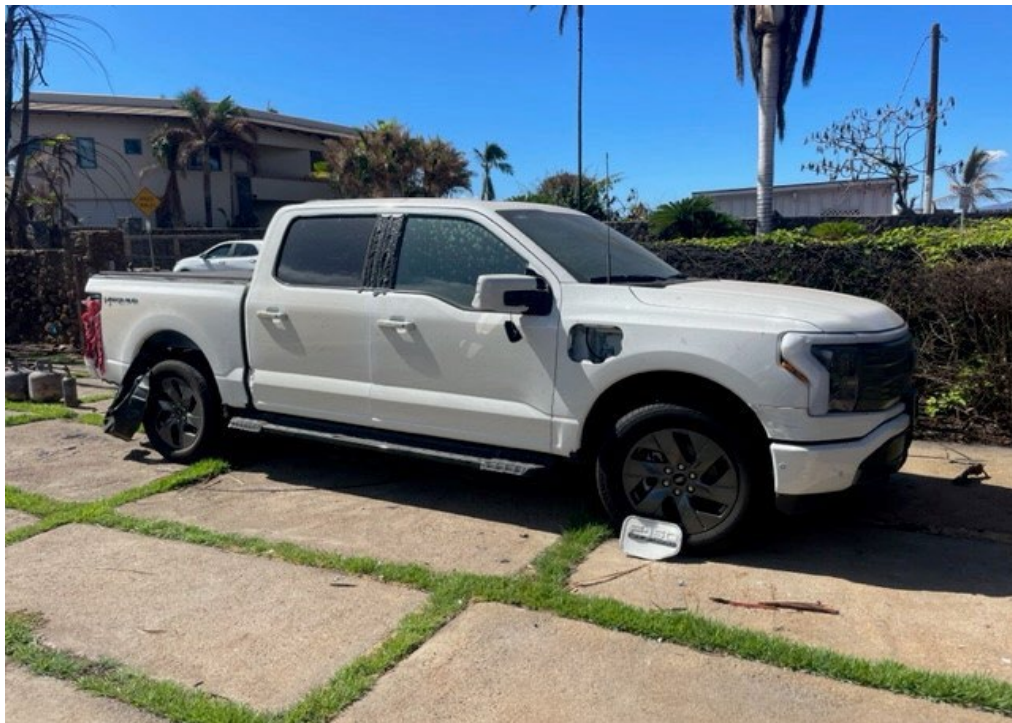
Ford F150 Lightning with visible heat damage. Taillights melted, wheel wells melted, discoloration of paint, plastic trim melted. Nearby structure fire.
