### **ACTION MEMORANDUM**

**SUBJECT:** Approval and Funding for a Removal Action at the Rumsey Mill Site in Philipsburg, Granite County, Montana

**Rumsey Mill RS**  
Philipsburg, Granite County, Montana  
**Figure A3**  
**Sample and Water Quality**  
**Locations**

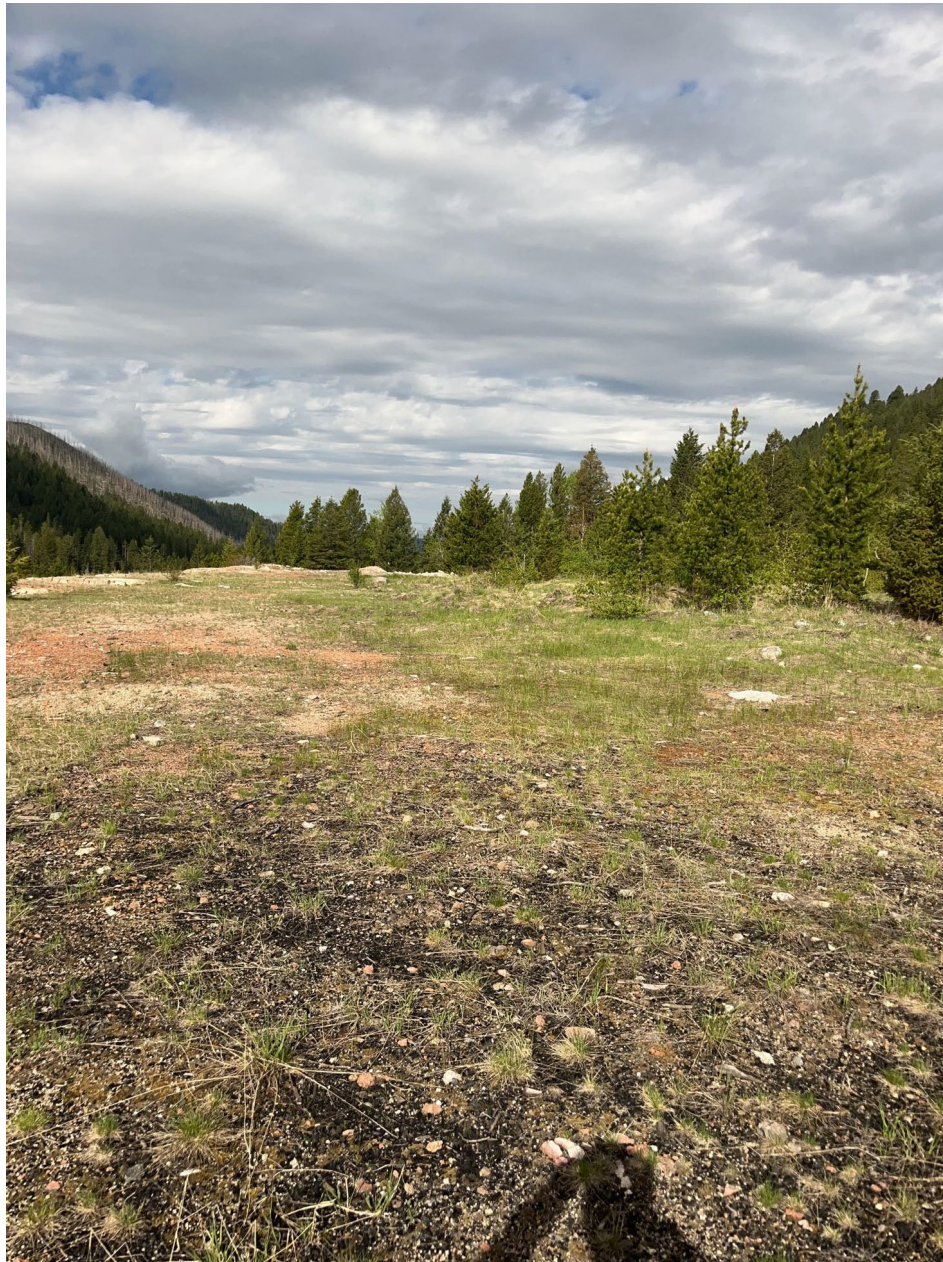
**Photo File:** Photos-20230524-151212.jpg

**Photo Description:** Upper level of mill site (decision units 01-04). Wide open area with stable ground. This area will be accessible with mini-excavator or other equipment.

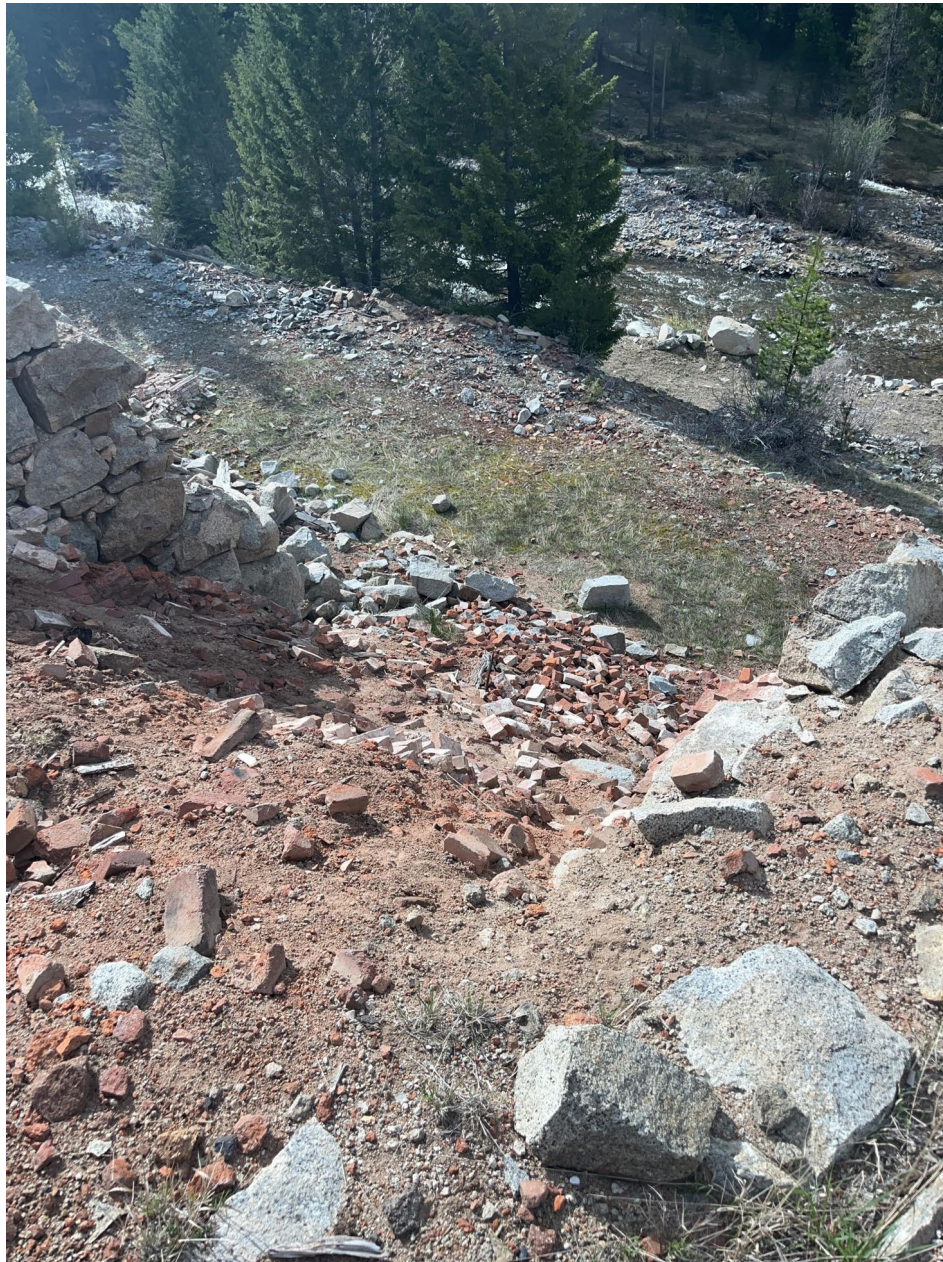
**Photo File:** Photos-20230524-150818.jpg

**Photo Description:** Steep drop-off from upper level of mill site down to middle section. Very steep drop-off with large, loose rocks and material. There are several of these chute-like structures across the upper portion of the mill site.

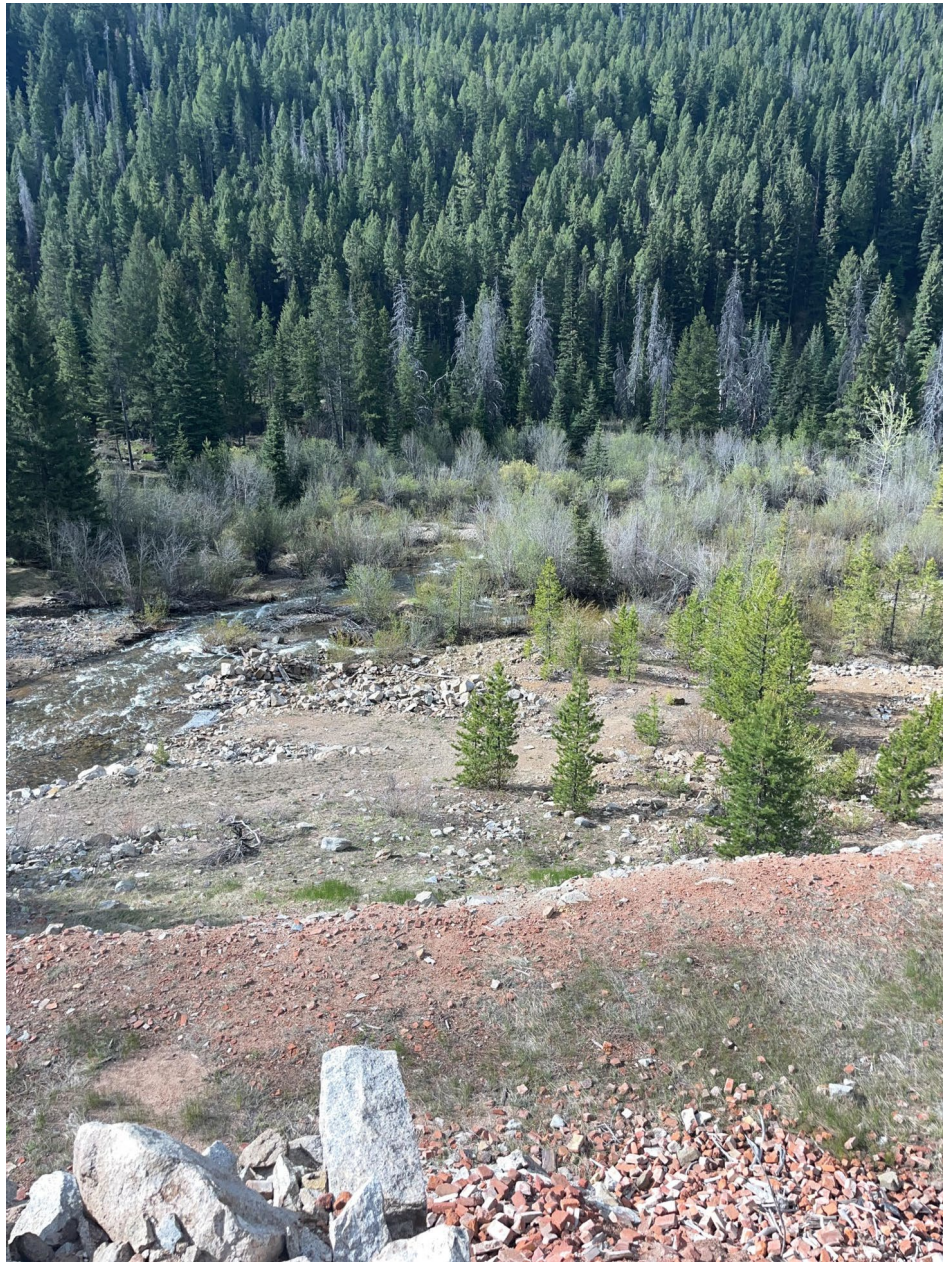
**Photo File:** Photos-20230524-152207.jpg

**Photo Description:** Photo taken standing on upper level of mill site near one of the chutes, looking down to the bottom-most level of the mill and Fred Burr Creek.

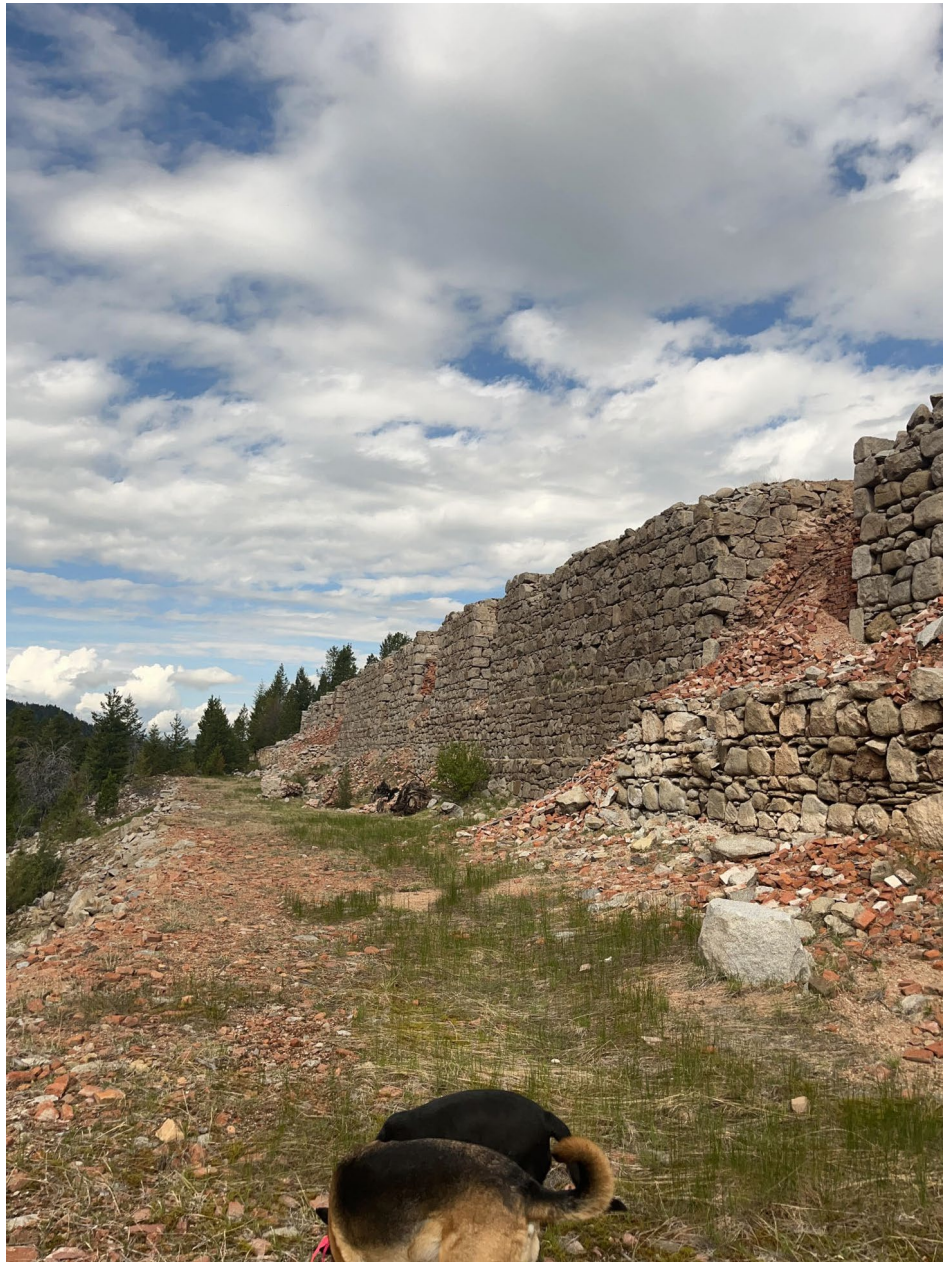
**Photo File:** Photos-20230524-155642.jpg

**Photo Description:** Middle bench of mill site where the former rail cart line is suspected to have been. The steep rock wall shown is from the upper-most level of the mill site and extends across the entire mill area.

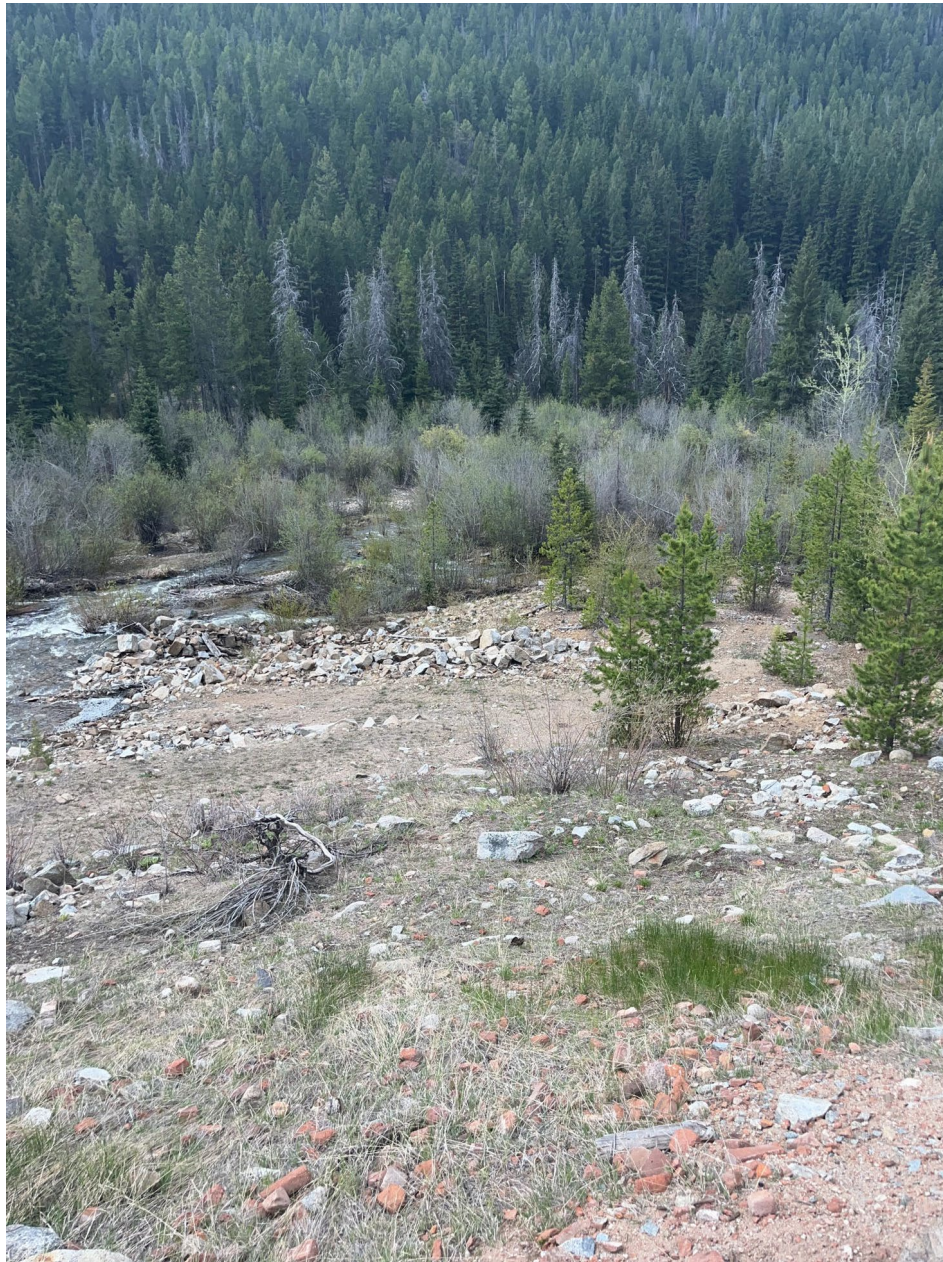
**Photo File:** Photos-20230524-155847.jpg

**Photo Description:** View of lower level of mill (decision units 07 and 08). Gentle slope with loose rock and some sandy soil.

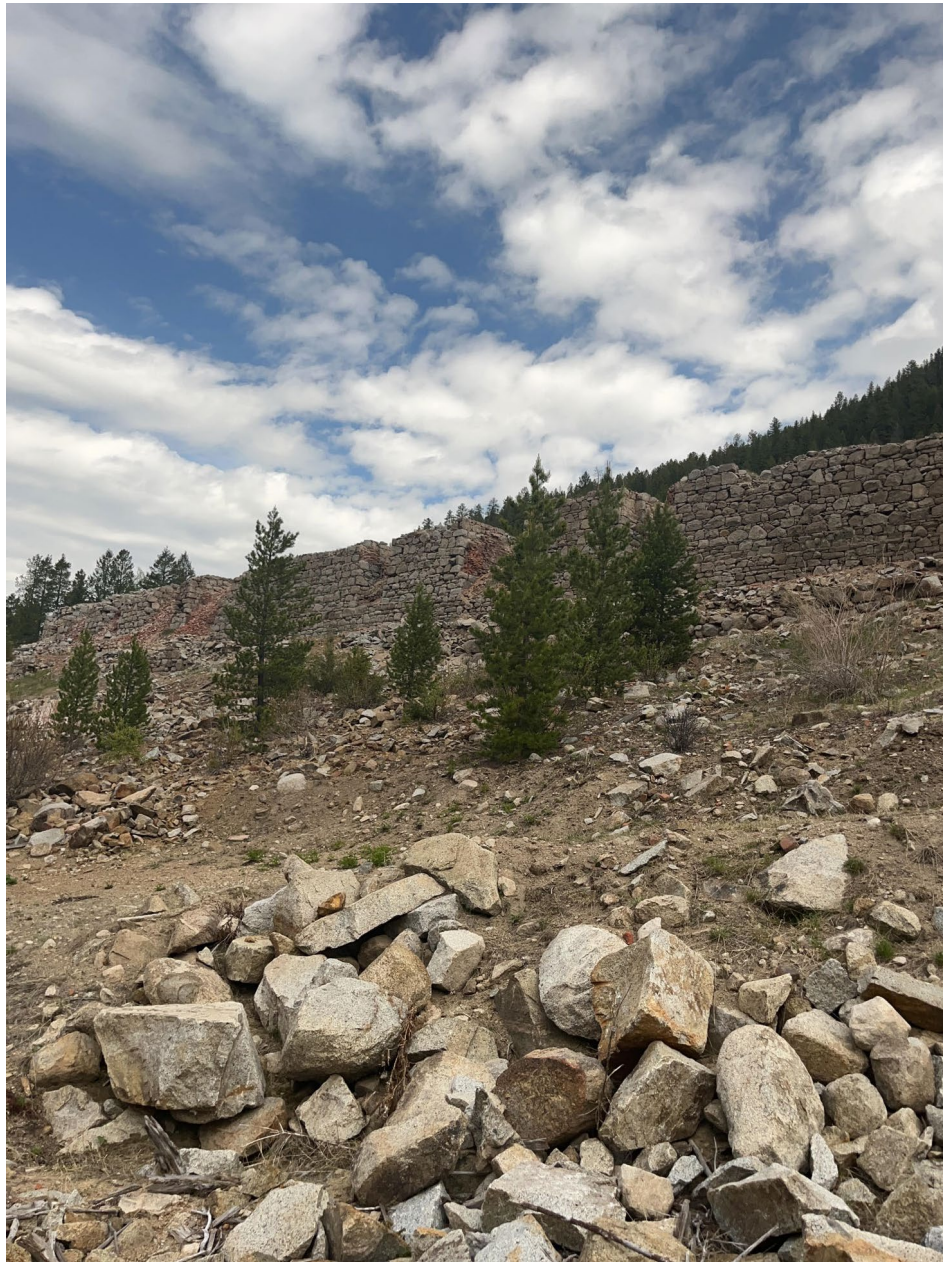
**Photo File:** Photos-20230524-163000.jpg

**Photo Description:** View from decision units 07 and 08 looking back up at the middle and upper level of mill.

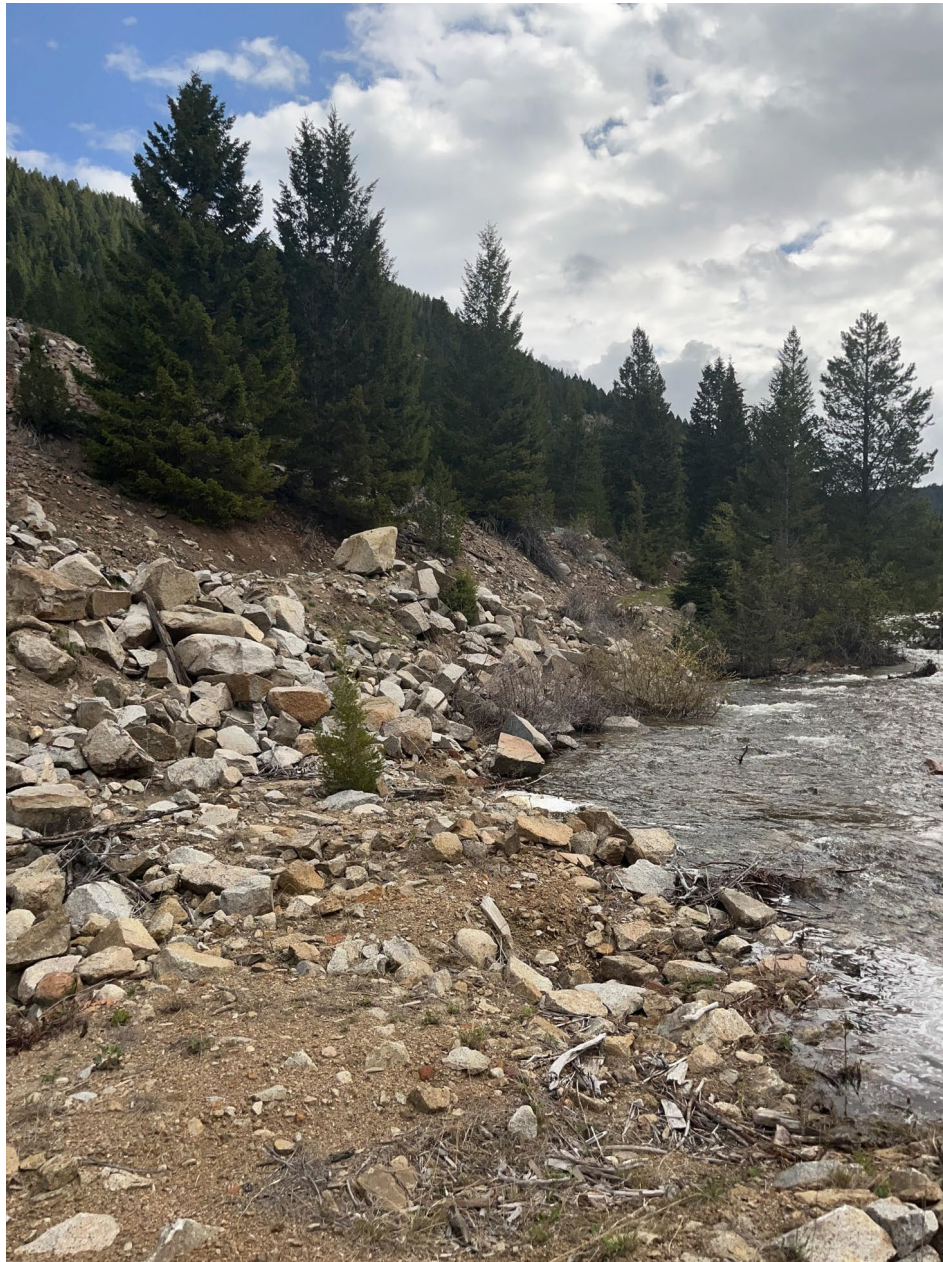
**Photo File:** Photos-20230524-163731.jpg

**Photo Description:** Steep bank in lower section of mill site along Fred burr creek. Large, loose boulders make traversing this area difficult. Location of surface water sample RM-SW-02A-2023-1010.

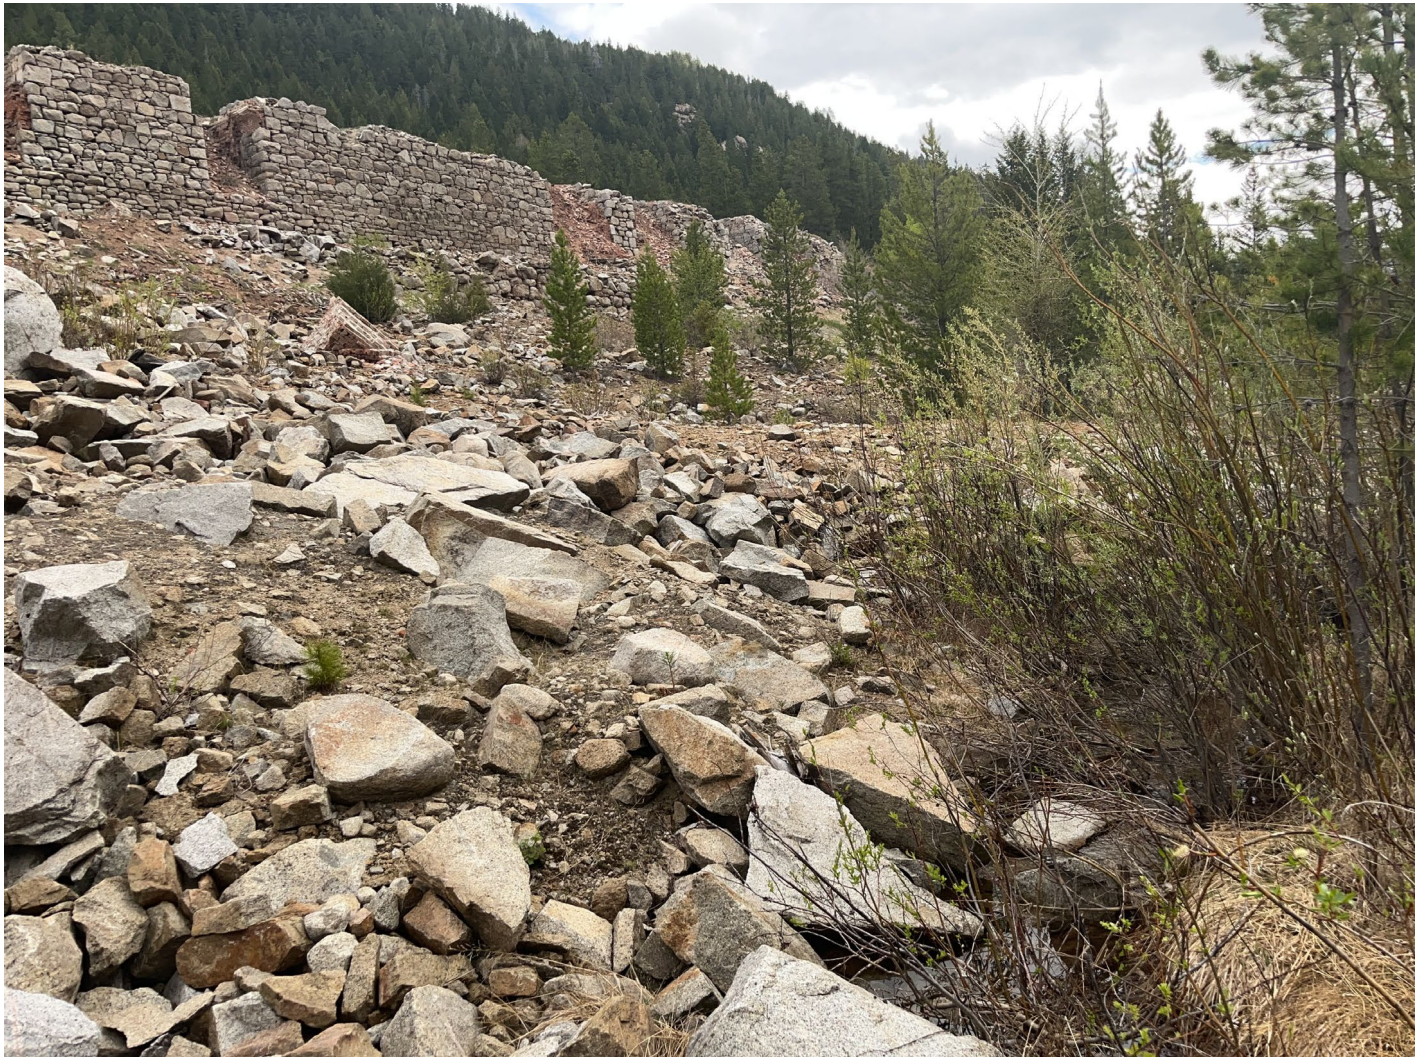
**Photo File:** Photos-20230524-164734.jpg

**Photo Description:** Additional unknown infiltration source in lower portion of decision unit 06. Location of surface water sample RM-SW-02B-2023-1010. Water is flowing from the top of the photo towards Fred Burr Creek.

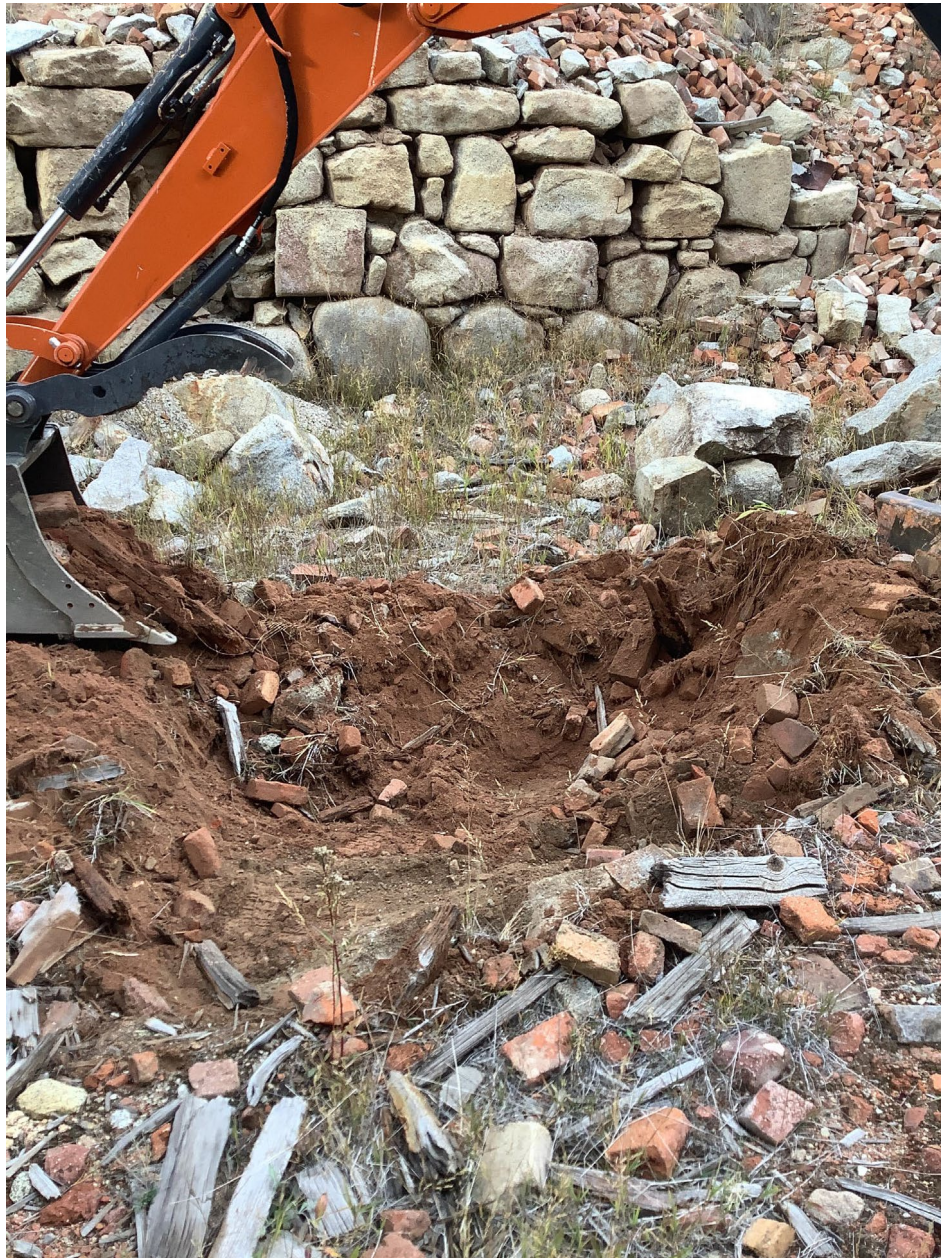
**Photo File:** Photos-20231010-225919.jpg

**Photo Description:** Sample location of RM-WR-06AL-2023-1010. Soil is a red color with pulverized brick material scattered throughout. Large boulders in the bottom of the hole making it hard to dig further than 2-3 feet bgs.

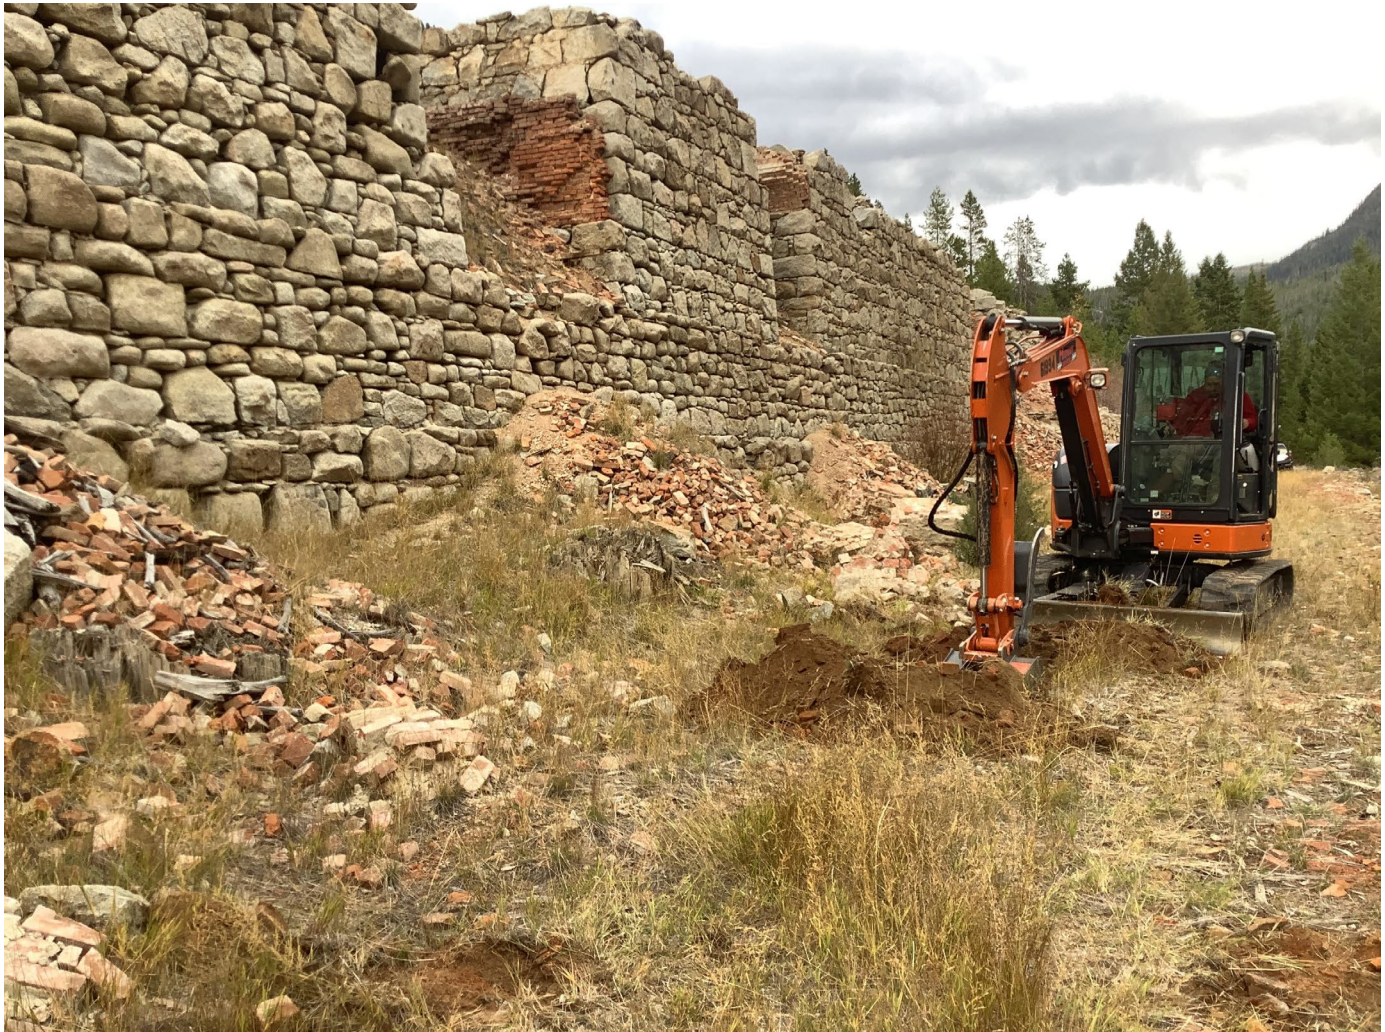
**Photo File:** Photos-20231010-231428.jpg

**Photo Description:** Excavator operations in the middle tier of the mill site near decision units 06A and 08A

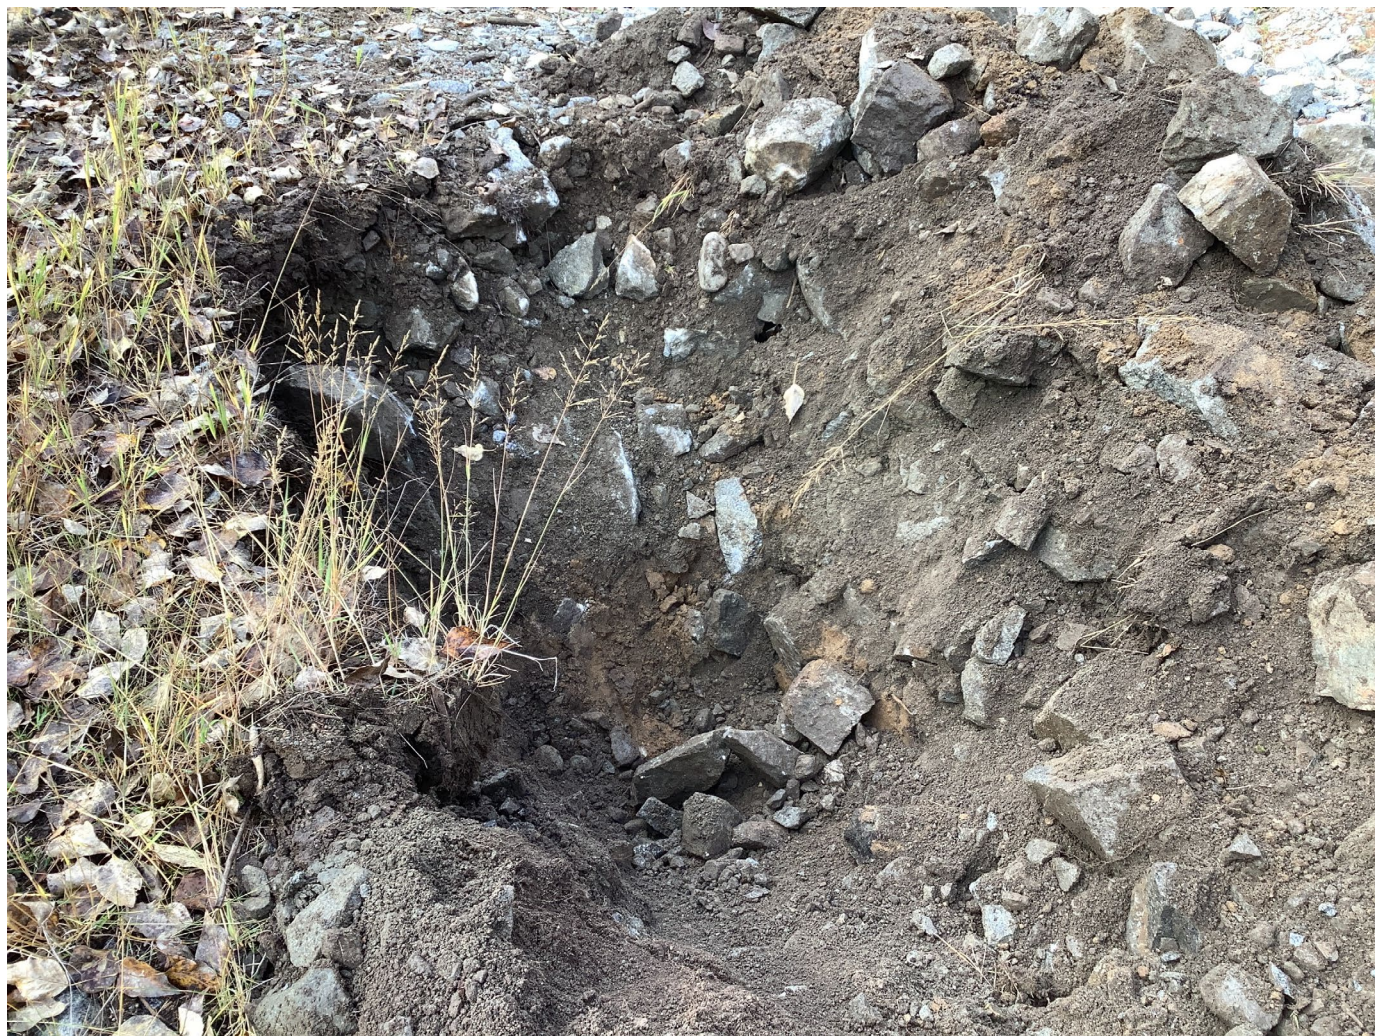
**Photo File:** Photos-20231011-183006.jpg

**Photo Description:** RM-WR-10NE-2023-1011. Top 2-3 feet bgs is a dark brown silty sand. Bottom 4-5 feet bgs is a heavy clay layer. Sample taken from both layers and composited.

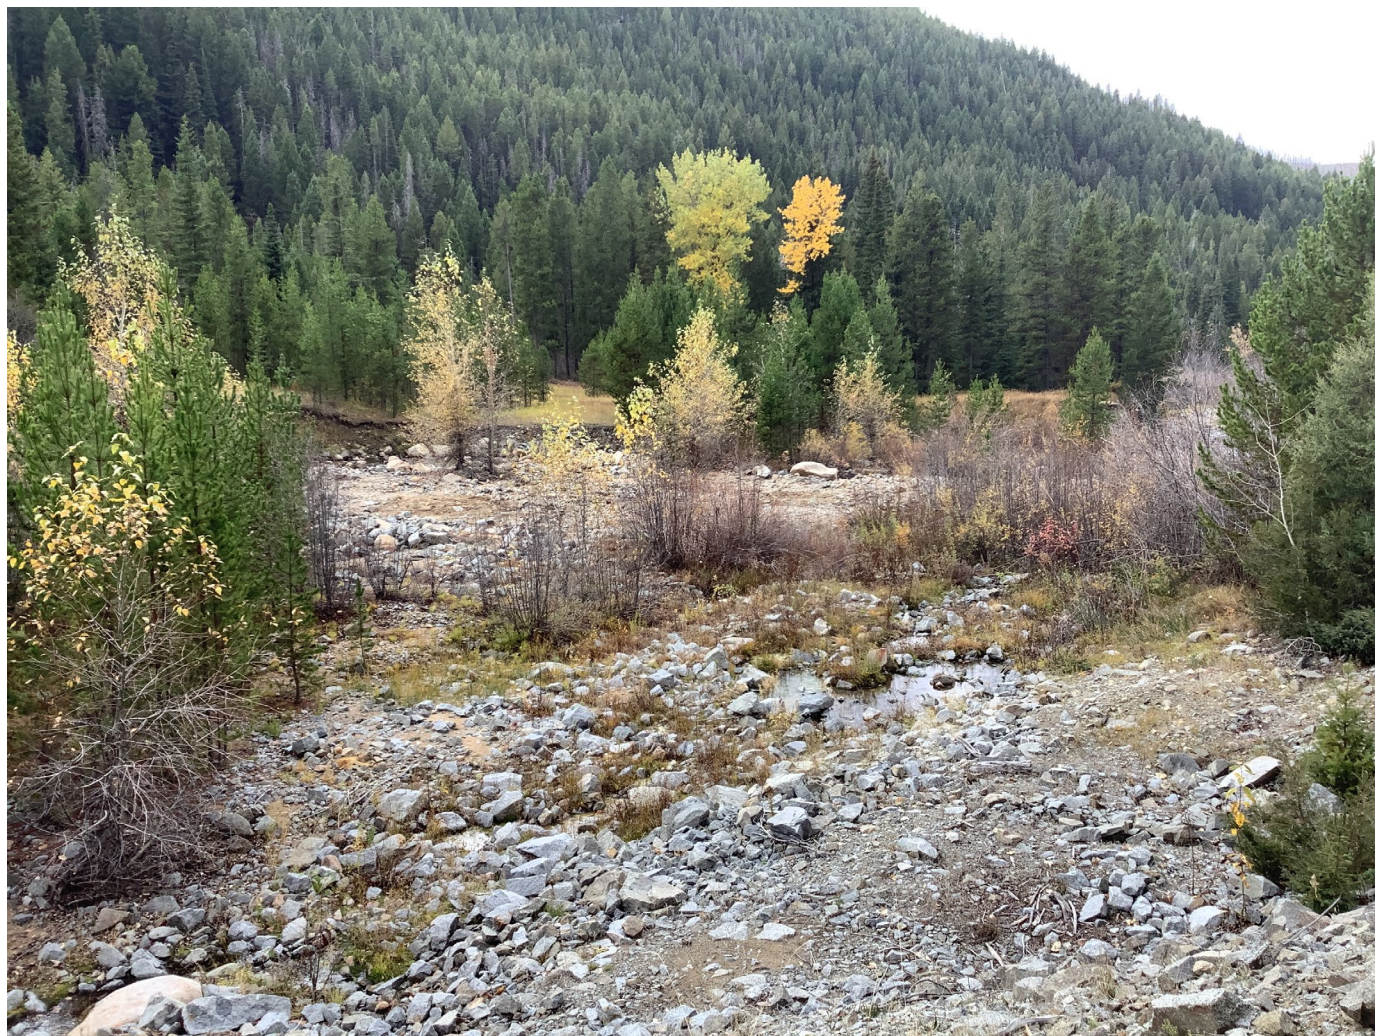
**Photo File:** Photos-20231011-192556.jpg

**Photo Description:** Lower floodplain area of mill site near decision unit 10.

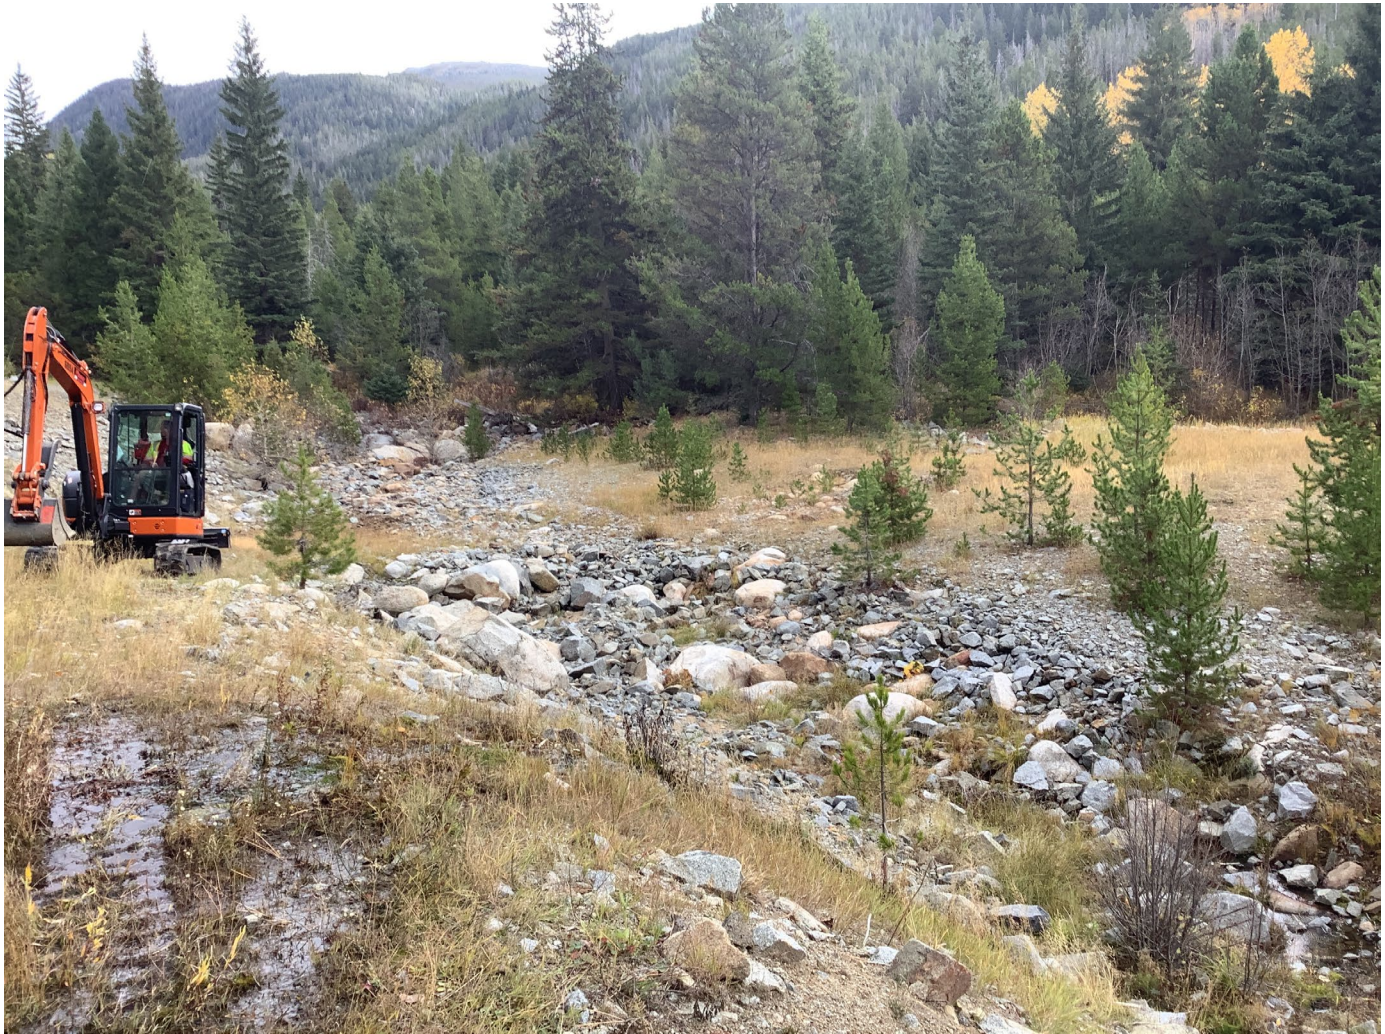
**Photo File:** Photos-20231011-192641.jpg

**Photo Description:** Lower floodplain area of mill site near decision units 10 and 11.

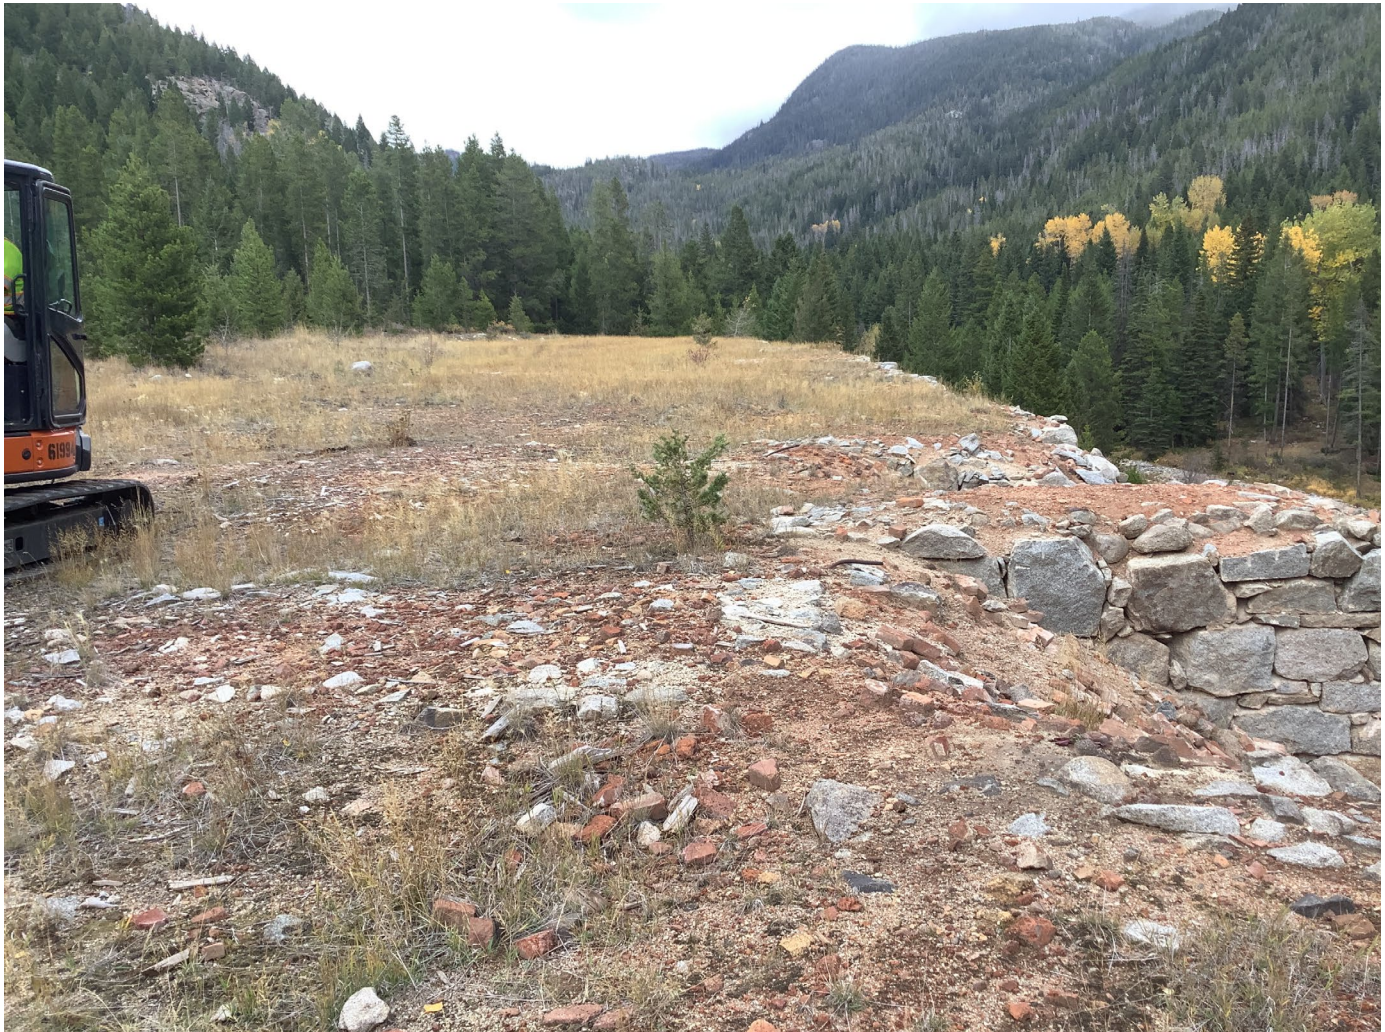
**Photo File:** Photos-20231011-215122.jpg

**Photo Description:** Upper level of mill site near decision units 03 and 04.

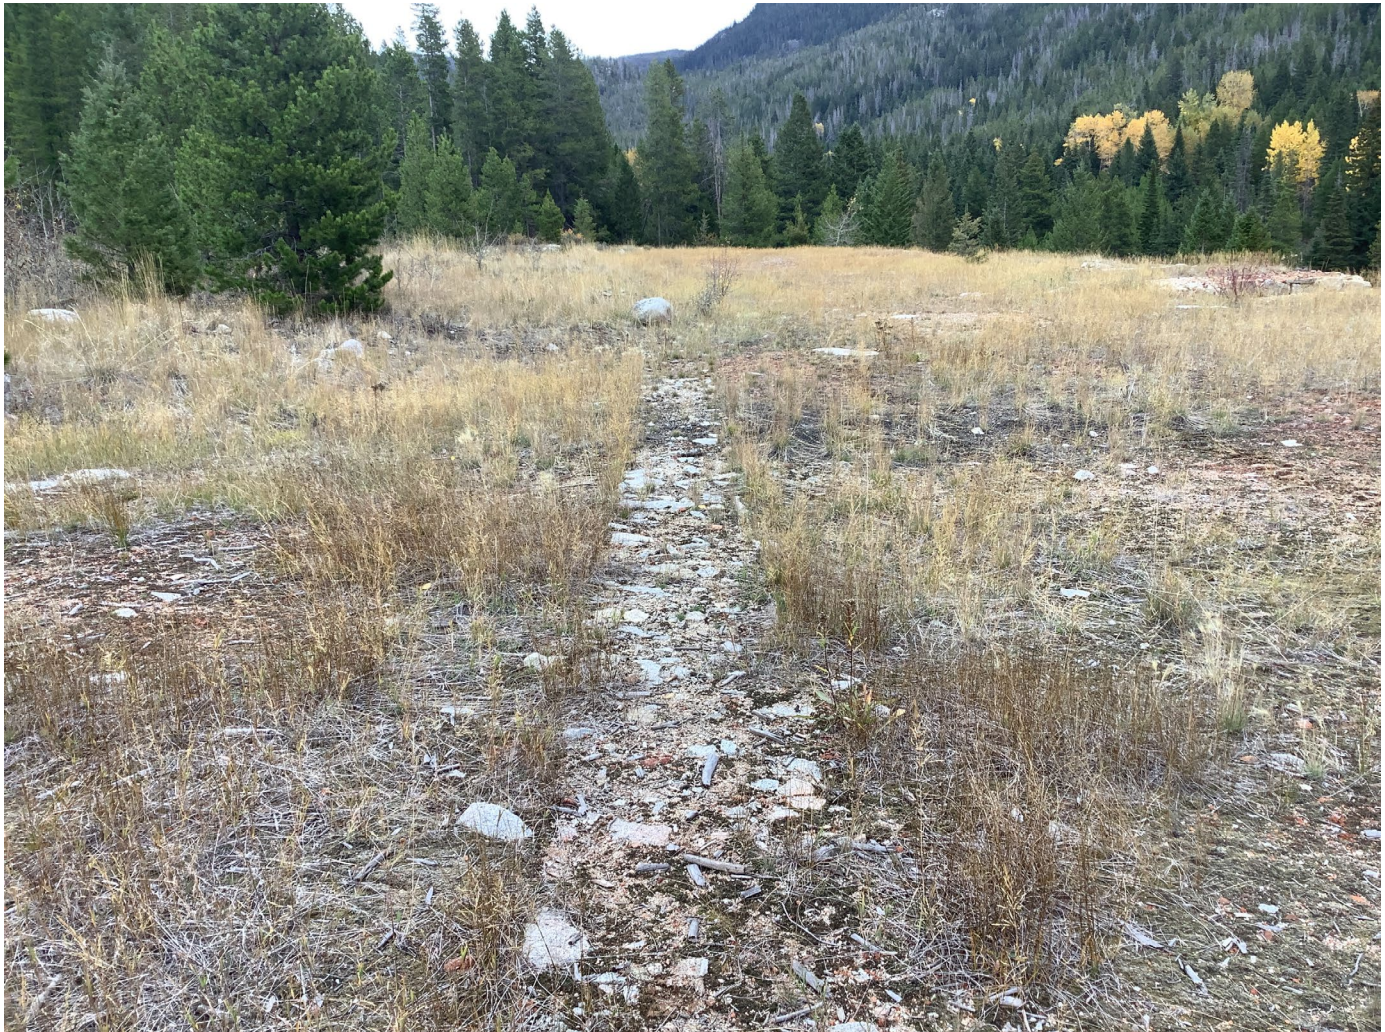
**Photo File:** Photos-20231011-215242.jpg

**Photo Description:** Suspected foundation wall from an old building on the top level of the mill site. This feature runs east to west across most of the upper level and divides decision units 01 and 02 horizontally from decision units 03 and 04.

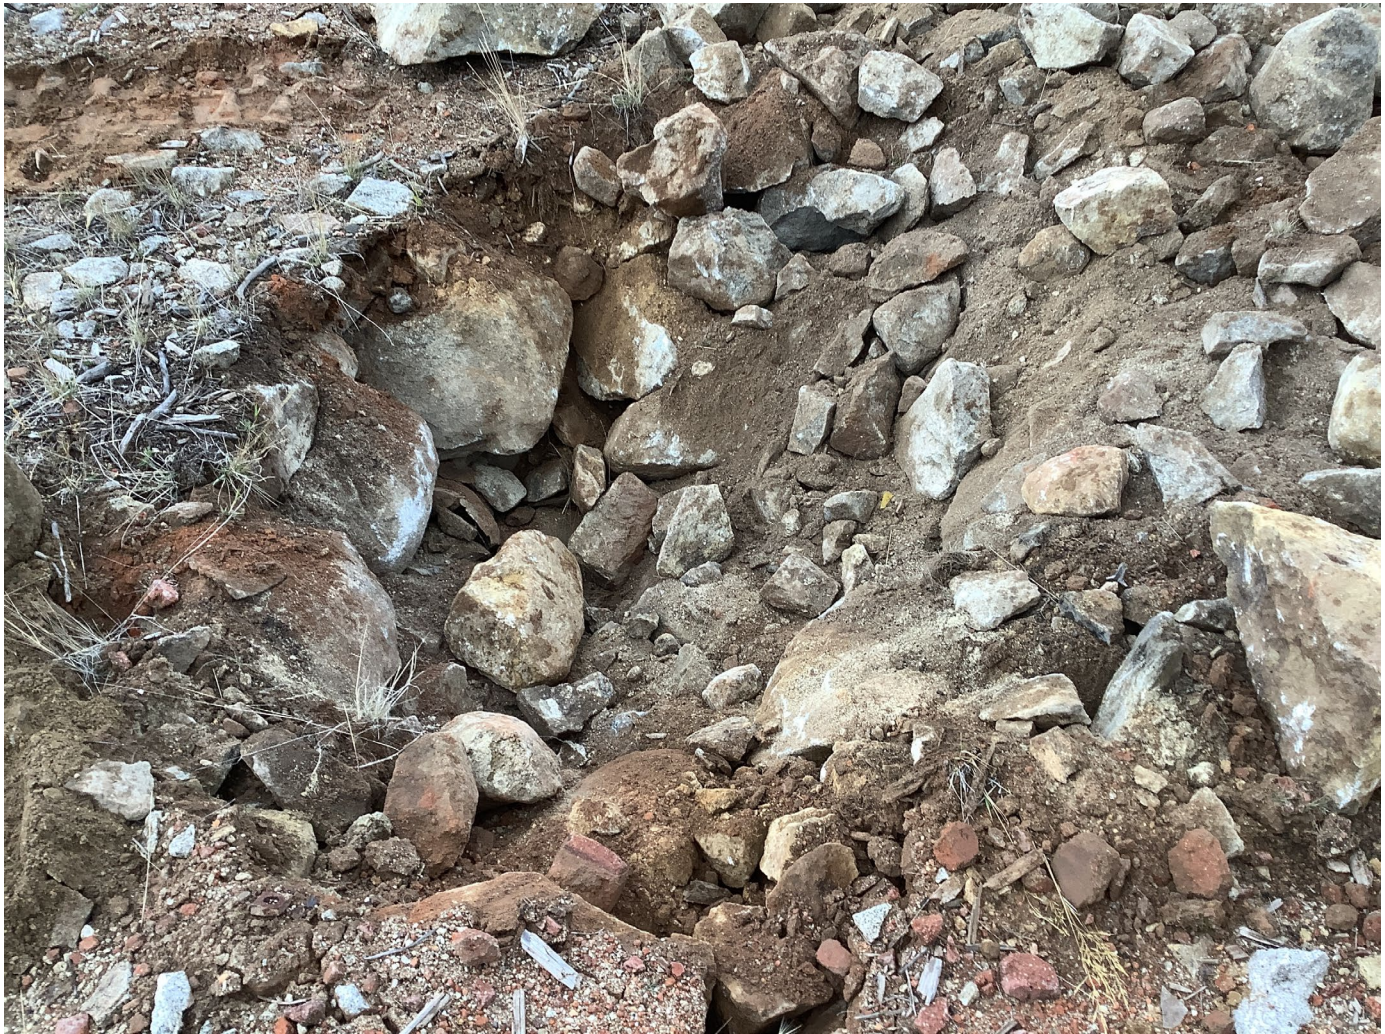
**Photo File:** Photos-20231011-231040.jpg

**Photo Description:** Sample location of RM-WR-03SE-2023-1011. Top 6 inches made up of pulverized brick material. Large angular rocks with voids in between down to 2 feet bgs.
