### **ACTION MEMORANDUM**

**SUBJECT:** Approval and Funding for a Removal Action at the Rumsey Mill Site in Philipsburg, Granite County, Montana

**Rumsey Mill RS**  
Philipsburg, Granite County, Montana  
**Figure A3**  
**Sample and Water Quality**  
**Locations**

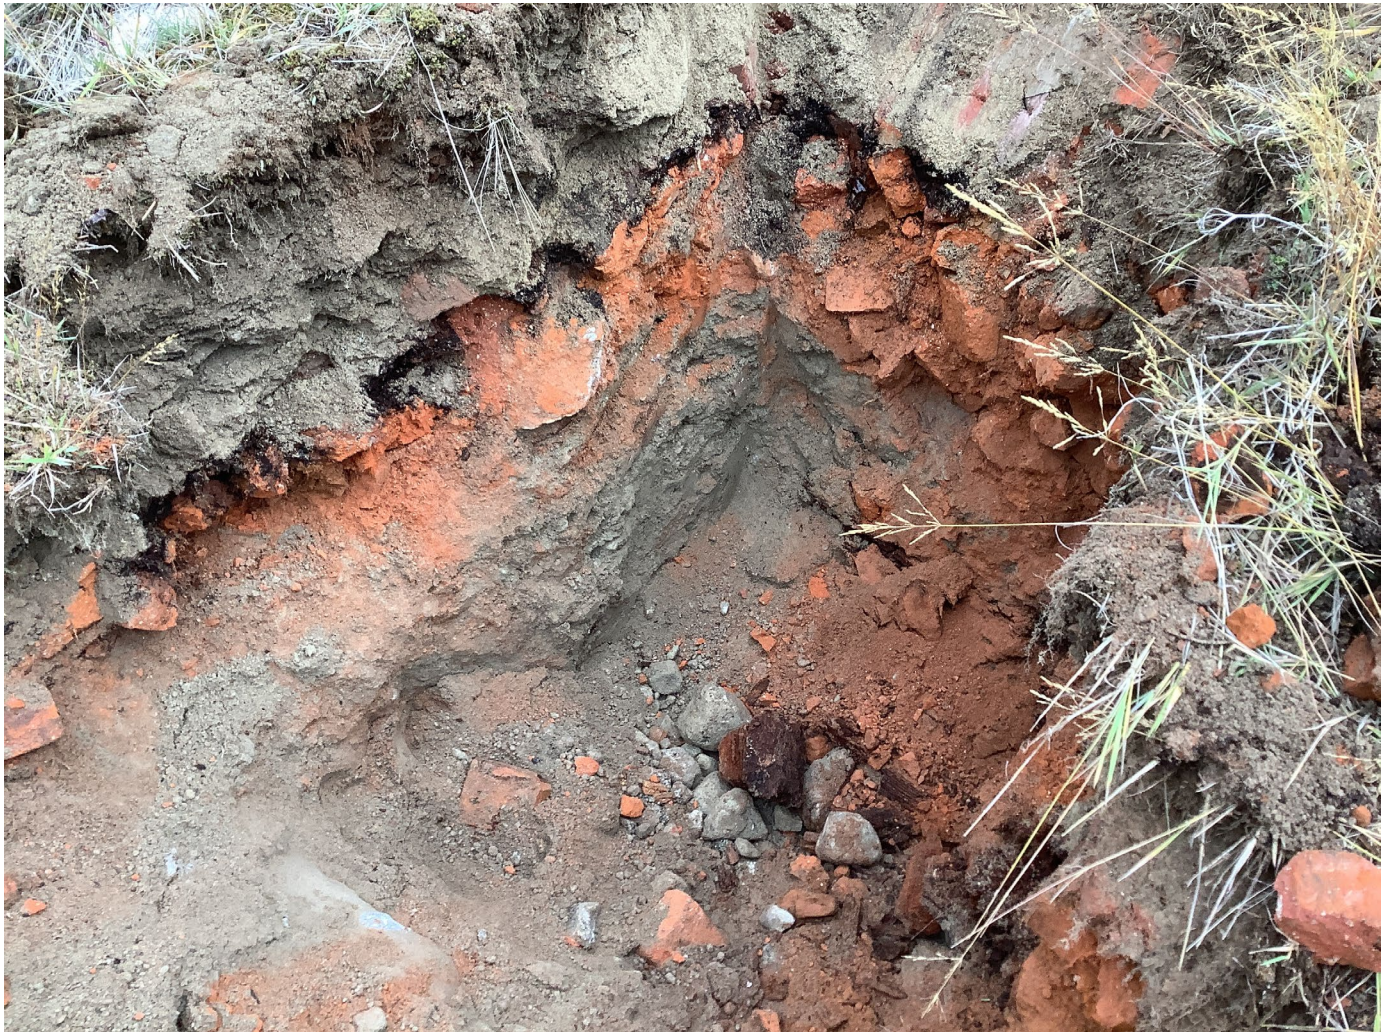
**Photo File:** Photos-20231012-163648.jpg

**Photo Description:** Test pit on the west side of decision unit 01. No sample collected here. Multiple layers of various colors. Light brown-grey sandy material in upper 2 feet. Pulverized brick material around 3 feet bgs. Light brown-grey layer from 4-5 feet bgs.

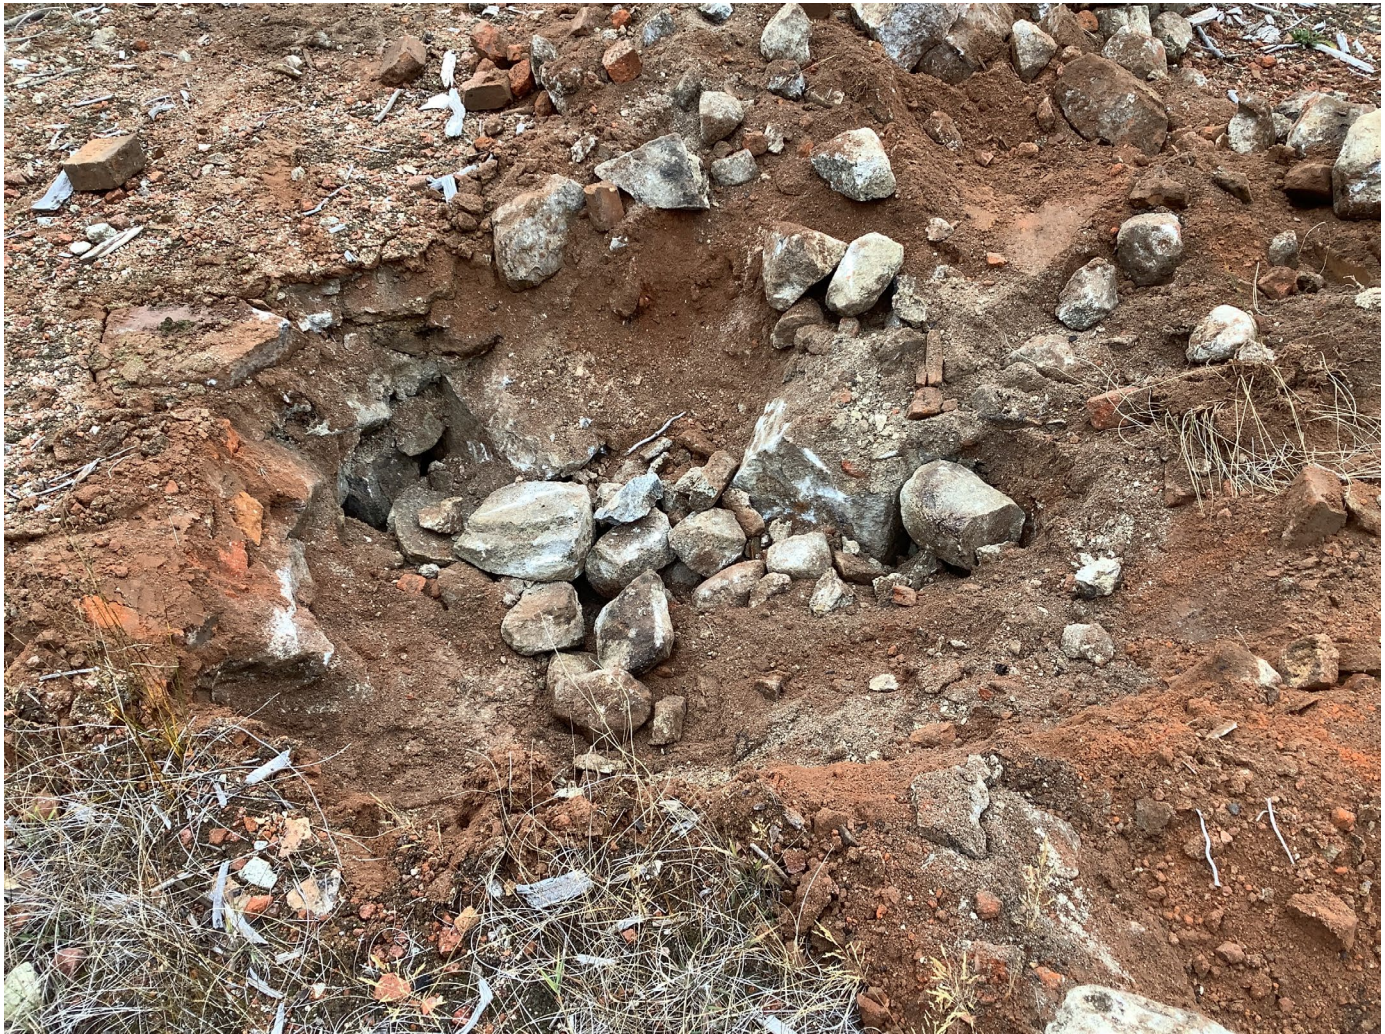
**Photo File:** Photos-20231012-175229.jpg

**Photo Description:** Sample location of RM-WR-04W-2023-1012 collected from 2 feet bgs. This hole was dug directly in line with a chute. Soil was light gray sandy material with red, clay-like areas scattered throughout. Large angular boulders with voids in between.

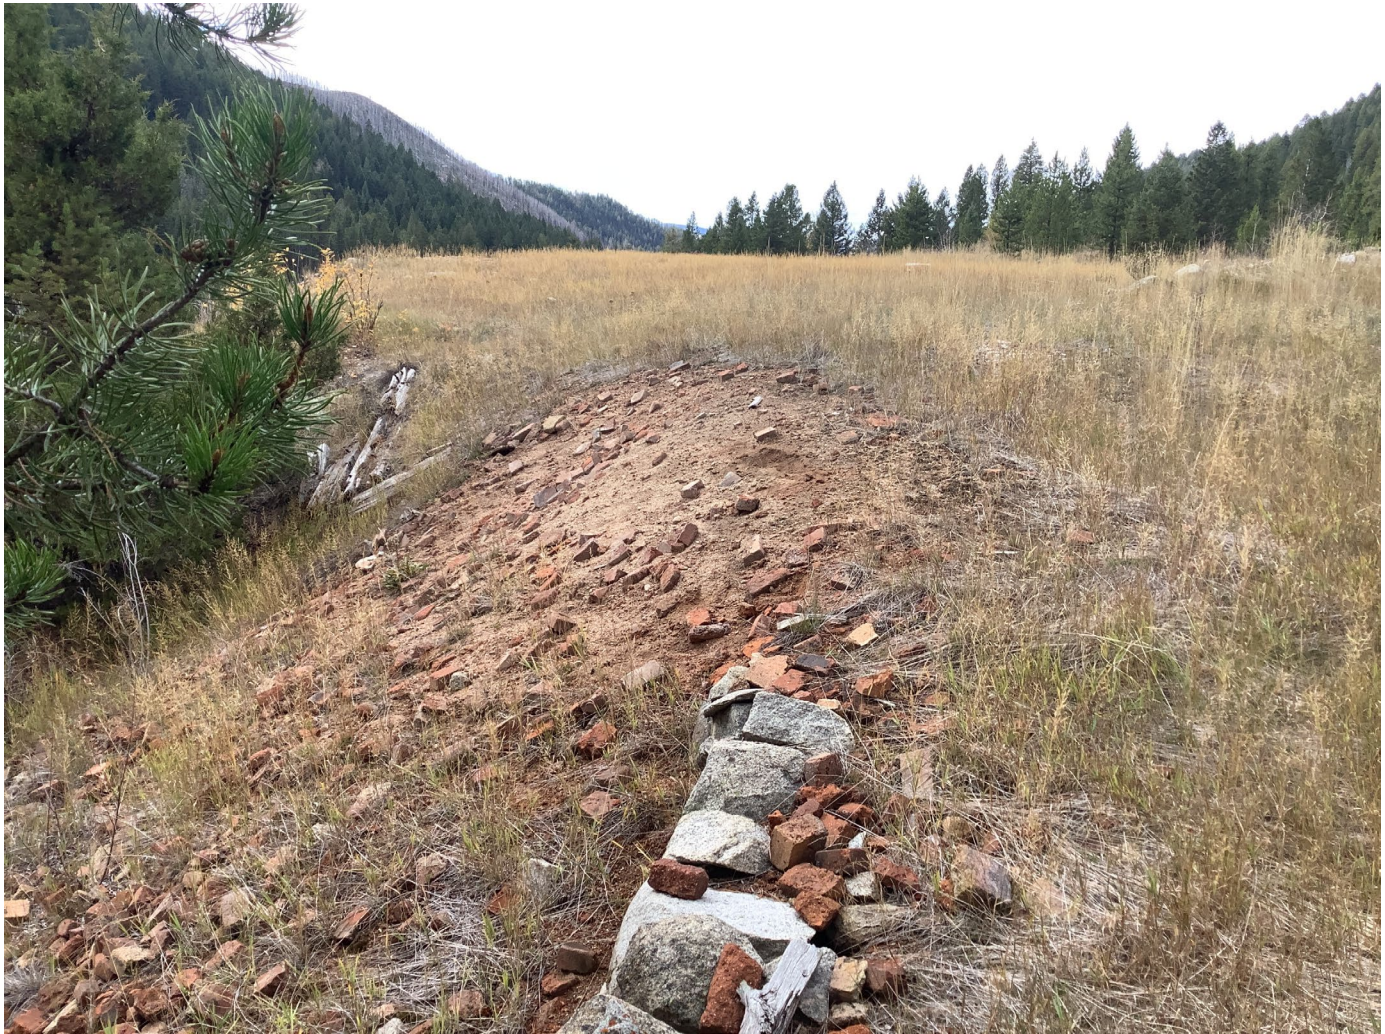
**Photo File:** Photos-20231012-190320.jpg

**Photo Description:** Sample location of RM-WR-04E-2023-1012. Large, bare mound of red-ish dirt with lots of brick fragments adjacent to a small, man-made wall of rocks (shown at bottom of photo). High in-situ lead and arsenic XRF readings observed in this area.

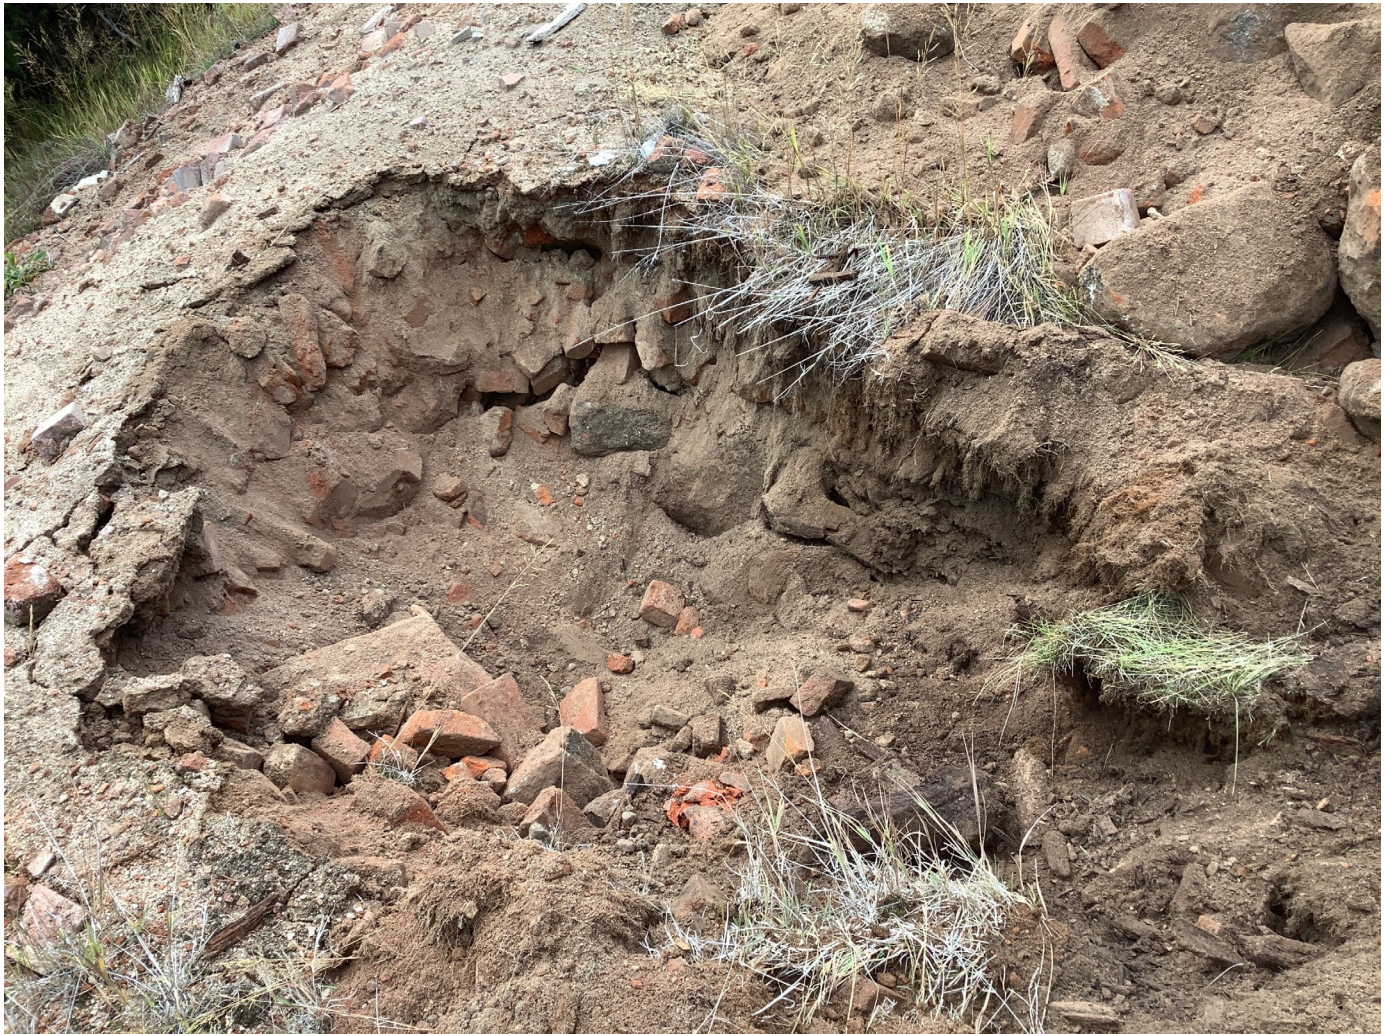
**Photo File:** Photos-20231012-190536.jpg

**Photo Description:** RM-WR-04E-2023-1012 collected from 3 feet bgs from a non-vegetated pile of what appears to be tailings. Soil is red in color with a sandy structure. High in-situ lead and arsenic XRF readings at this location.

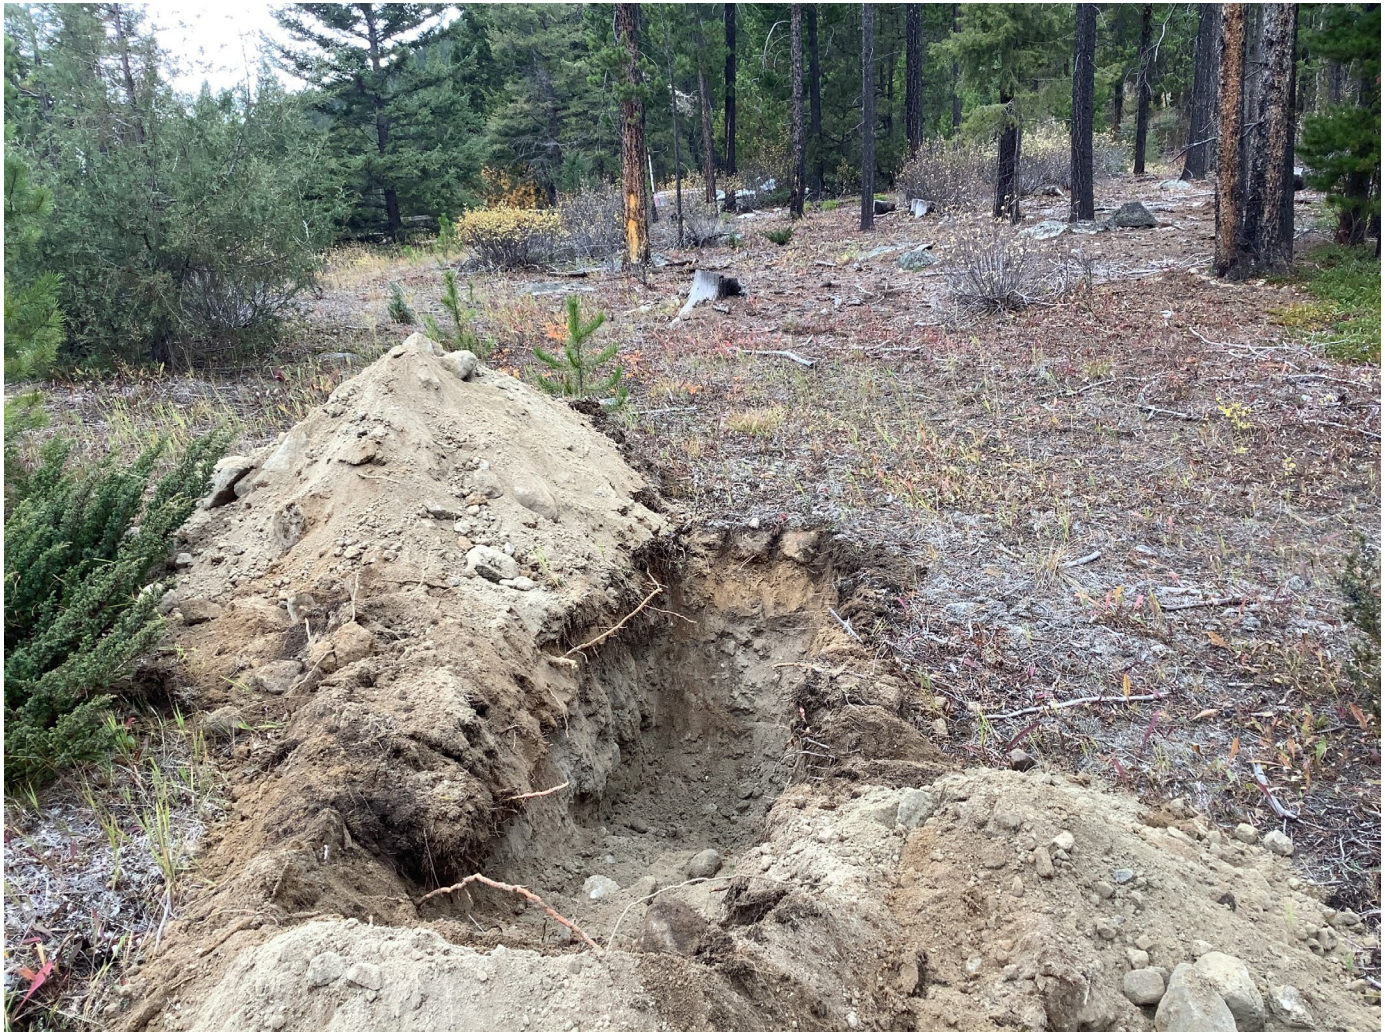
**Photo File:** Photos-20231012-193907.jpg

**Photo Description:** Sample location RM-WR-02E-2023-1012. Light brown, very fine grain sandy soil throughout entire pit.

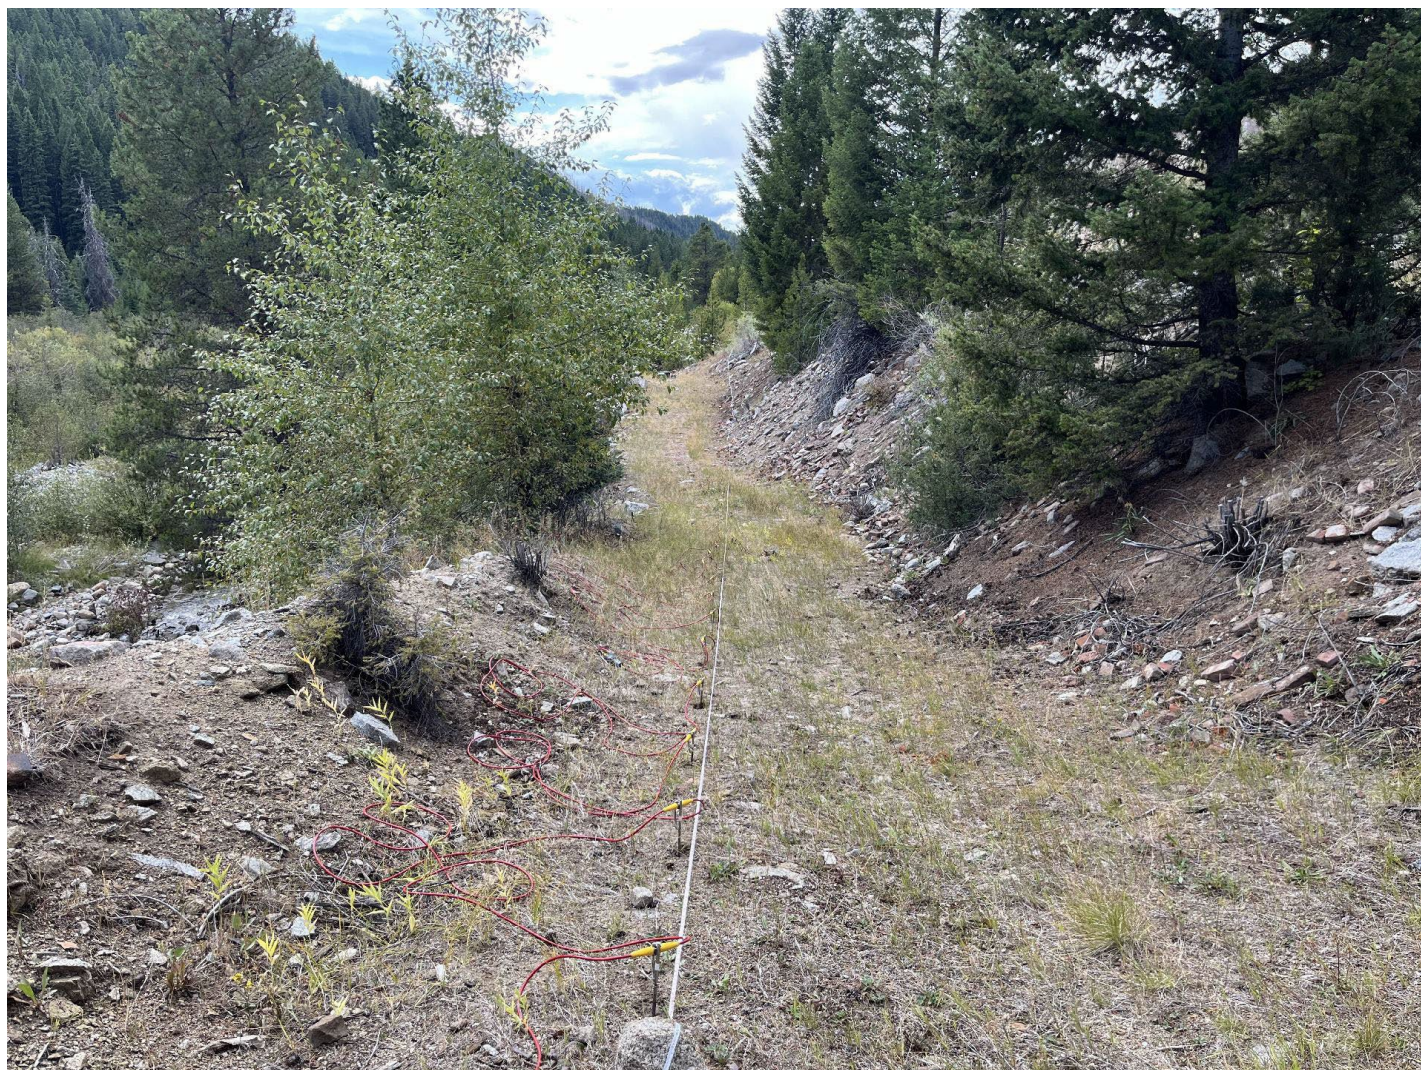
**Photo File:** Photos-20240927-152325.jpg

**Photo Description:** Electrical resistivity tomography (ERT) line ERT-1 oriented west to east along the lower level of the mill. ERT-1 was approximately 400 feet long.

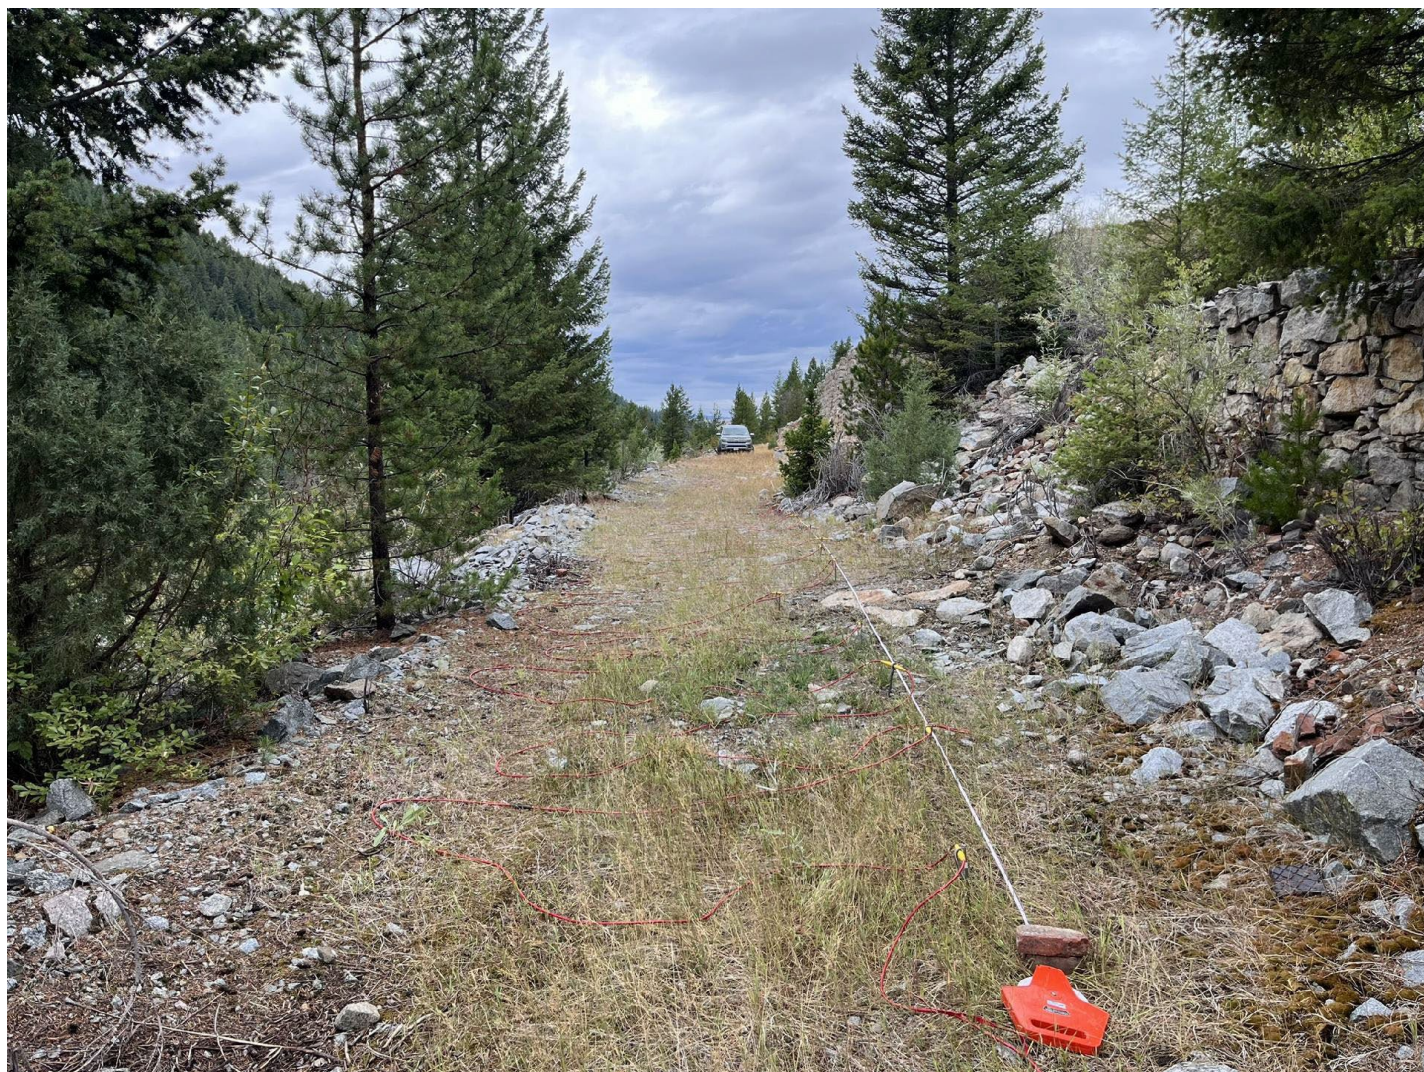
**Photo File:** Photos-20240927-153318.JPG

**Photo Description:** ERT-2 line along middle level of the mill. ERT-2 was approximately 440 feet long.

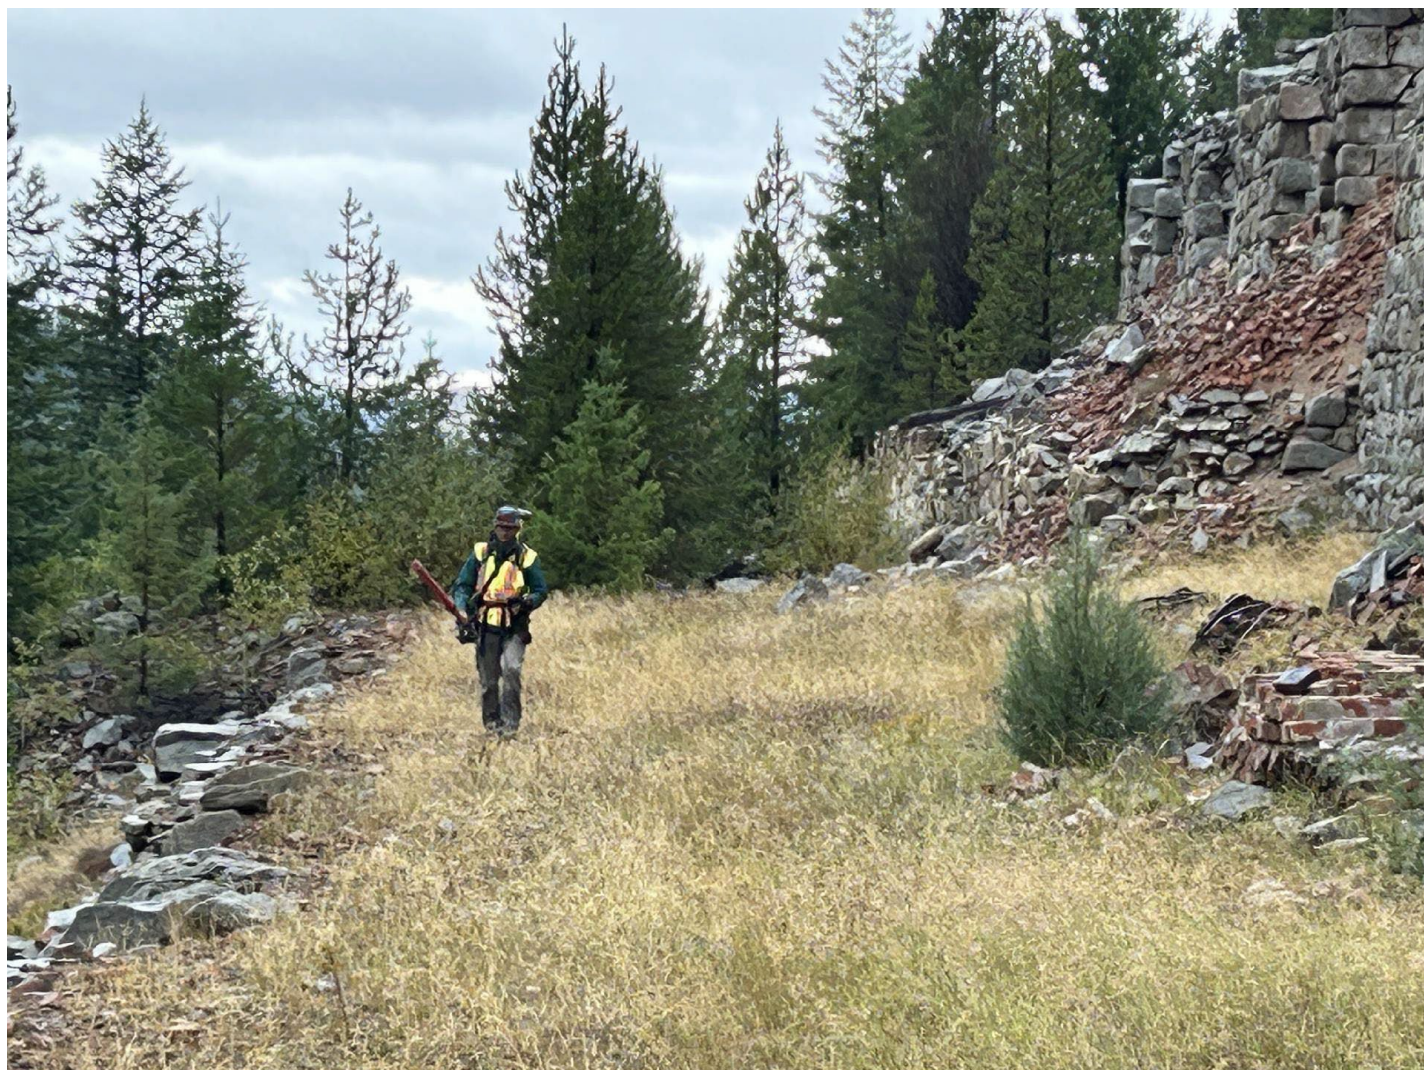
**Photo File:** Photos-20240922-220142.JPG

**Photo Description:** Conducting the EM-31-MK2 ground conductivity meter survey on the middle level of the mill.

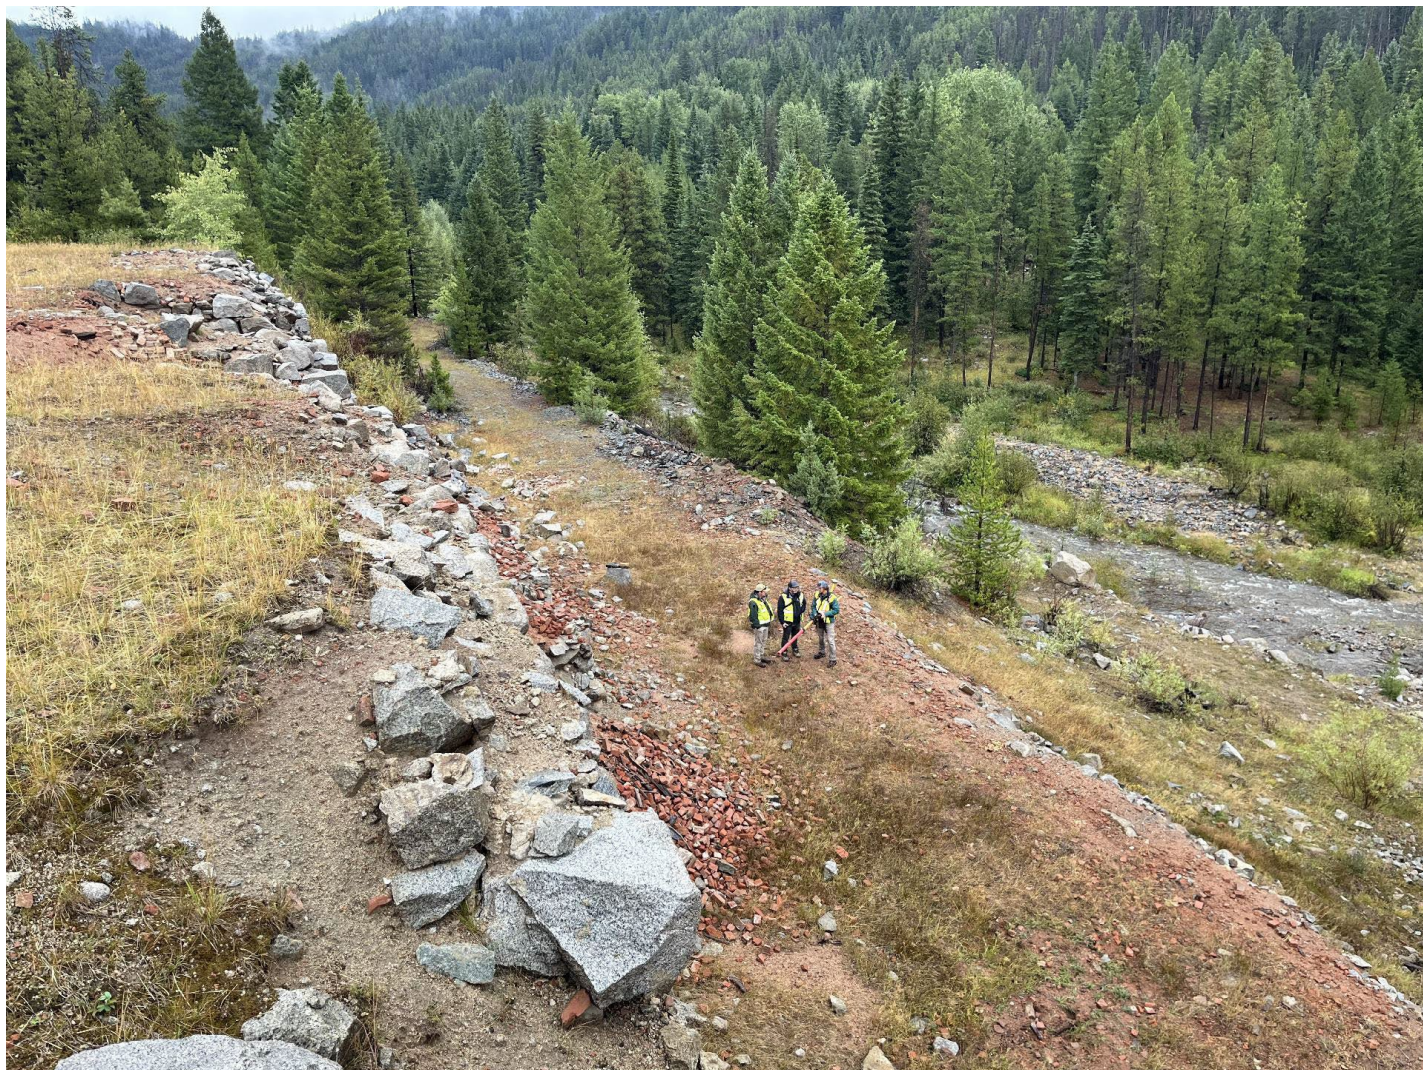
**Photo File:** Photos-20240927-153957.jpg

**Photo Description:** Discussing EM31 geophysical survey on the middle level of the mill.

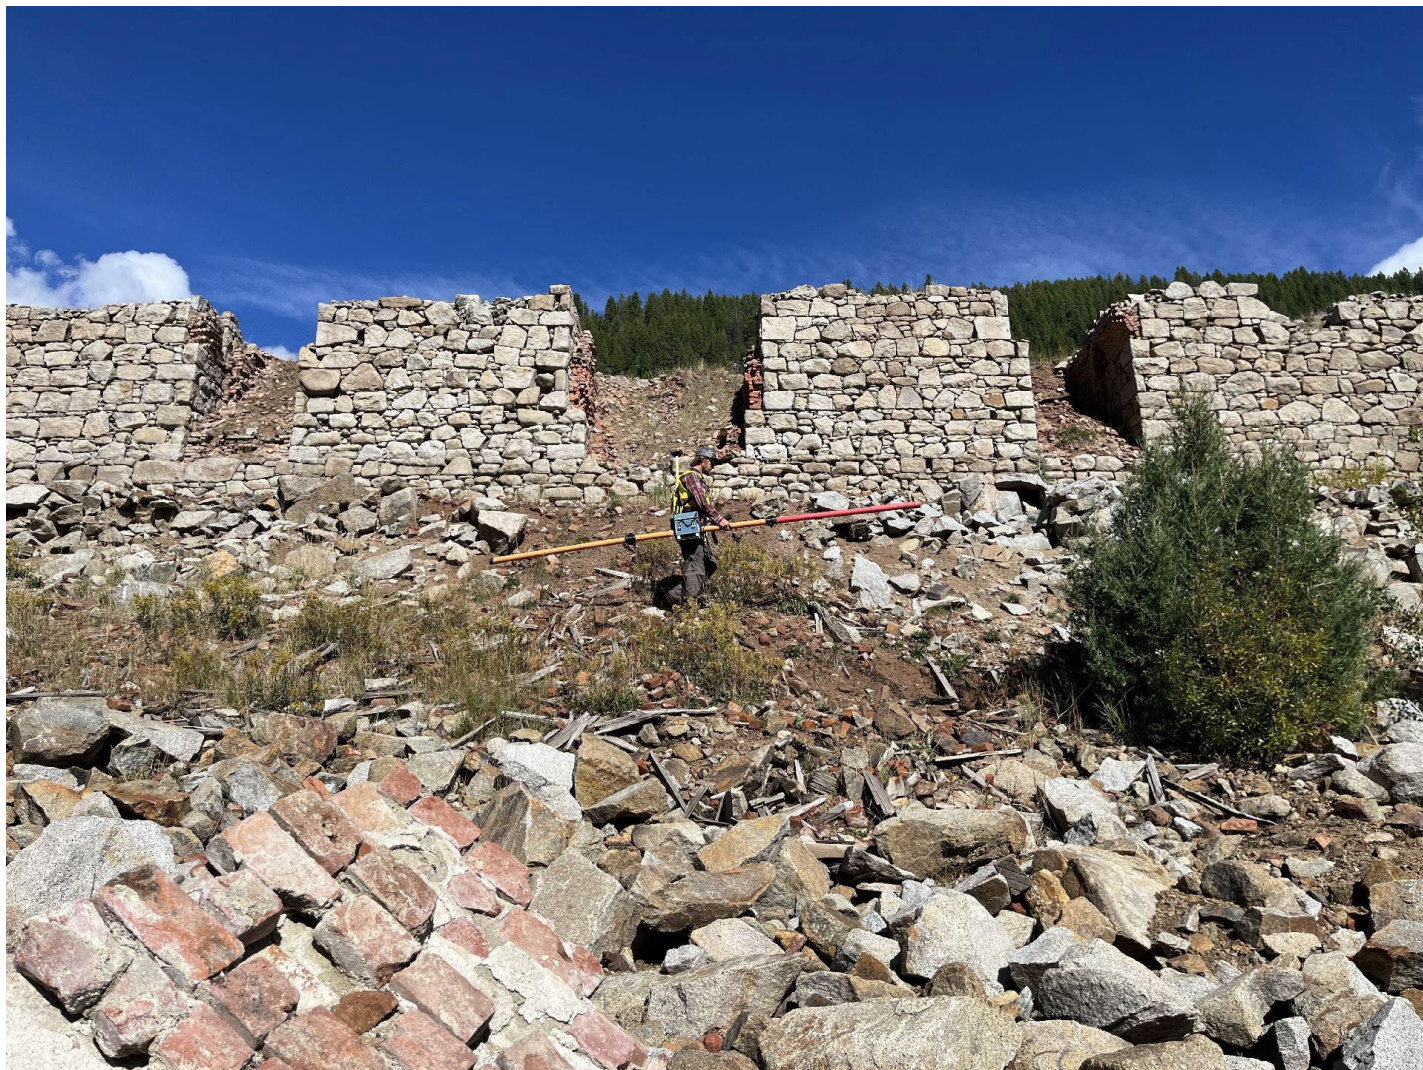
**Photo File:** Photos-20240927-155917.jpg

**Photo Description:** EM31 geophysical survey data collection along transects east to west on the lower level of the mill adjacent to Fred Burr Creek.

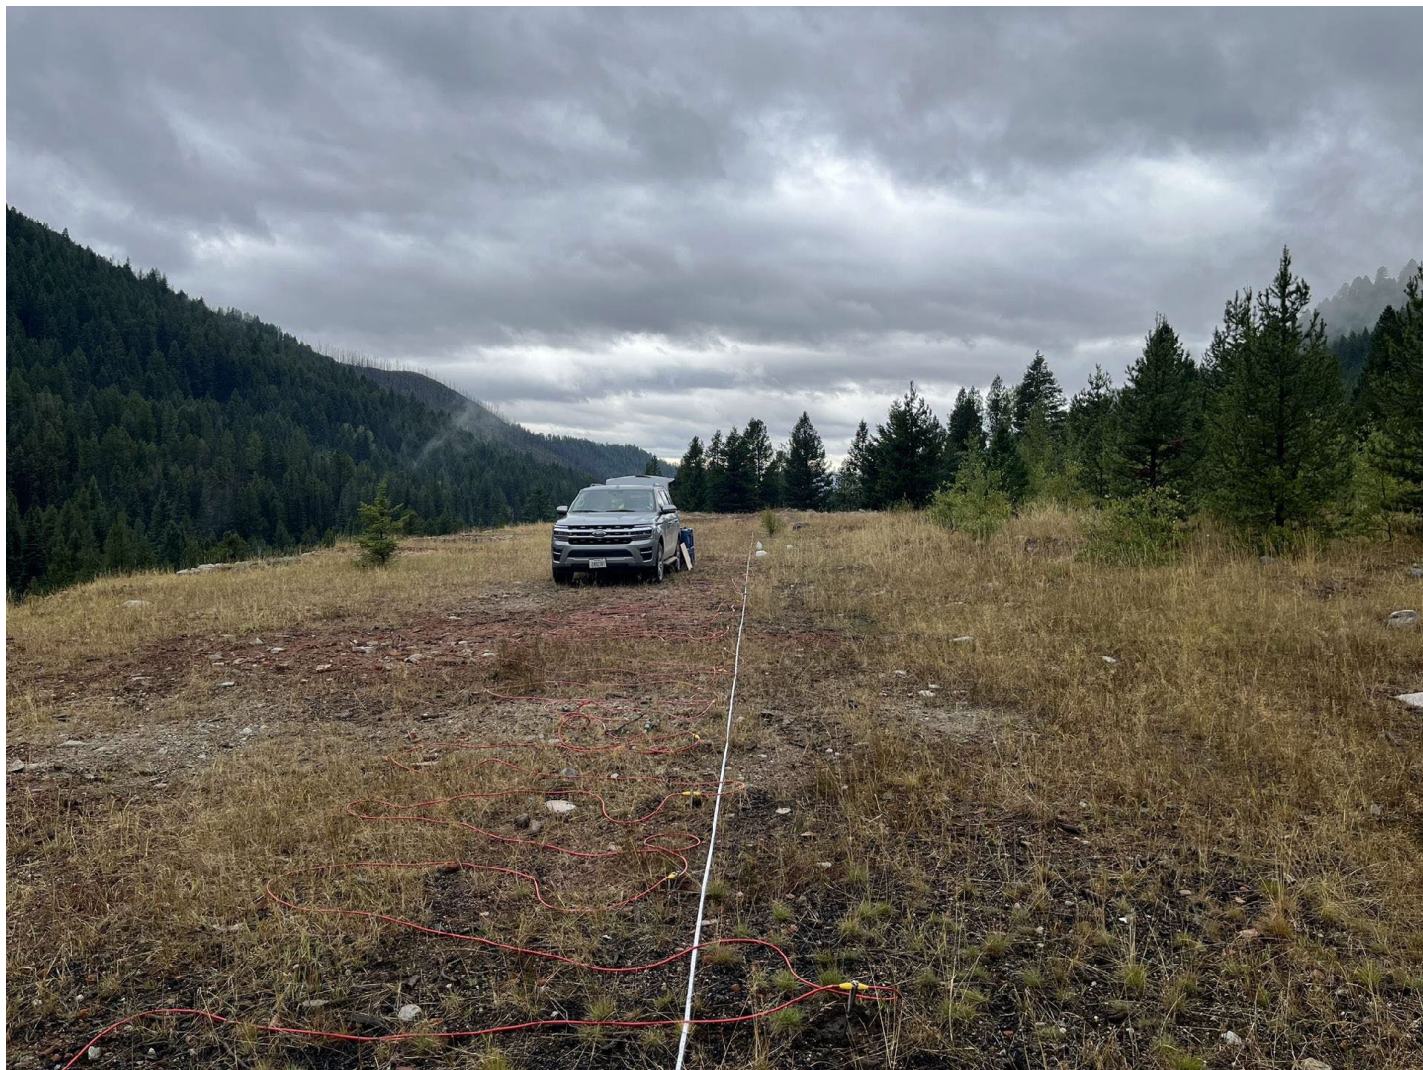
**Photo File:** Photos-20240927-155231.JPG

**Photo Description:** ERT-3 line along upper level of the mill.

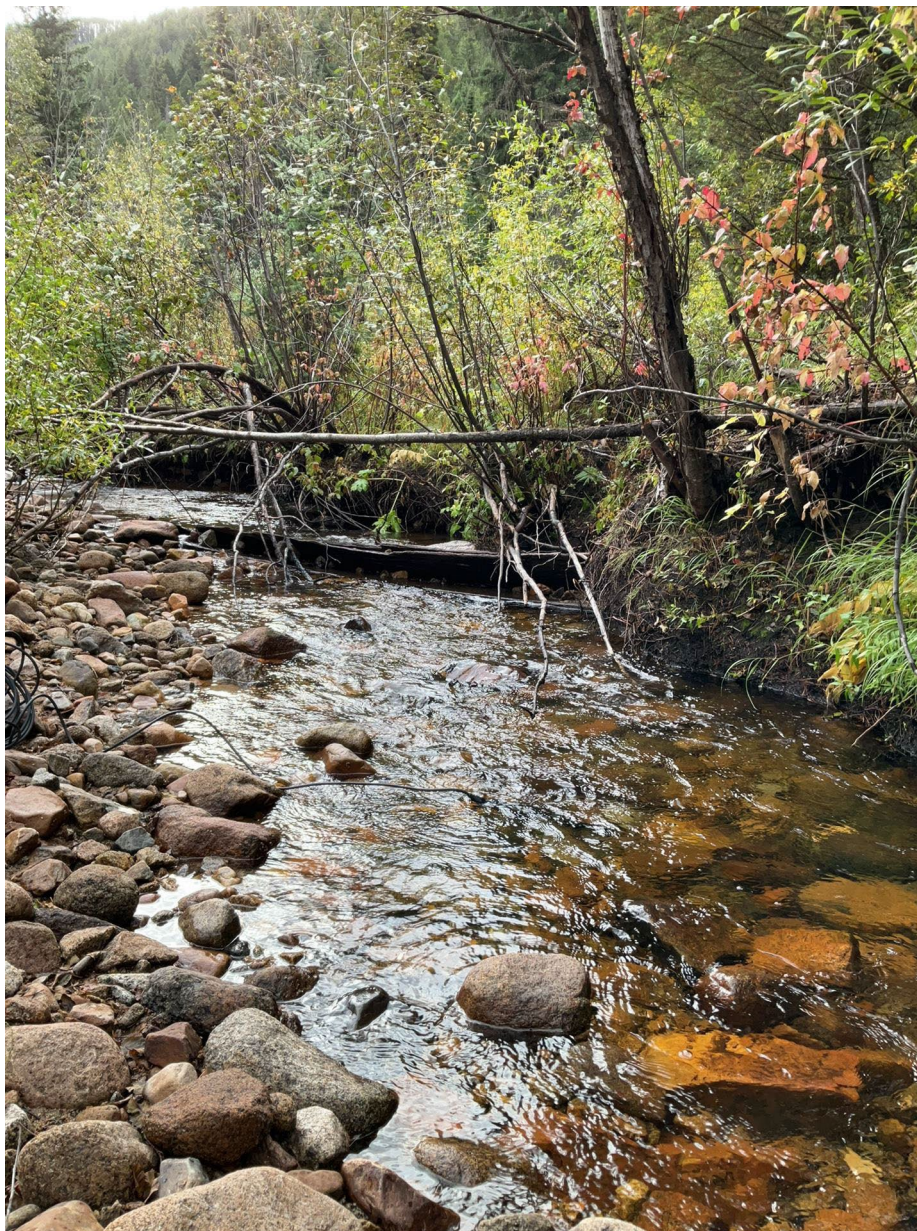
**Photo File:** Photos-20240917-161603.jpg

**Photo Description:** Water quality monitoring at RM-SW-03.

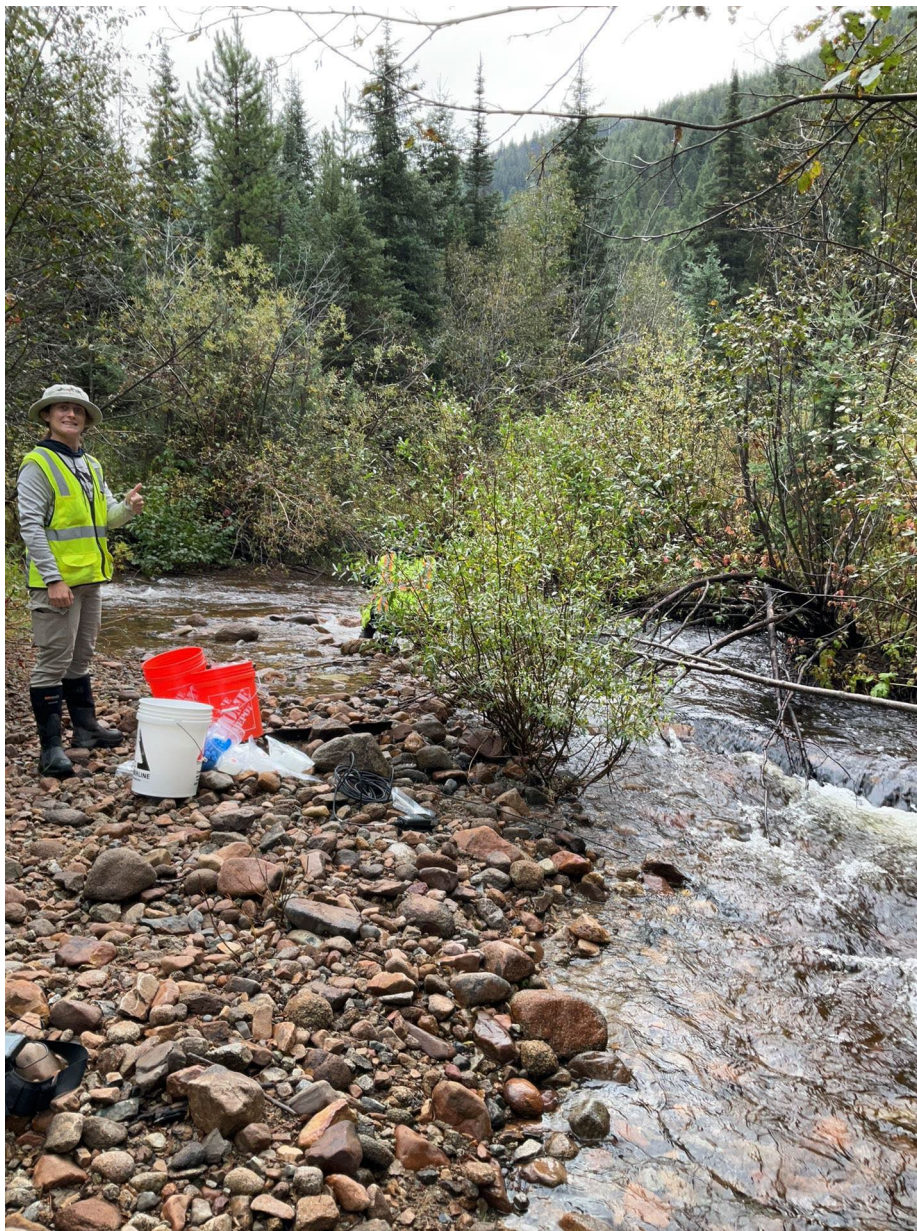
**Photo File:** Photos-20240918-220250.jpg

**Photo Description:** Surface water, sediment, and stable isotope sampling at RM-SW-03. The flow rate of the creek was greater at the time of sampling than when initial water quality monitoring was conducted on 9/17/2024.

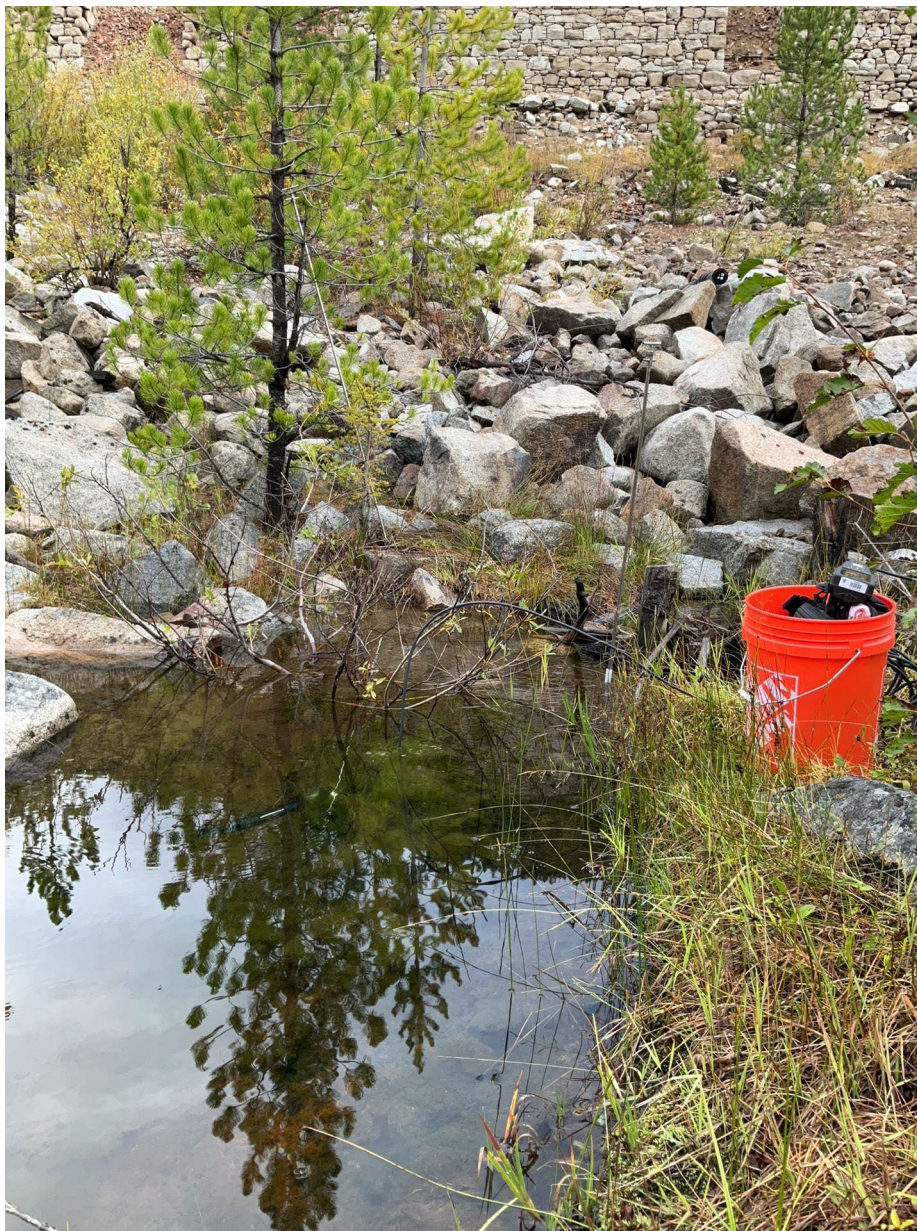
**Photo File:** Photos-20240917-160119.jpg

**Photo Description:** Water quality monitoring at RM-SW-02B.

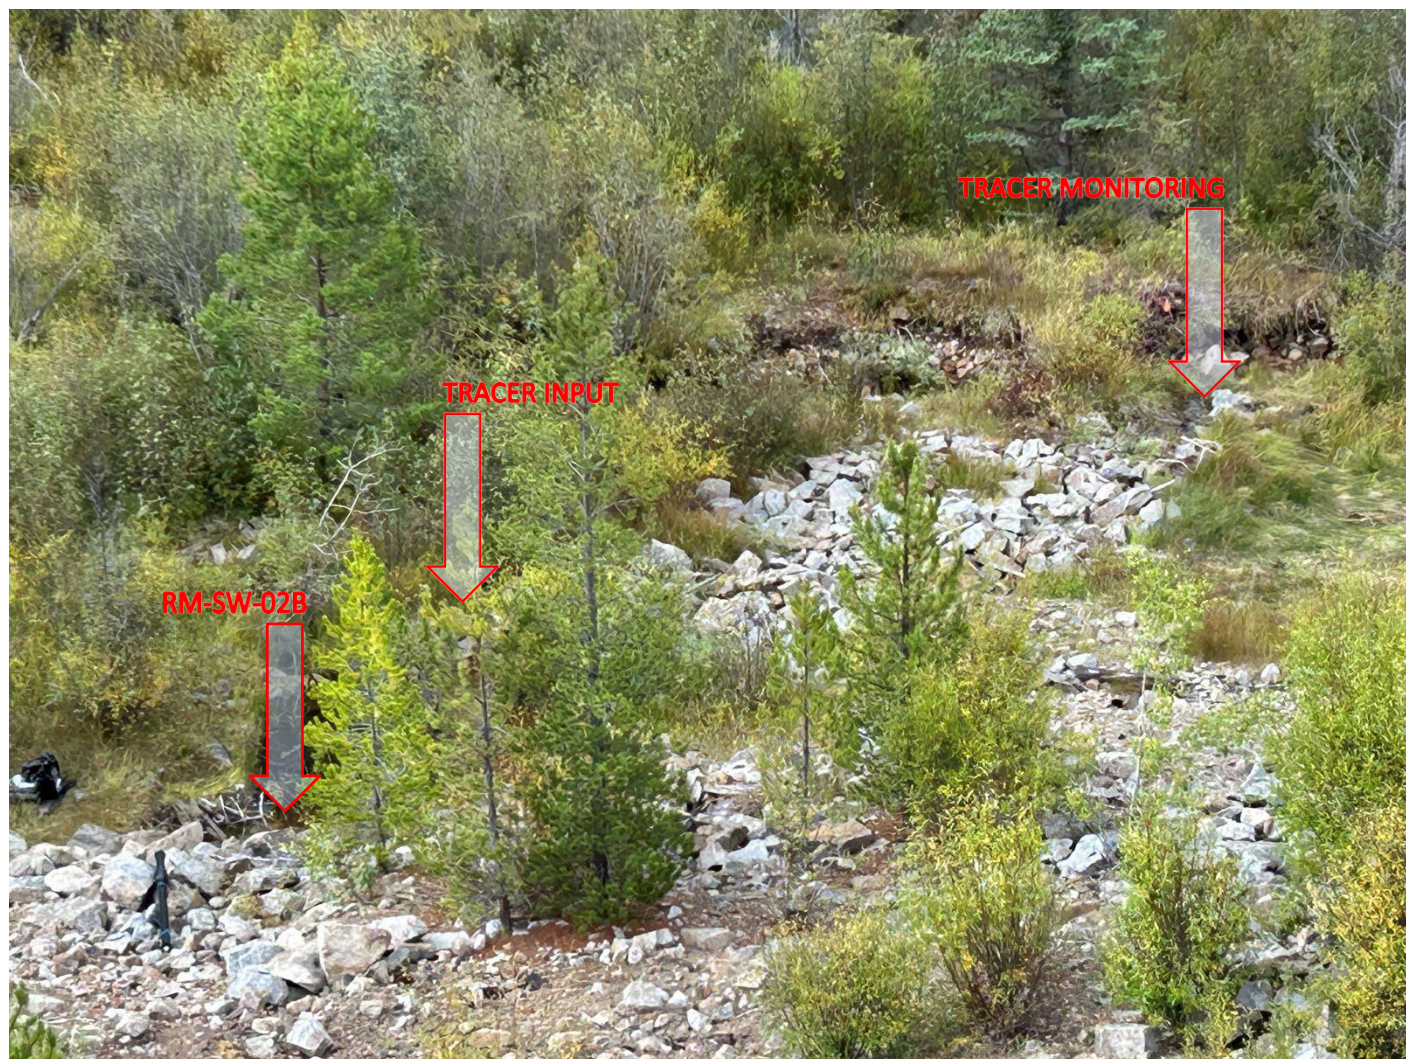
**Photo File:** Photos-20240917-IMG 1426.jpg

**Photo Description:** RM-SW-02B is where high total metals concentrations were present in 2023. Pore water sampling was attempted but was not successful due to rocky substrate. In the area between the red arrows, water quality tracer testing was conducted using salt water with a salinity of approximately 30 parts per thousand. After 3.5 minutes, water quality parameters notably increased at the right most arrow.

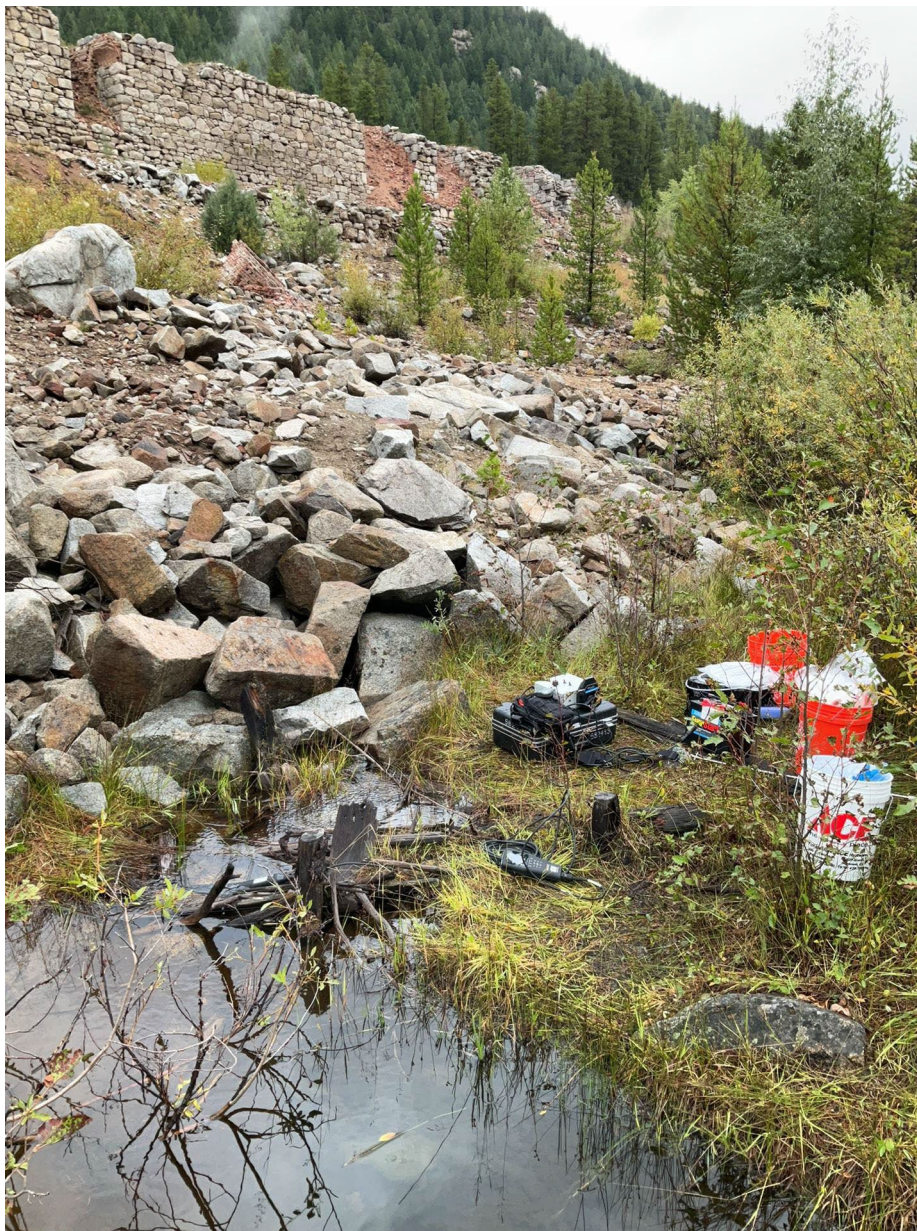
**Photo File:** Photos-20240918-223305.jpg

**Photo Description:** Surface water, sediment, and stable isotope sampling at RM-SW-02B. Pore water sampling was unsuccessful due to hitting refusal when advancing the sampling apparatus to the correct depth.
