### **ACTION MEMORANDUM**

**SUBJECT:** Approval and Funding for a Removal Action at the Rumsey Mill Site in Philipsburg, Granite County, Montana

**Rumsey Mill RS**  
Philipsburg, Granite County, Montana  
**Figure A3**  
**Sample and Water Quality**  
**Locations**

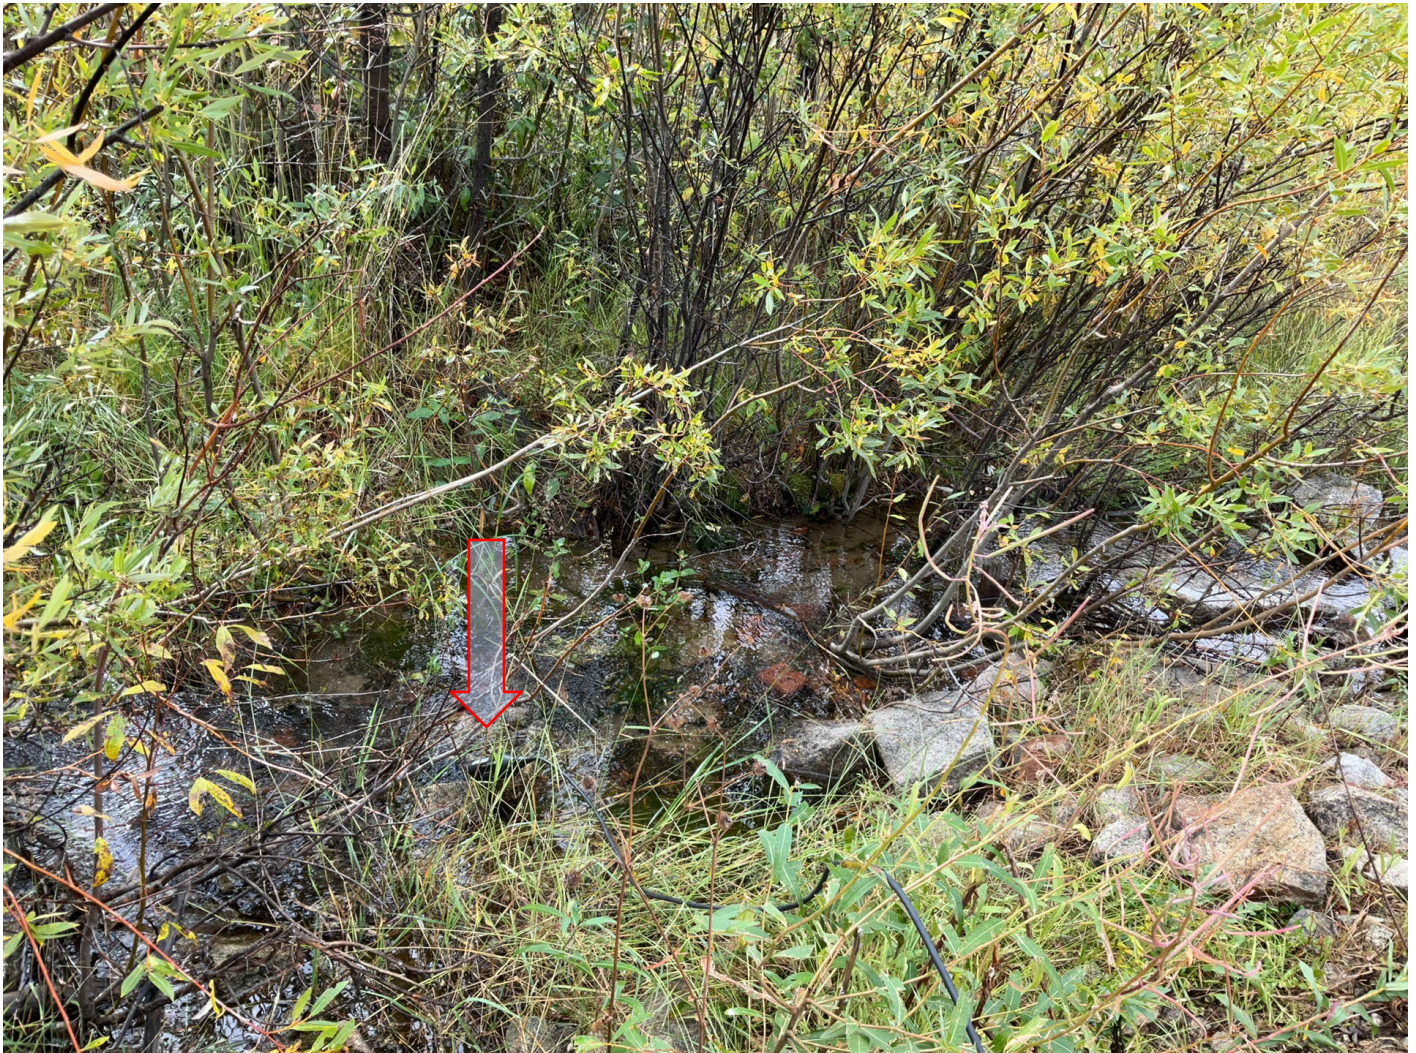
**Photo File:** Photos-20240917-163731.jpg

**Photo Description:** Water quality monitoring at RM-SW-02A-03, which is at the toe of the slope of decision unit 07 between RM-SW-02B and RM-SW-02A-02.

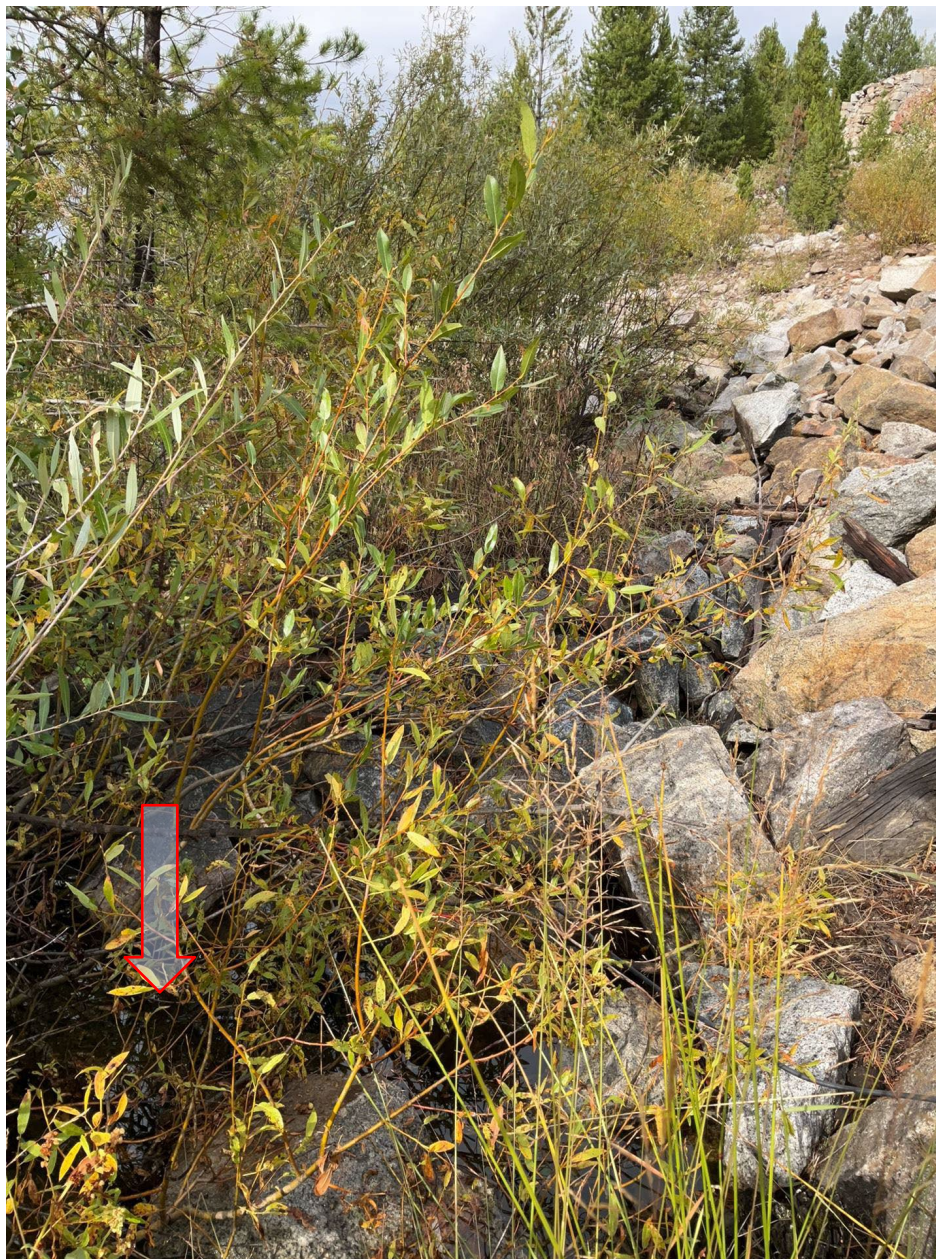
**Photo File:** Photos-20240917-164936.jpg

**Photo Description:** Water quality monitoring at RM-SW-02A-02, which is at the toe of the slope of decision unit 07 between RM-SW-02A-03 and RM-SW-02A-01.

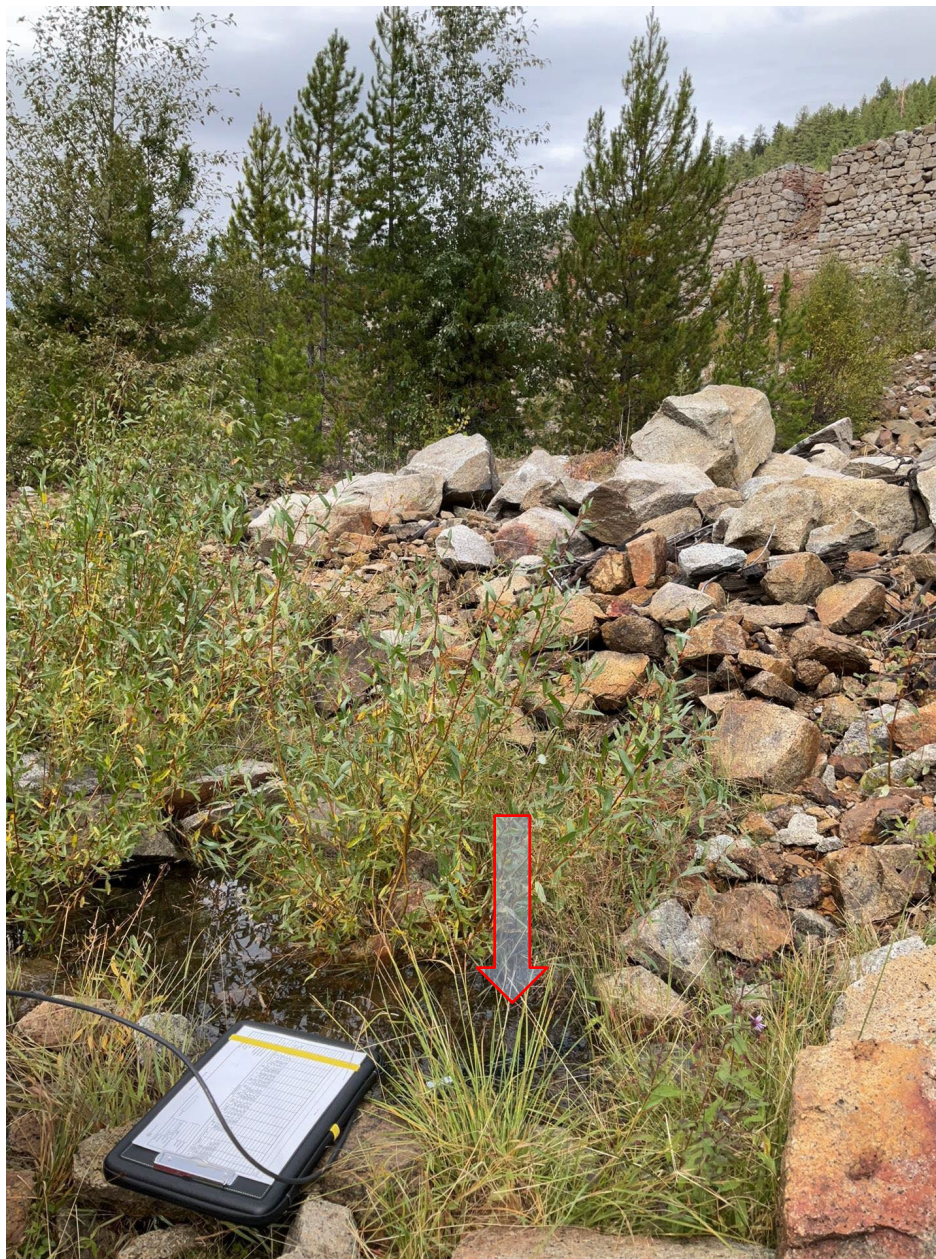
**Photo File:** Photos-20240917-170336.jpg

**Photo Description:** Water quality monitoring at location RM-SW-02A-01, which is at the toe of the slope of decision unit 07 between RM-SW-02A-02 and RM-SW-02A.

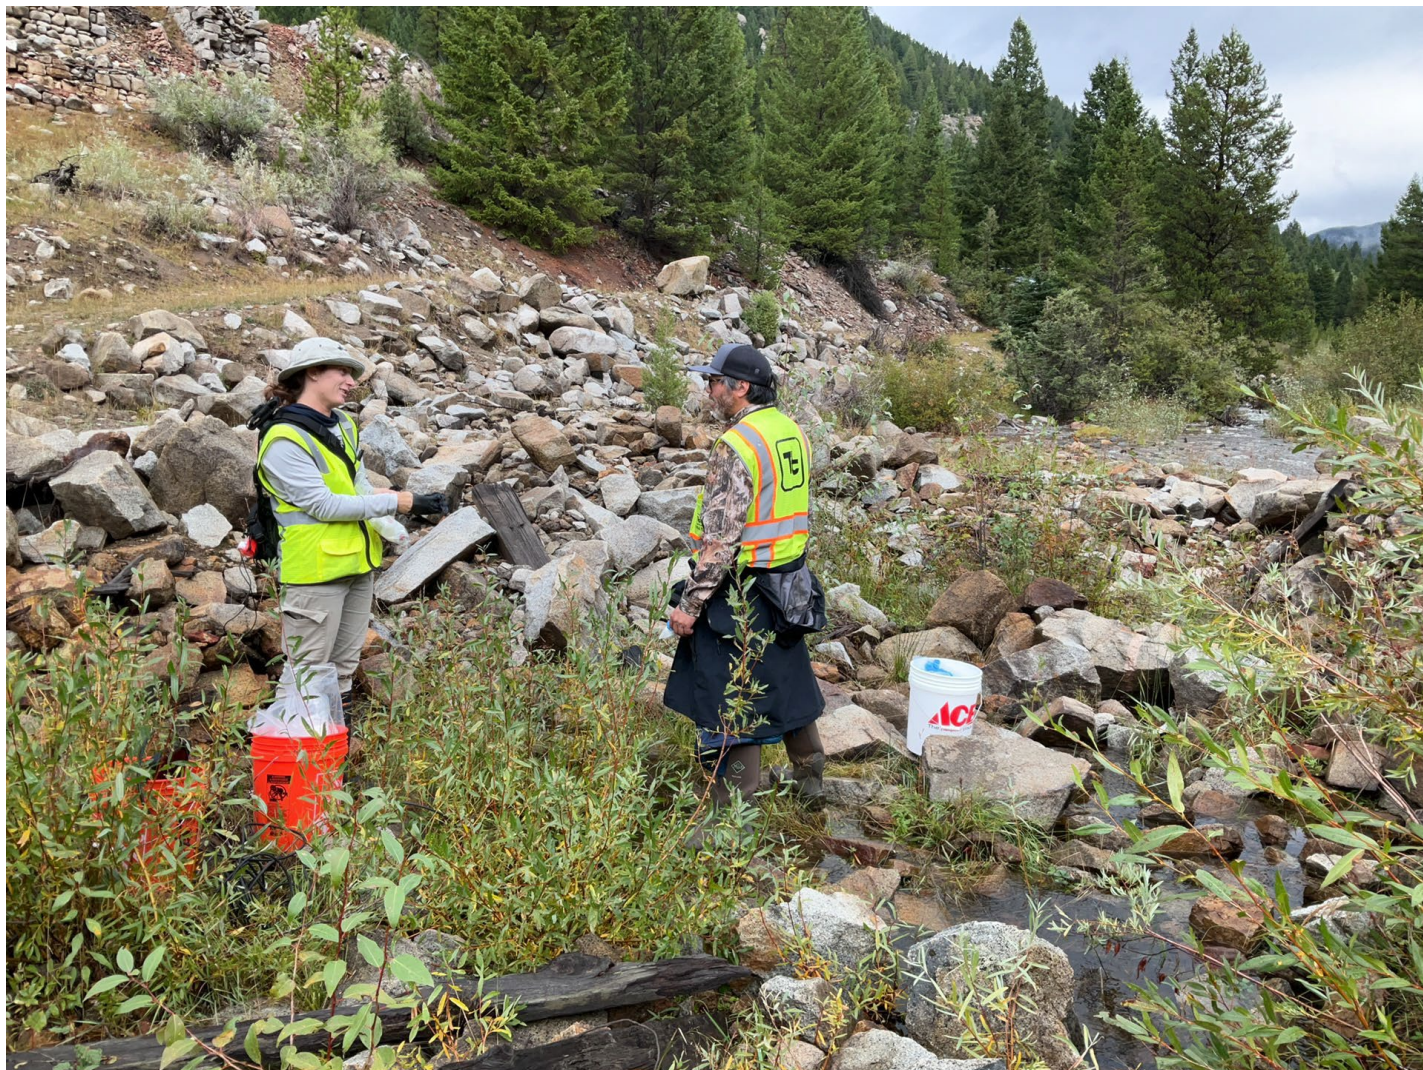
**Photo File:** Photos-20240918-231203.jpg

**Photo Description:** Surface water, sediment, and stable isotope sampling at RM-SW-02A-01.

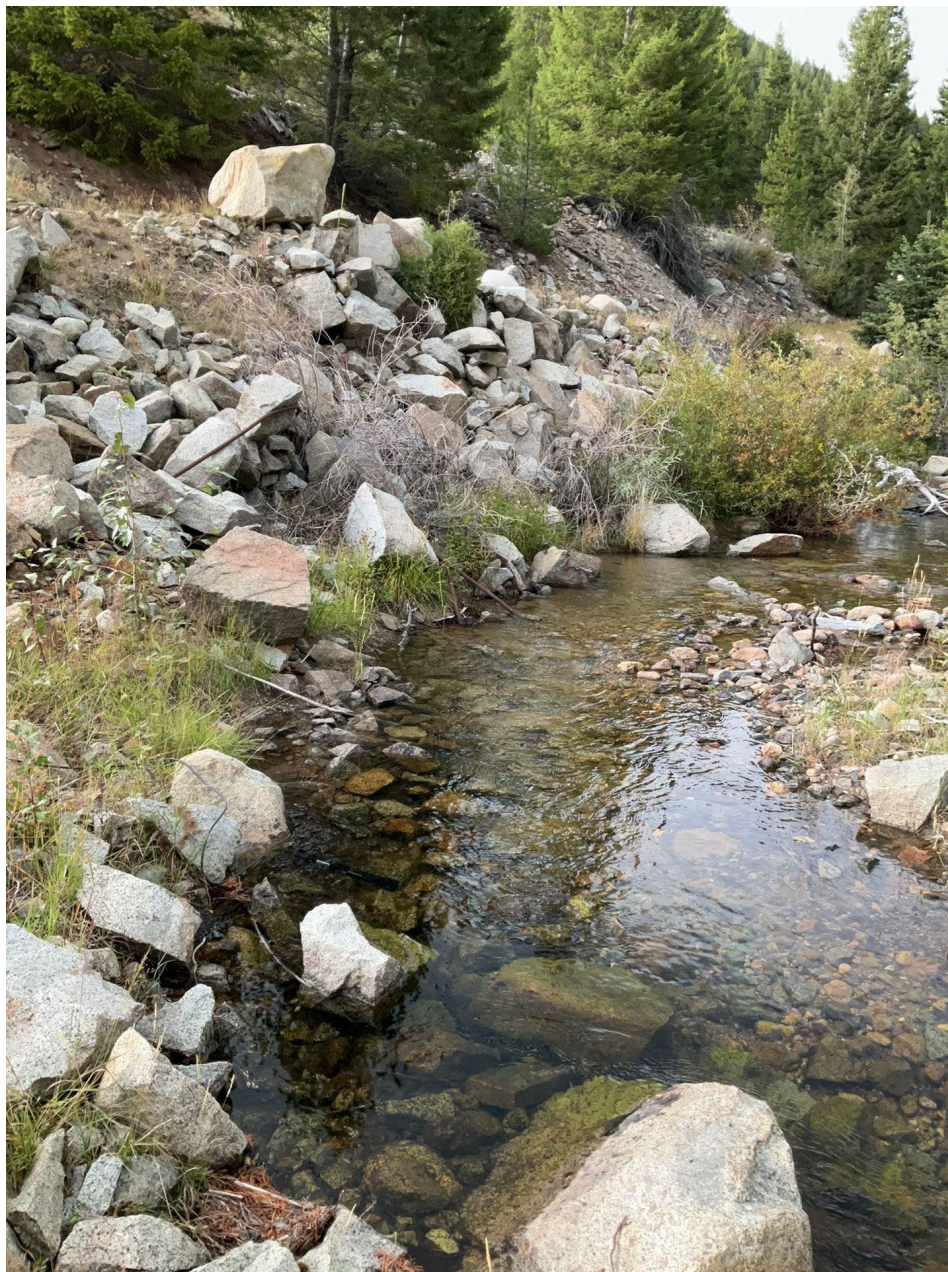
**Photo File:** Photos-20240916-231527.jpg

**Photo Description:** Water quality monitoring at RM-SW-02A.

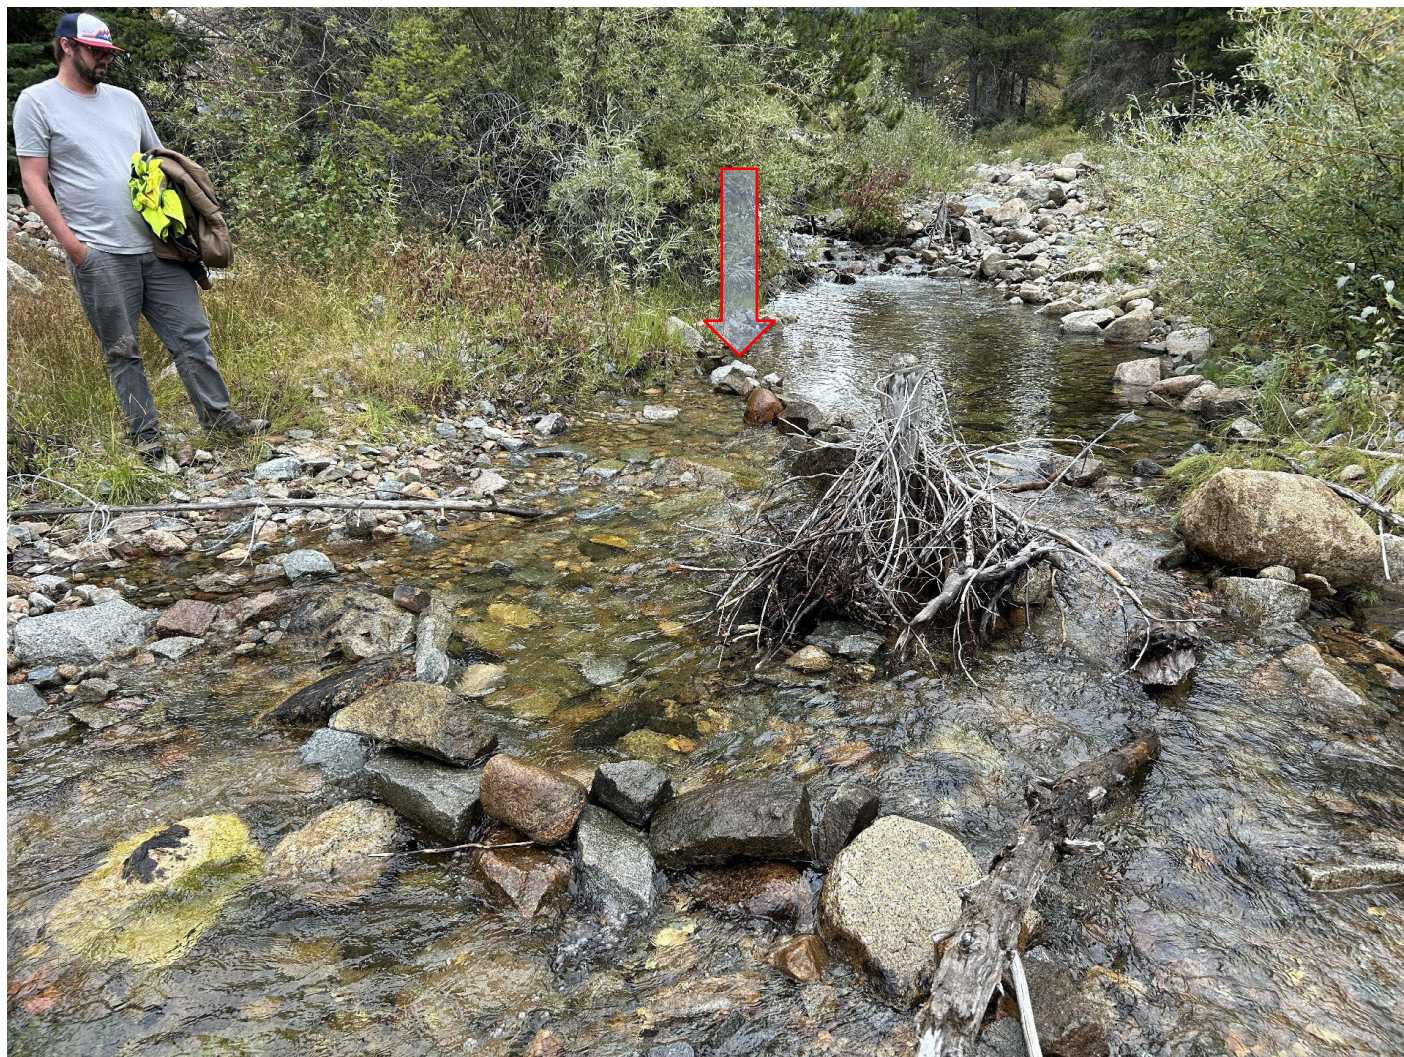
**Photo File:** Photos-20240922-220842.JPG

**Photo Description:** Rock diversion dams installed to redirect creek water away from the rock bank upstream of RM-SW-02A where, water was observed entering the bank. The goal was to observe if the water level would be affected at location RM-SW-02B. A water level change could not be correlated.

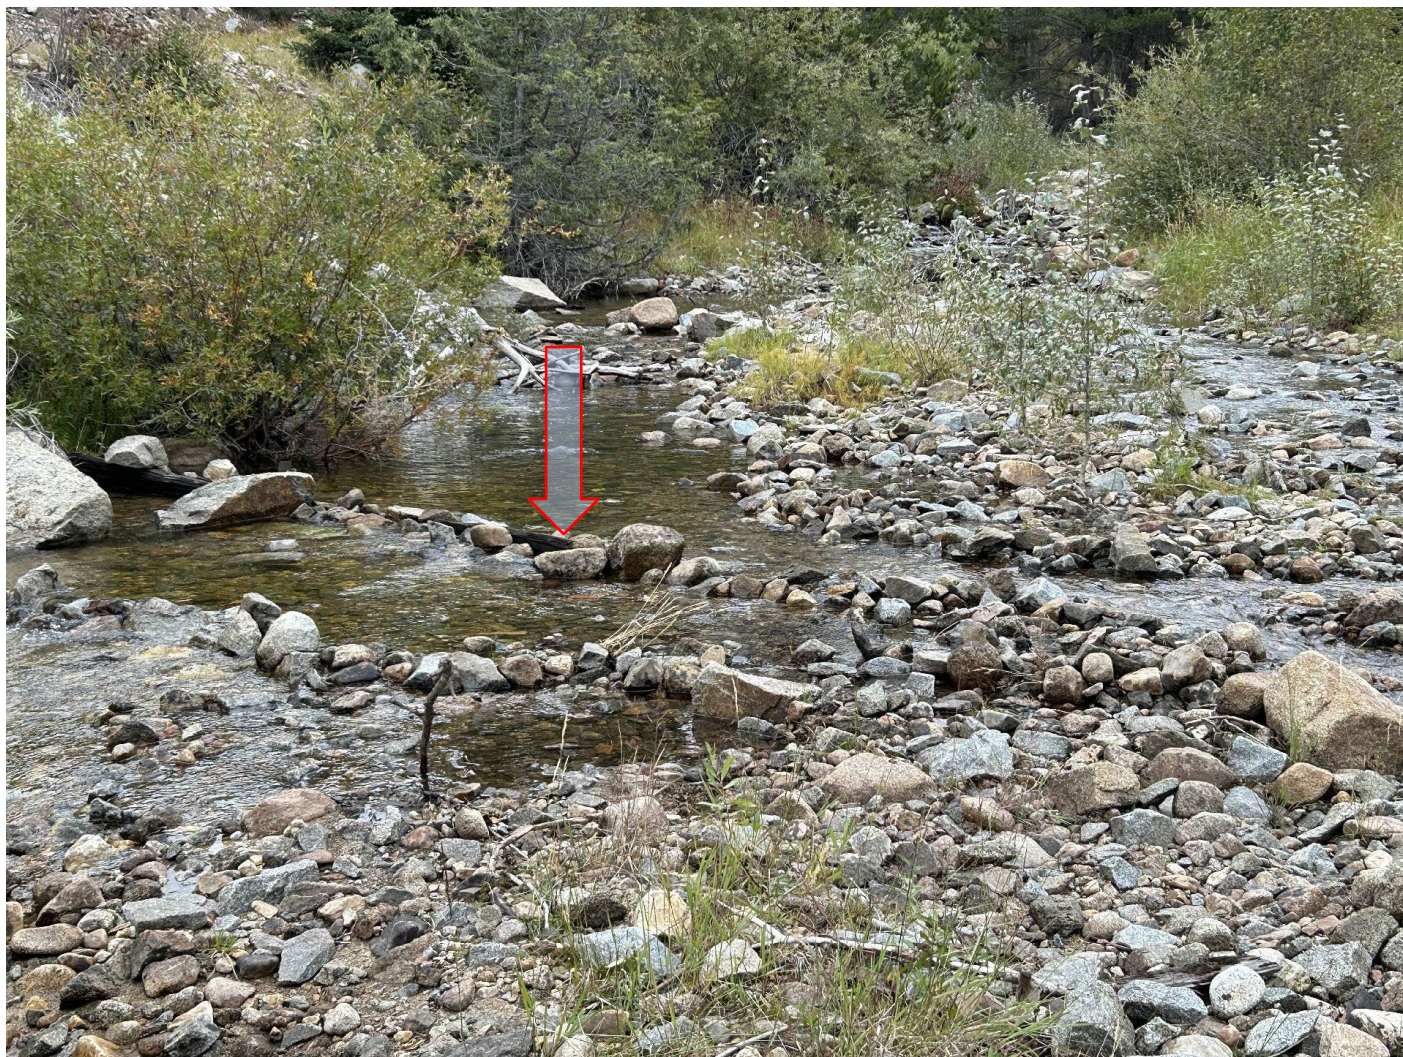
**Photo File:** Photos-20240922-215233.JPG

**Photo Description:** Rock diversion dams installed to redirect creek water away from the rock bank upstream of RM-SW-02A, where water was observed entering the bank. The goal was to observe if the water level would be affected at location RM-SW-02B. A water level change could not be correlated.

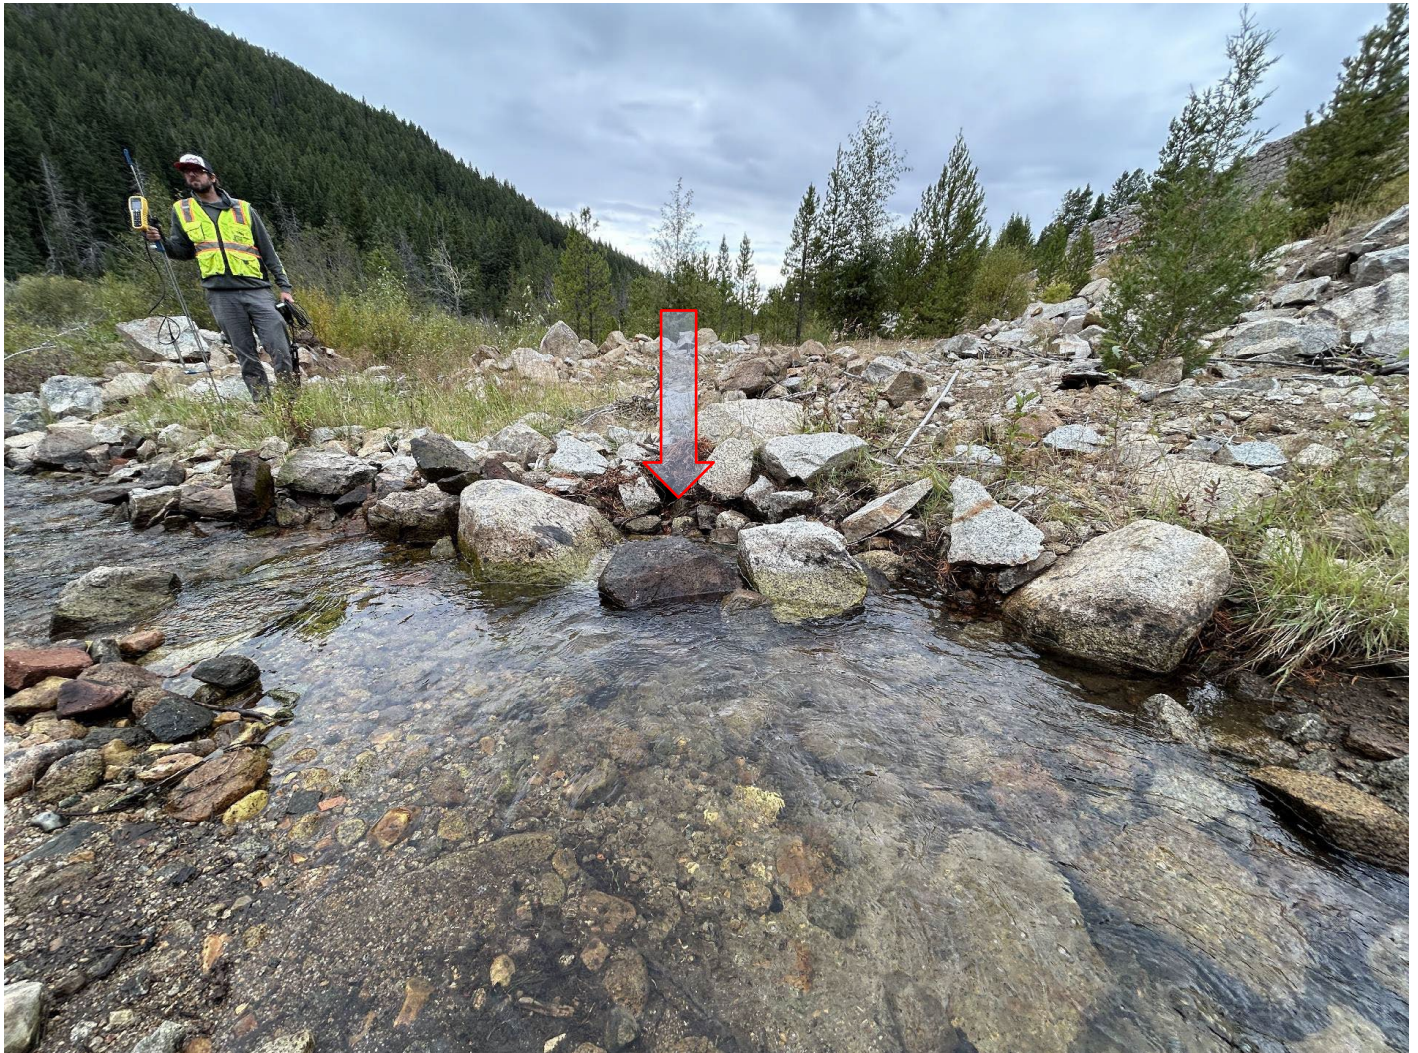
**Photo File:** Photos-20240922-215652.JPG

**Photo Description:** Water observed entering the bank near RM-SW-02A.

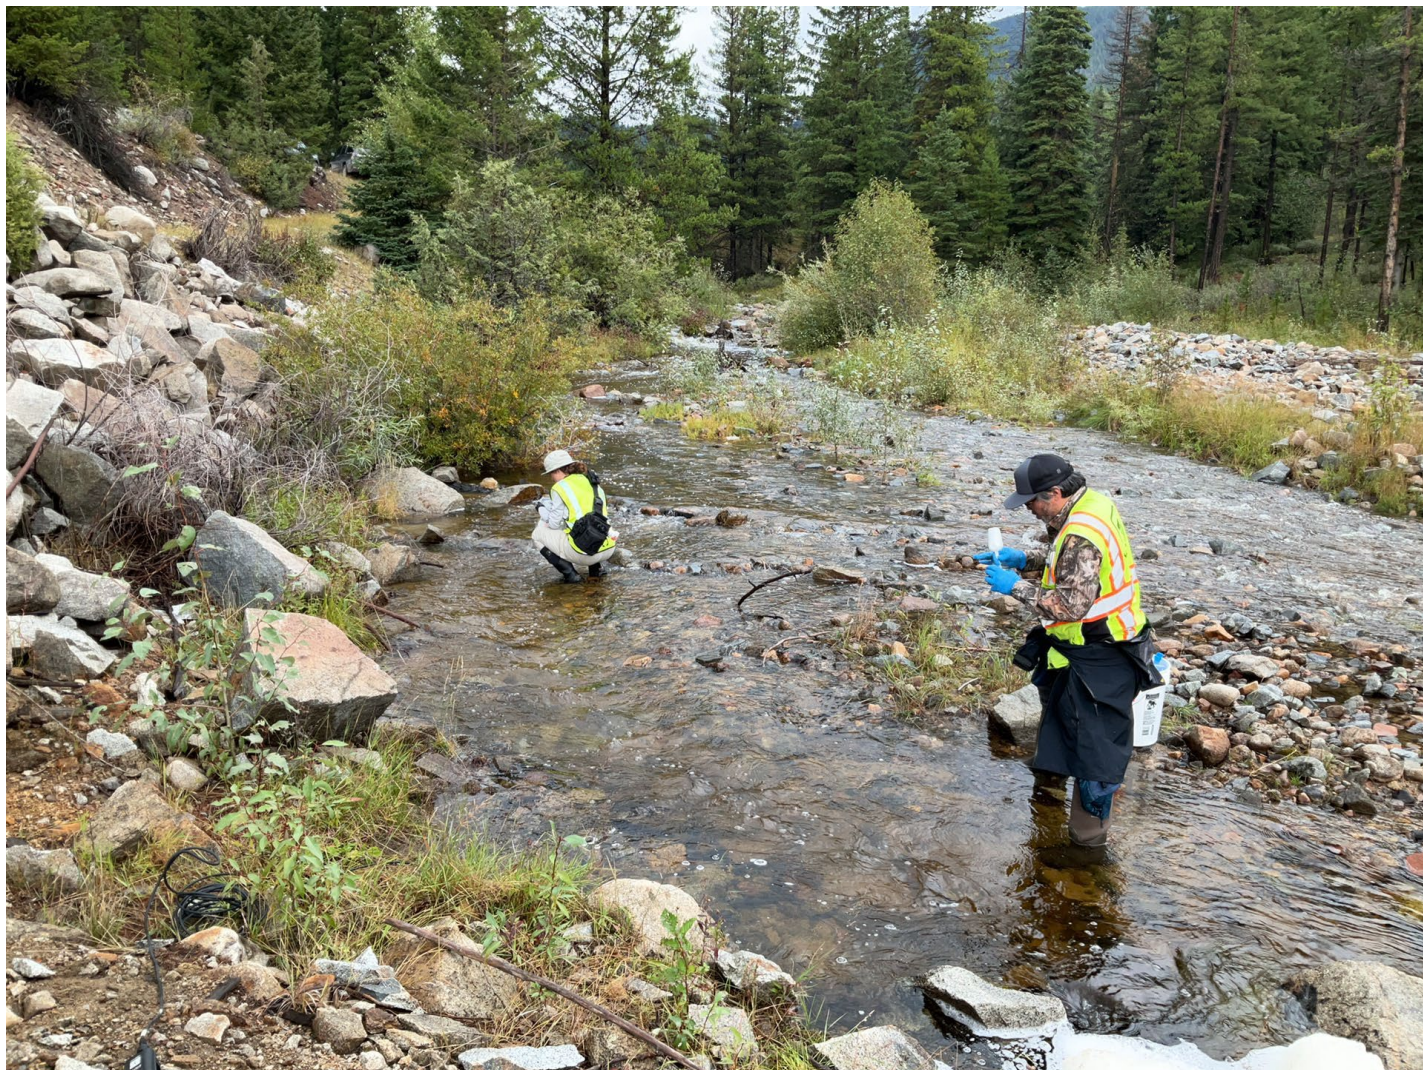
**Photo File:** Photos-20240918-232208.jpg

**Photo Description:** Surface water, sediment, and stable isotope sampling at RM-SW-02A.

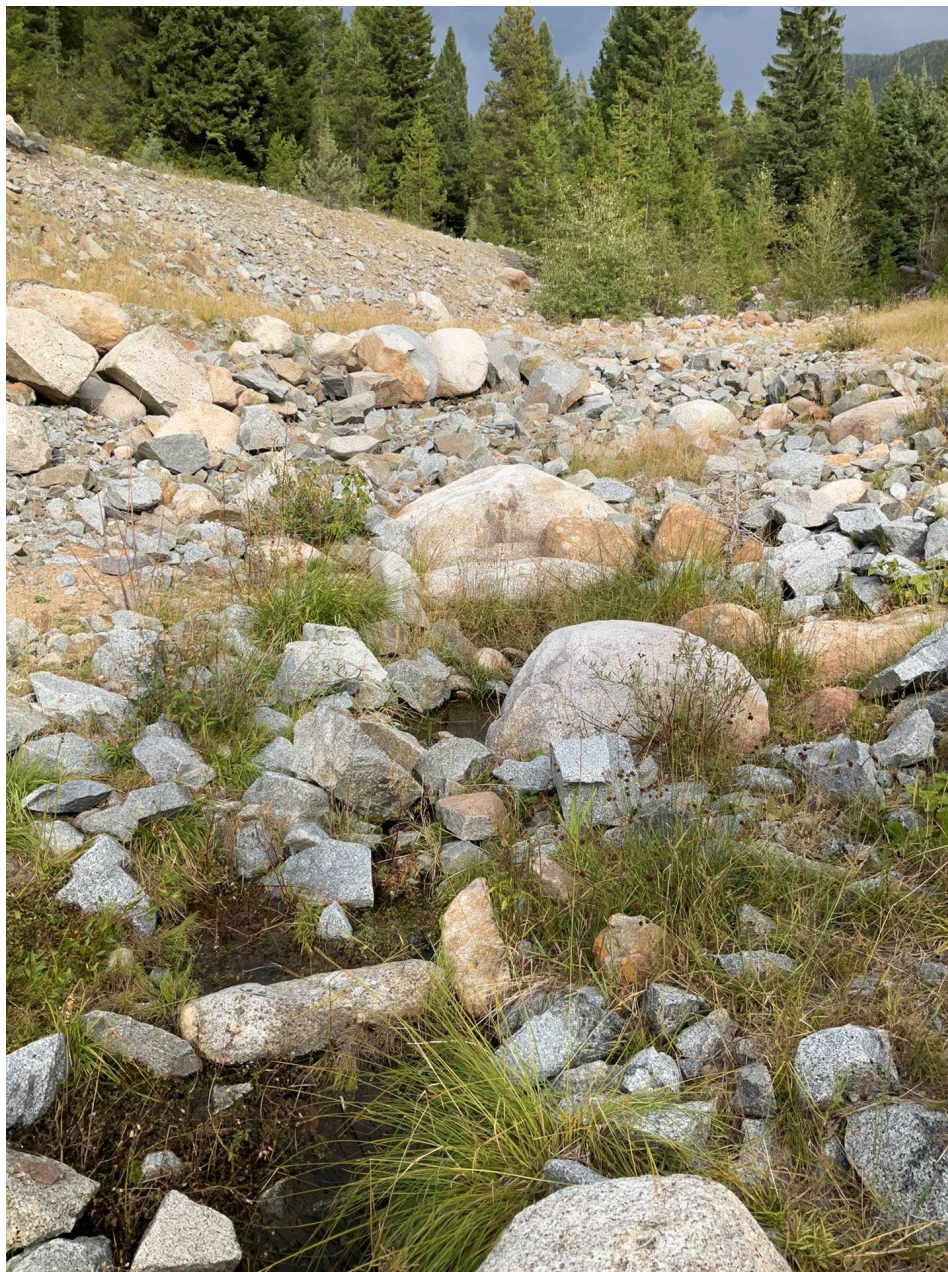
**Photo File:** Photos-20240916-223811.jpg

**Photo Description:** Water quality monitoring just upstream of the adit at RM-SW-ADIT-00 in the lower section of boulders.
