MEMORANDUM

SUBJECT: Request for Approval of a Time-Critical Removal Action, Ceiling Increase and 12-Month Exemption at the Allied Textile Printing Site, Passaic County, Paterson, New Jersey

Attachment B
Photographic Documentation
Allied Textile Printing Site
Paterson, Passaic County, New Jersey

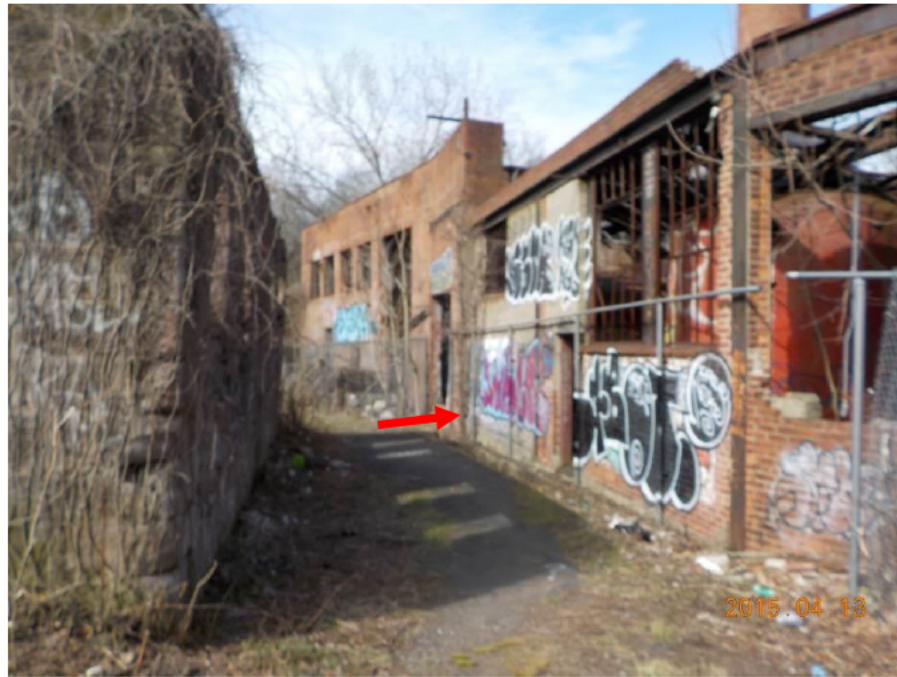
Photograph 5: A view of the south wall of Building No. 16, indicated by the red arrow.

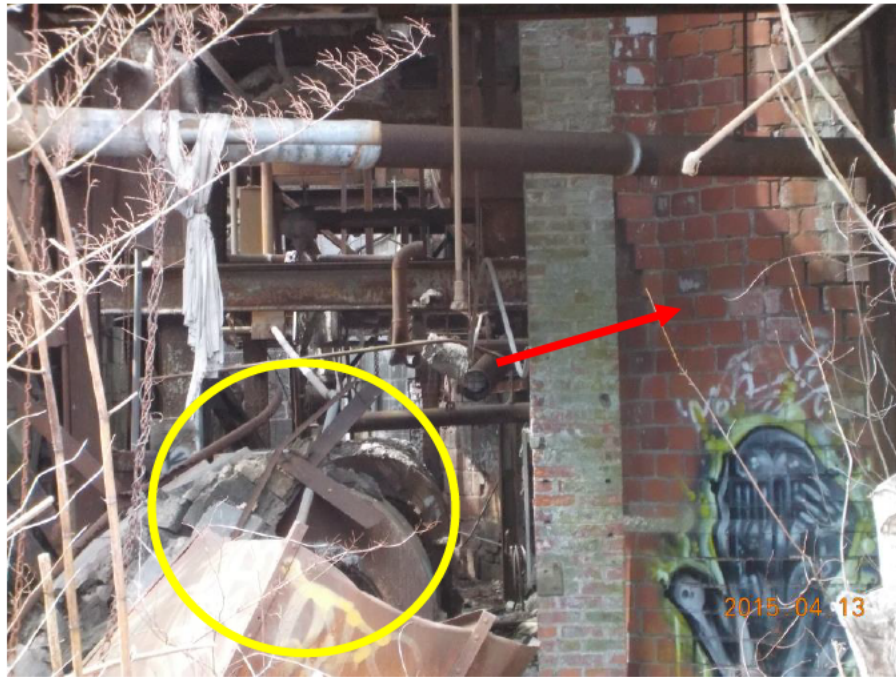
Photograph 27: The red arrow shows the base of the exhaust stack in Building No. 14. The blower and ducts indicated by the yellow circle are associated with the exhaust stack.

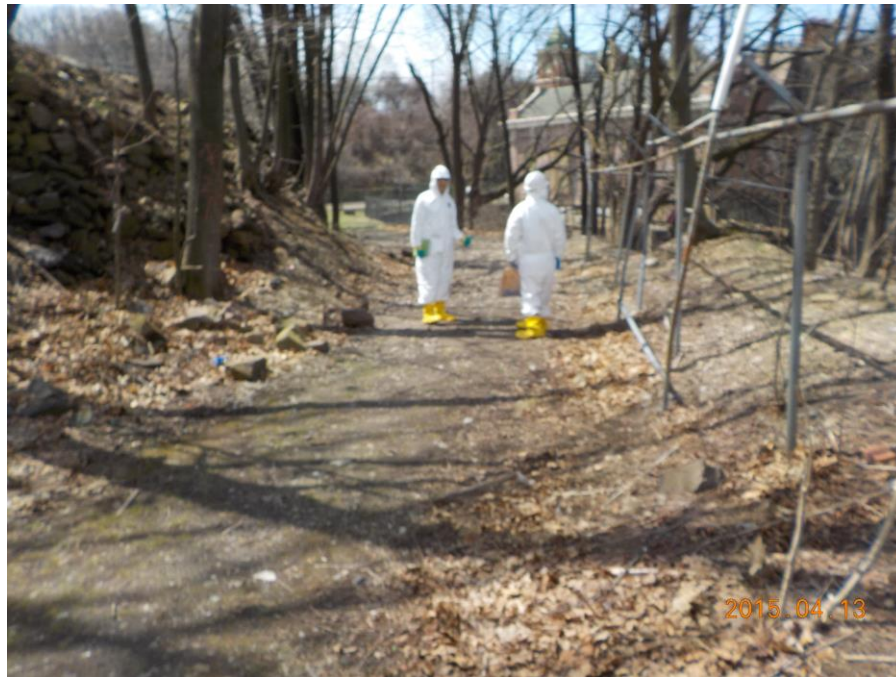
Photograph 29: EPA identified an entry gate located at the southeast area of the Site as a possible point of entry for a manlift.

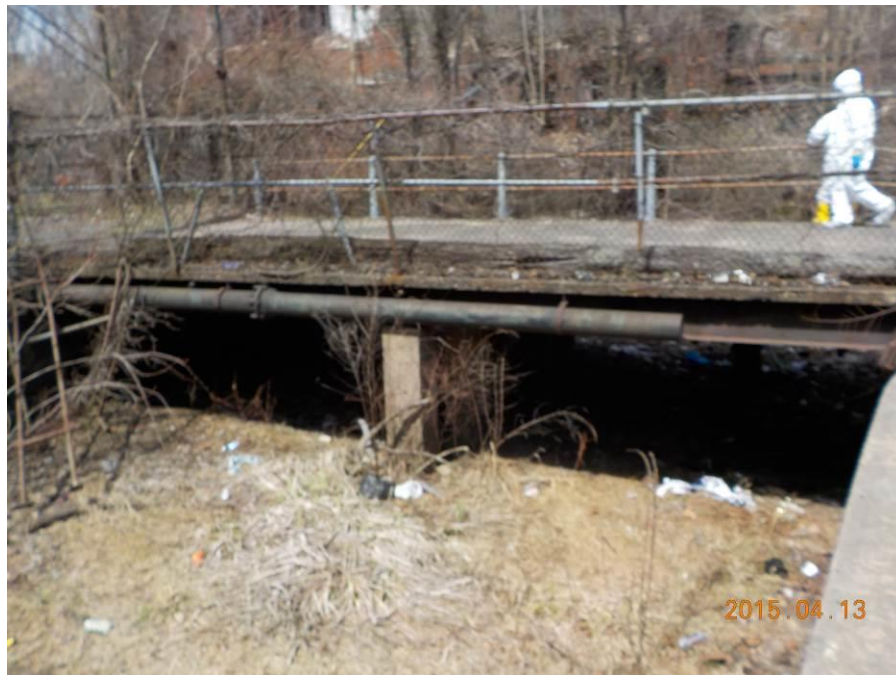
Photograph 30: EPA investigated the structural integrity of the bridge into the property to determine if it was structurally capable of carrying the weight of a manlift.
