**SUPERFUND TECHNICAL ASSESSMENT RESPONSE TEAM
STANDARD OPERATING PROCEDURE FOR RECONNAISSANCE OF
ELECTRIC VEHICLES
2023 MAUI WILDFIRE RESPONSE
OCTOBER 27, 2023**

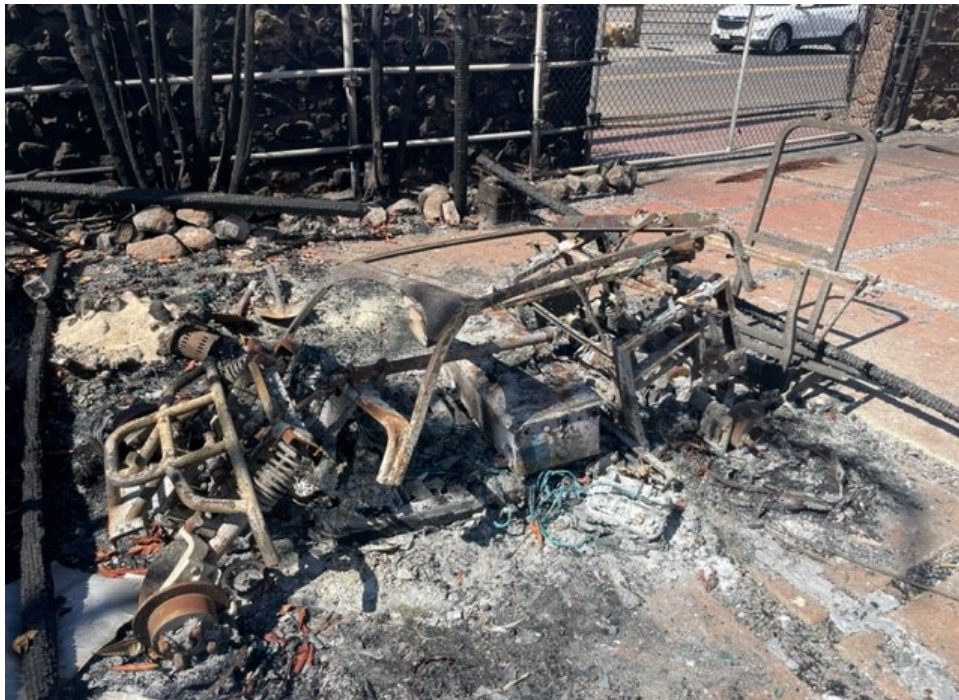
Electric Golf Cart with Lithium-Ion Battery Pack

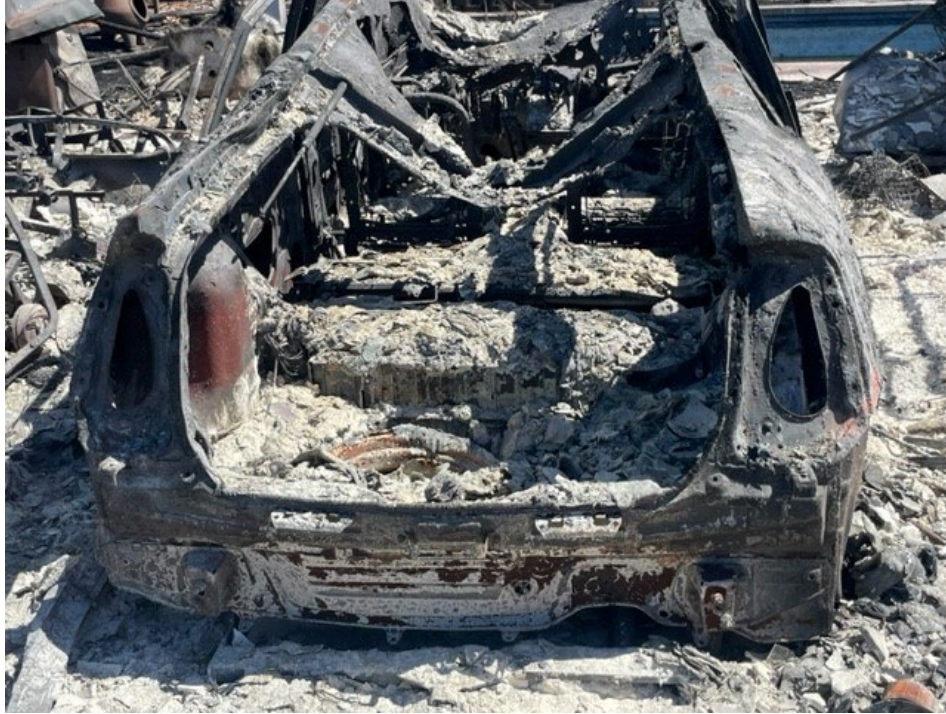
Toyota Prius battery pack located behind rear seat.

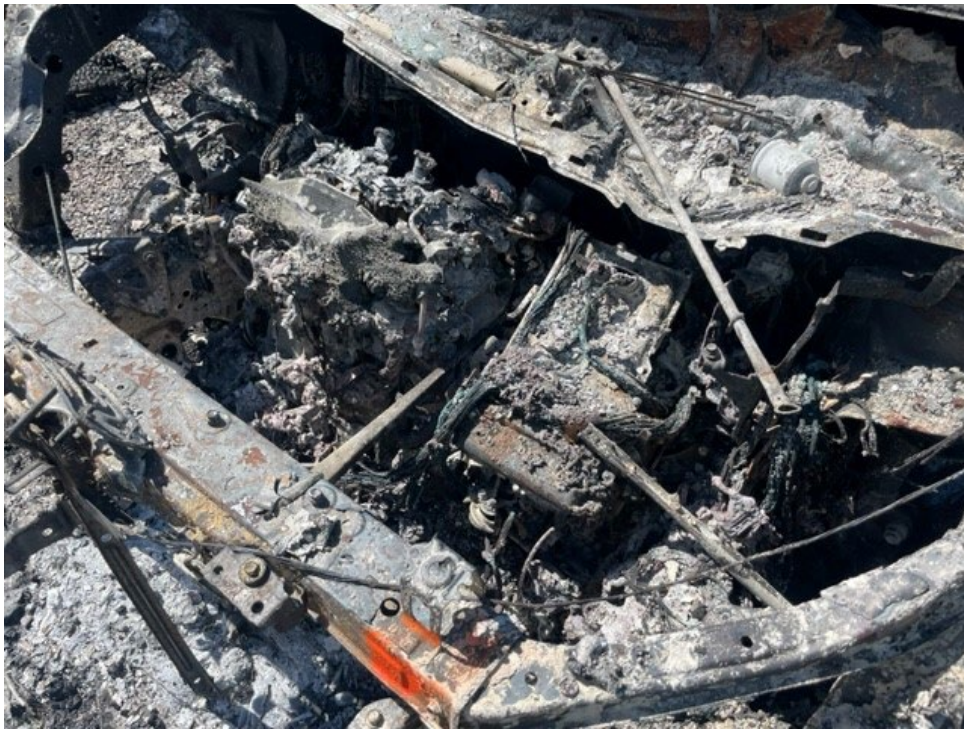
Toyota Sienna hybrid engine bay. Note electric motor components above transaxle coupled with typical 4-cylinder gasoline engine.

- The absence of a gas motor can often be an indication of an electric vehicle. Check the rear of a vehicle as well, as some manufacturers install rear mounted gasoline engines. Even after a severe fire, a gasoline or diesel engine has distinguishing characteristics such as exhaust manifolds, catalytic converters, ignition coils, camshafts, and crankshafts. A full EV does not have these components. A hybrid vehicle will have those components. Further inspection of the transaxle is needed to identify the presence of an electric motor.

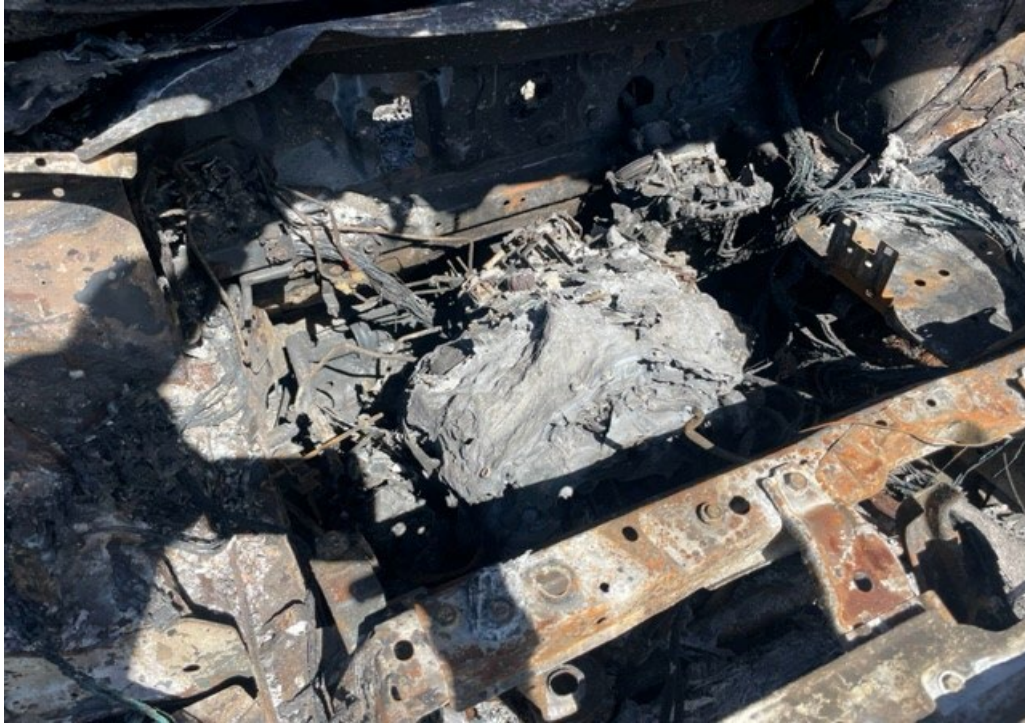
Nissan Leaf full electric vehicle engine bay. Note none of the components of a gasoline engine can be distinguished.

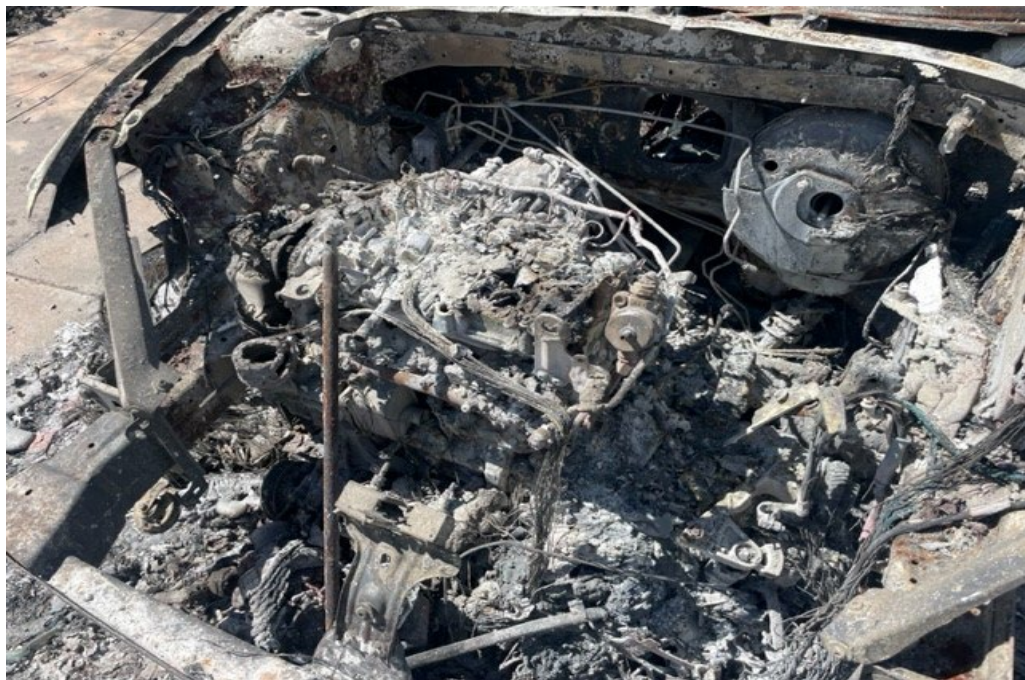
Volkswagen Golf Non-Hybrid Non-Electric engine bay.

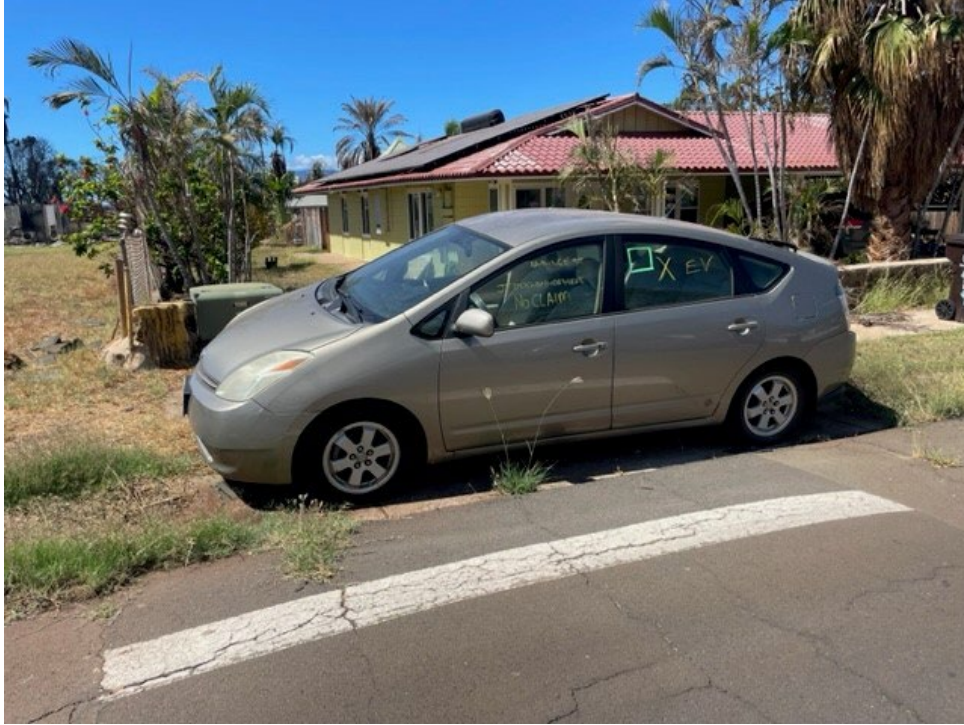
Toyota Prius with no visible burn evidence but located in survey zone. Note: plants and structures unburned nearby.

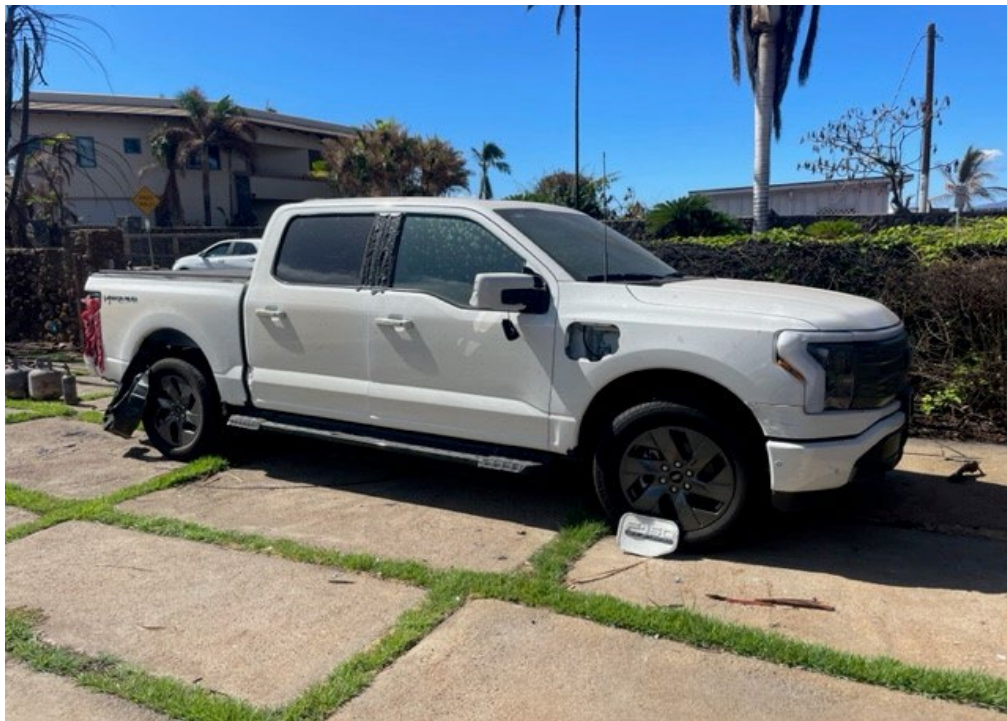
Ford F150 Lightning with visible heat damage. Taillights melted, wheel wells melted, discoloration of paint, plastic trim melted. Nearby structure fire.
