Ottawa Lake, Michigan Diesel Spill Response
Frequently Asked Questions
Updated April 8, 2024

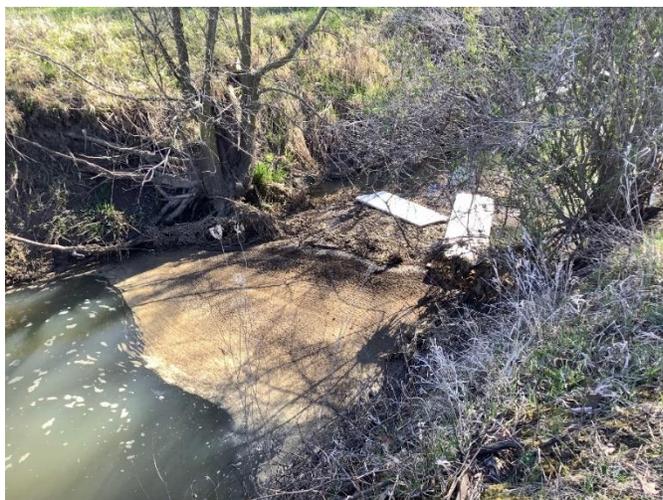
A: Containment measures such as containment booms and underflow dams have been installed on North Tenmile Creek to prevent downstream migration of any sheens released by cleanup activities. While the purpose of these booms is to capture any oil on the surface of the water, other materials such as pollen, algae, sediments, and debris can also collect in front of them over time. Here's an example.

Buildup of natural materials in North Tenmile Creek on April 6, 2024

One thing that can distinguish the two is that absorbent booms and pads are oleophilic meaning that while they absorb oil and hydrocarbons, they repel water and other materials. If you see buildup in front of a booming location and it is not being absorbed by the pads, it may not be oil. EPA is monitoring the two underflow dams and six containment boom locations on North Tenmile Creek several times per day. If a resident believes they see or smell oil in North Tenmile Creek outside of the work area, please contact EPA or EGLE.
