SUBJECT: Trowbridge Dam, Dam ID No. 604; Allegan County

**DAM SAFETY INSPECTION REPORT  
TROWBRIDGE DAM – DAM ID NO. 604  
KALAMAZOO RIVER  
ALLEGAN COUNTY – SECTION 12, T 01N, R 13W**

**INSPECTION DATE:** August 18, 2023

**REPORT DATE:** September 19, 2023

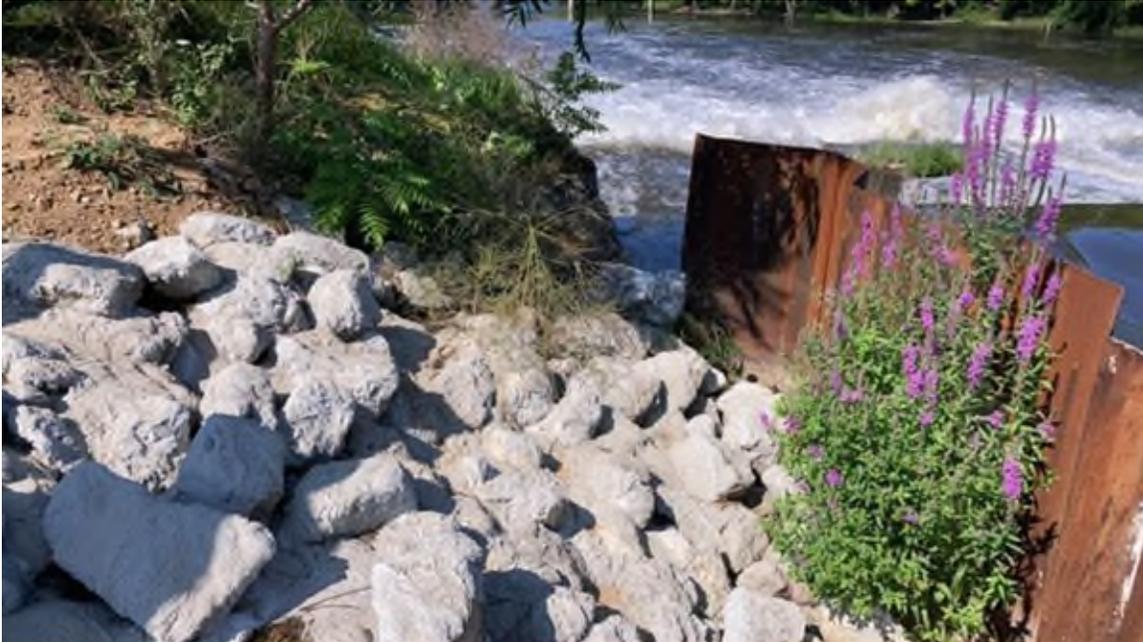
**Photo #3 - Upstream slope of left embankment near downstream end of Phase 1A sheetpile wall**

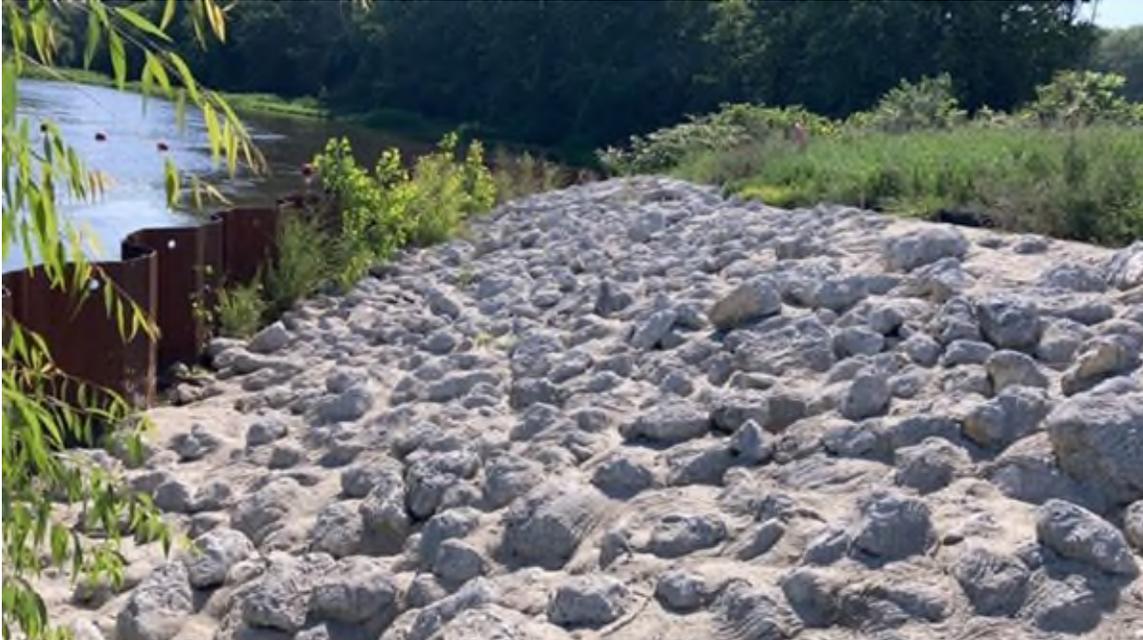
**Photo #5 - Upstream slope of left embankment, Phase 1A sheetpile wall, grouted riprap armoring**

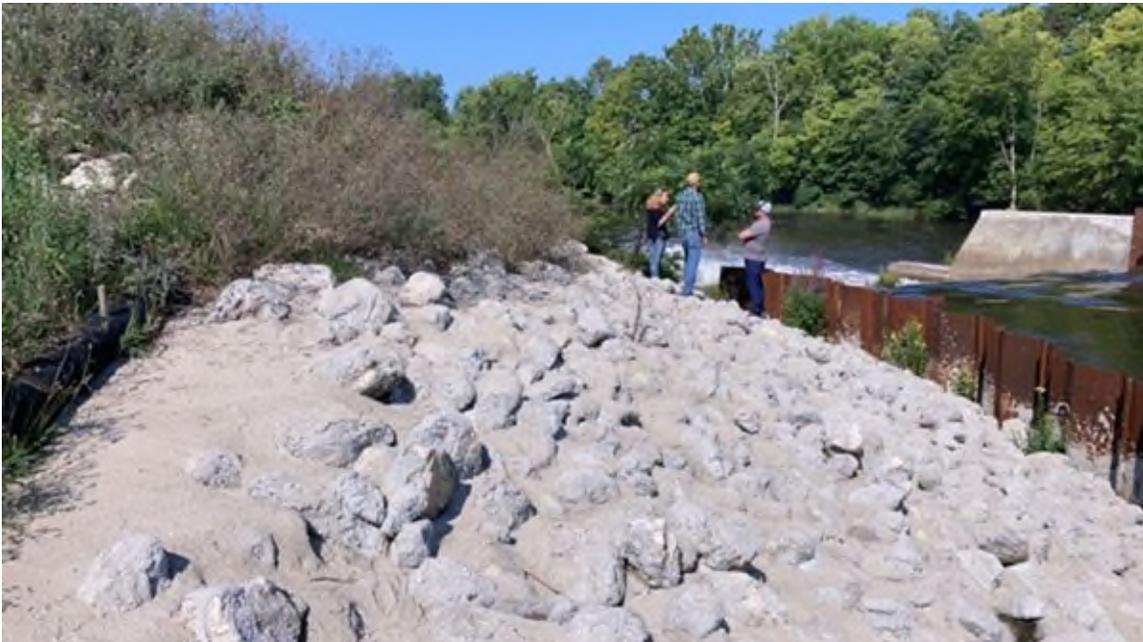
**Photo #6 - Upstream slope of left embankment, Phase 1A sheetpile wall, grouted riprap armoring**

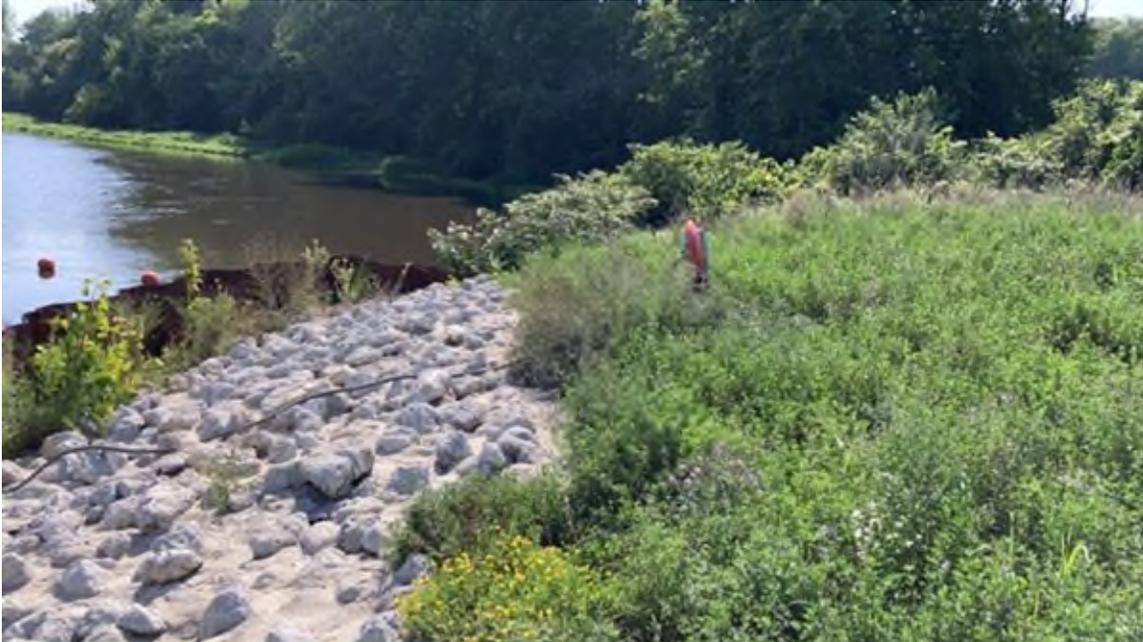
**Photo #7 - Upstream slope of left embankment, Phase 1A grouted riprap armoring up to weeds on embankment**

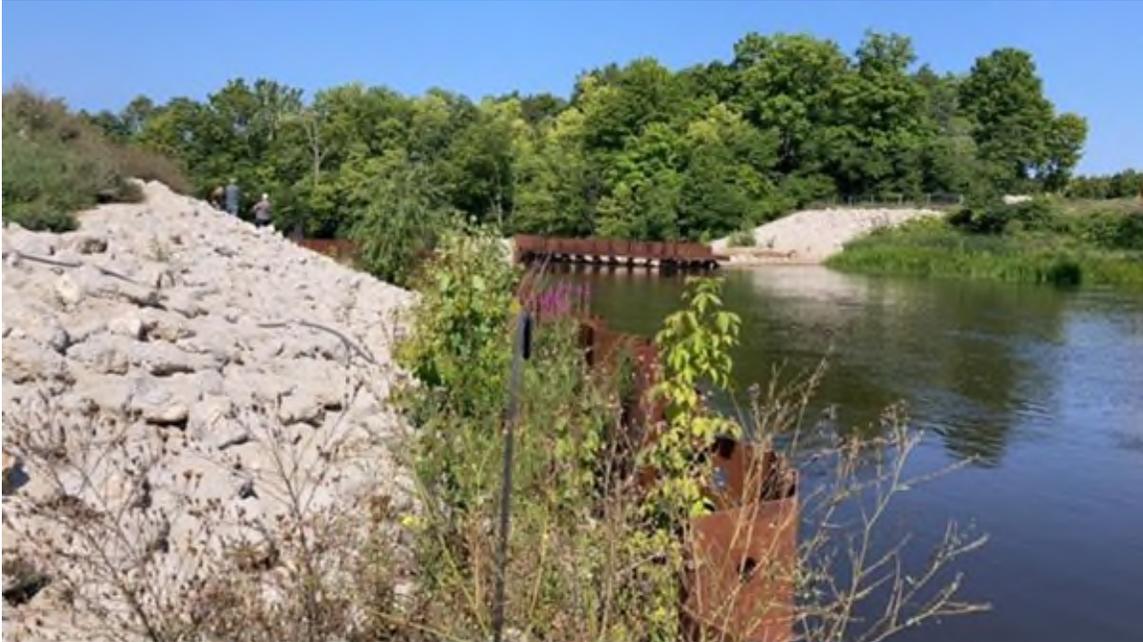
**Photo #9 - Upstream slope of left embankment at left end of Phase 1A sheetpile wall**

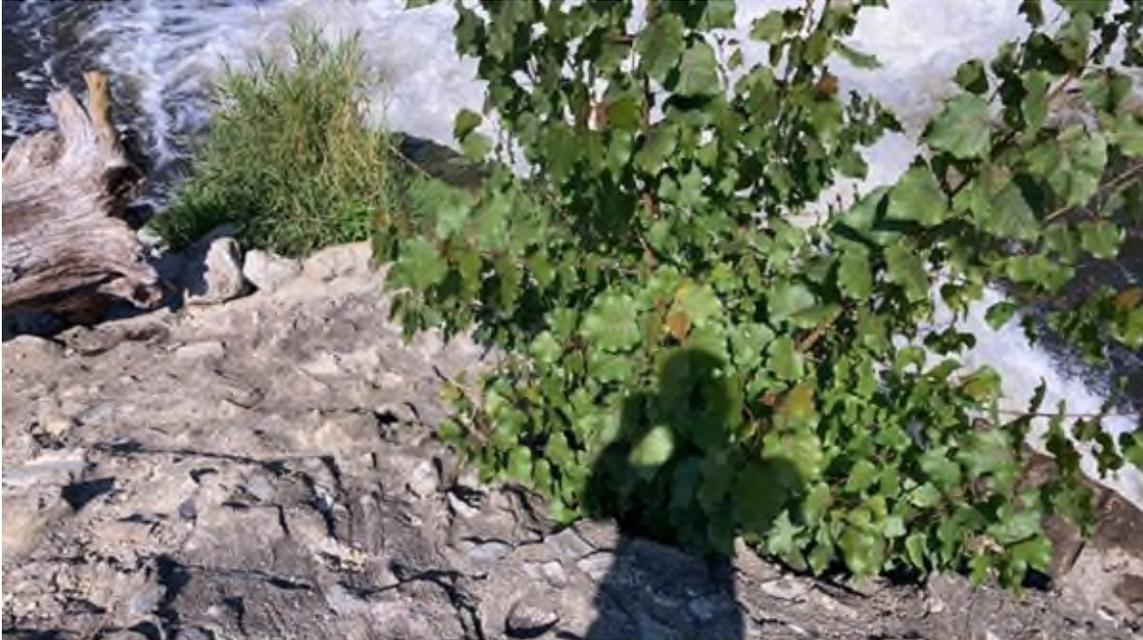
3. Significant voids and cracks in the old grouted riprap on the left embankment downstream slope were observed throughout, especially near the principal spillway outlet. Some brush was growing within larger voids. Flow over the grouted riprap raises concerns of instability during large floods. Also, the left end of the downstream riprap has undermining occurring from tailwater conditions during some flow events. Continued undermining could cause instability of the embankment slope. Monitor grouted riprap areas on a monthly basis for further deterioration. Fill/repair any deteriorated areas as they are observed.

**Photo #21 - Downstream slope of left embankment near principal spillway outlet.  
Brush growing in holes in grouted riprap**

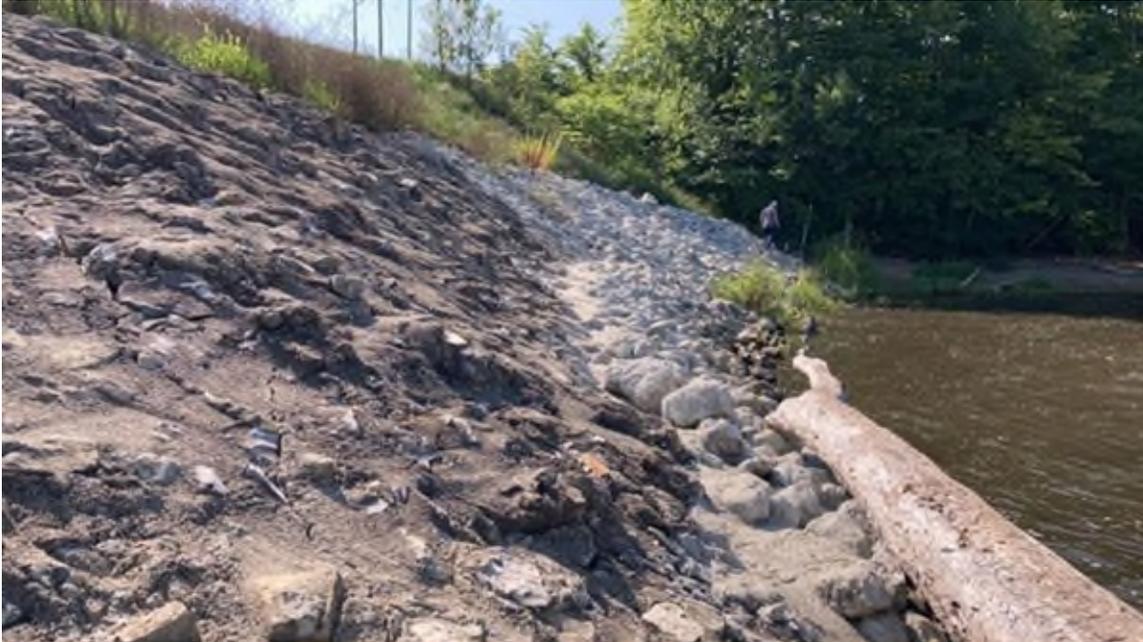
**Photo #25 - Downstream slope of left embankment where old grouted riprap ends and Phase 1A grouted riprap begins**

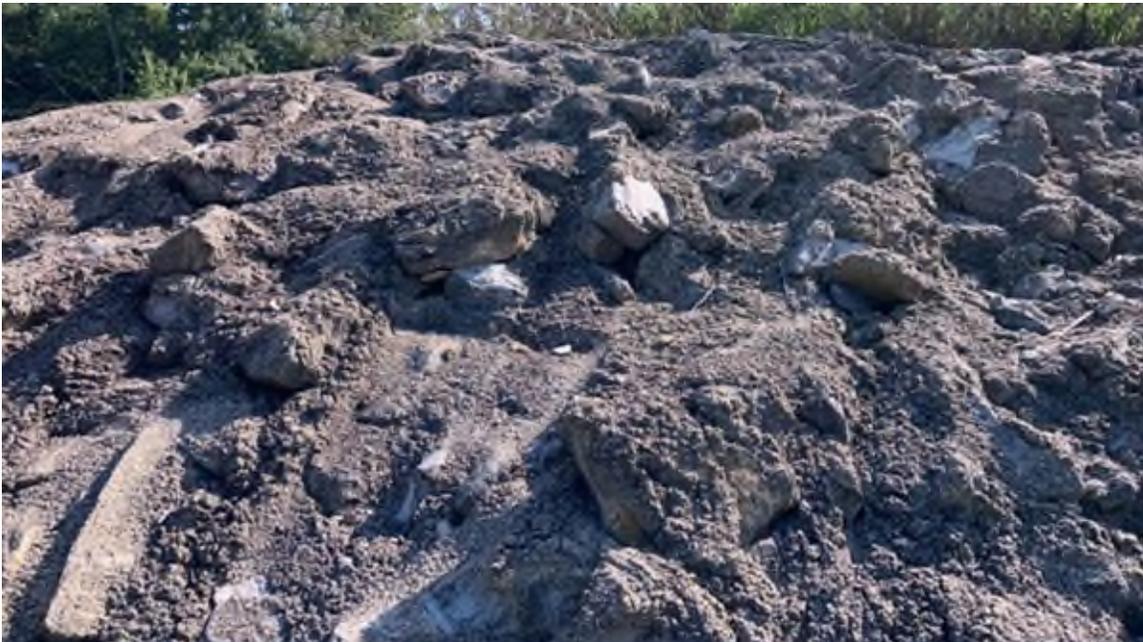
**Photo #26 - Old grouted riprap on downstream slope of left embankment**

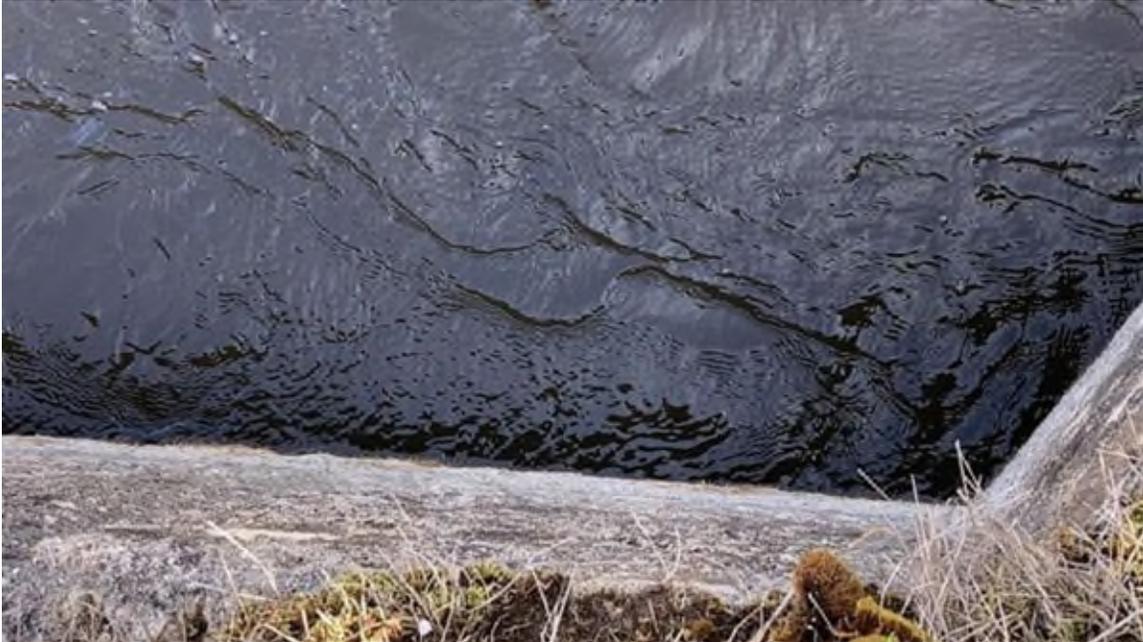
**Photo #41 - Left upstream principal spillway abutment wall**

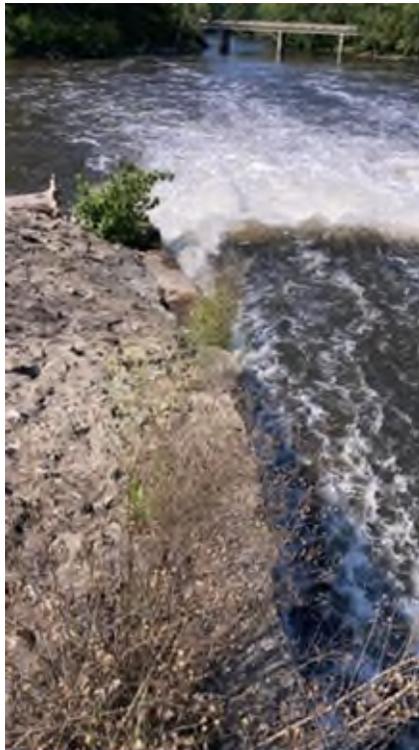
**Photo #46 - Principal spillway left downstream abutment, viewed from top**

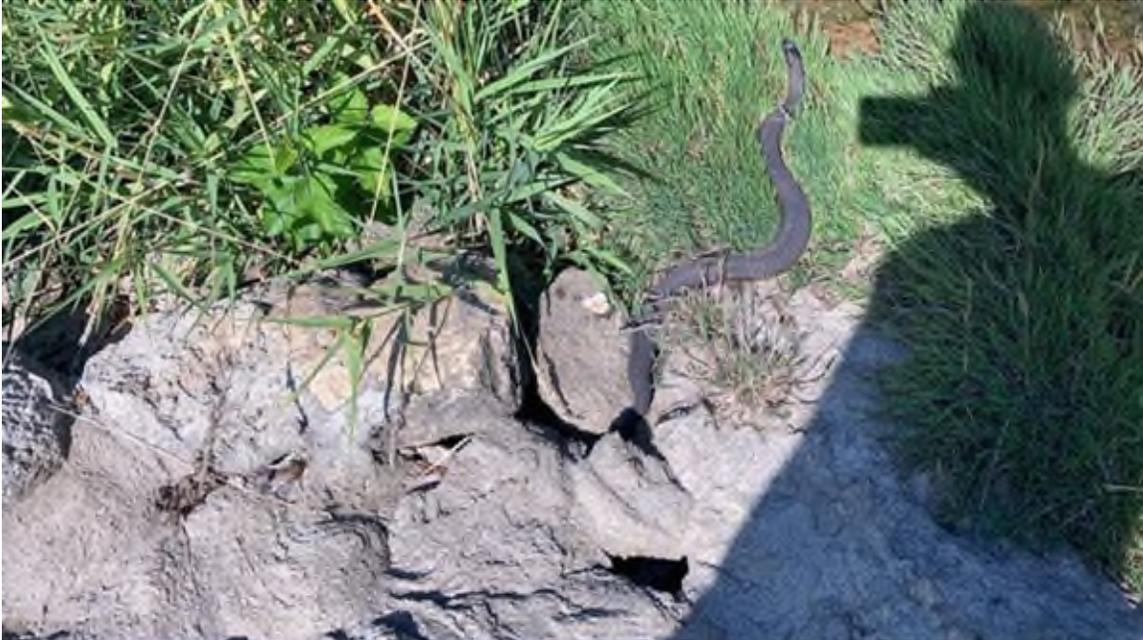
**Photo #53 - Grouted riprap armoring near principal spillway left downstream abutment. Note voids in armoring**

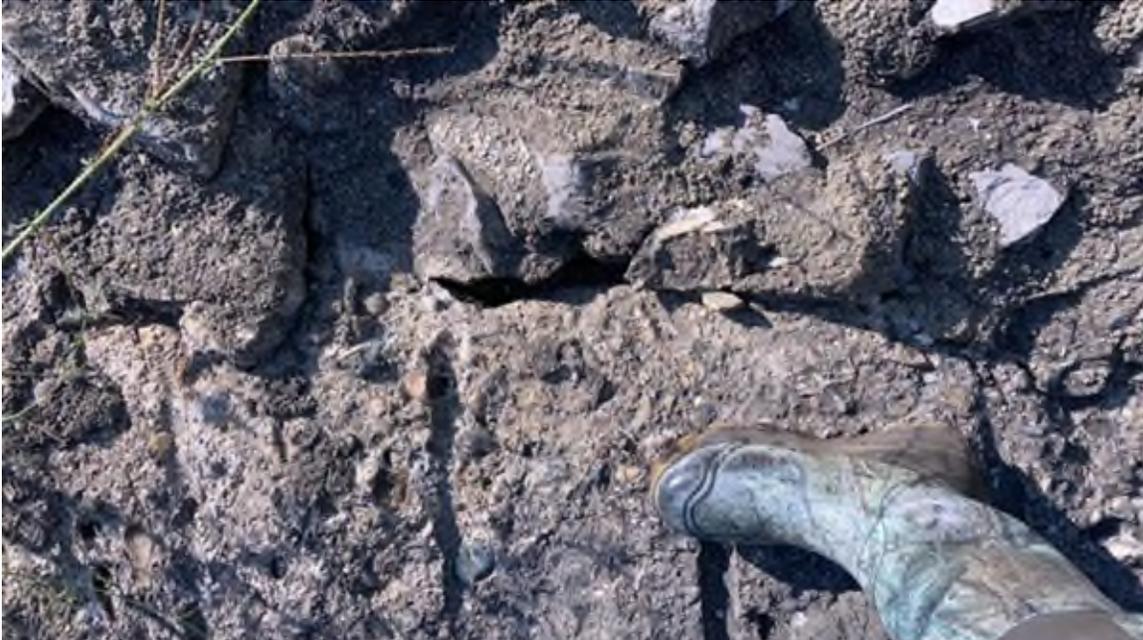
**Photo #59 - Riprap abutment with left spillway downstream wall. Note voids**

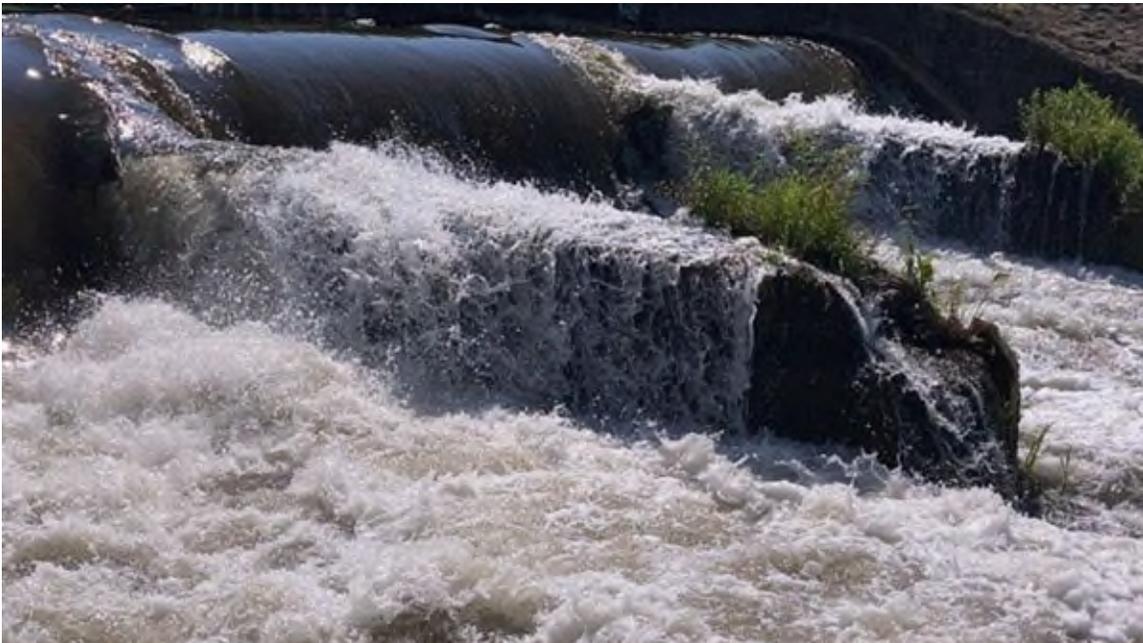
**Photo #62 - Right pier within principal spillway**

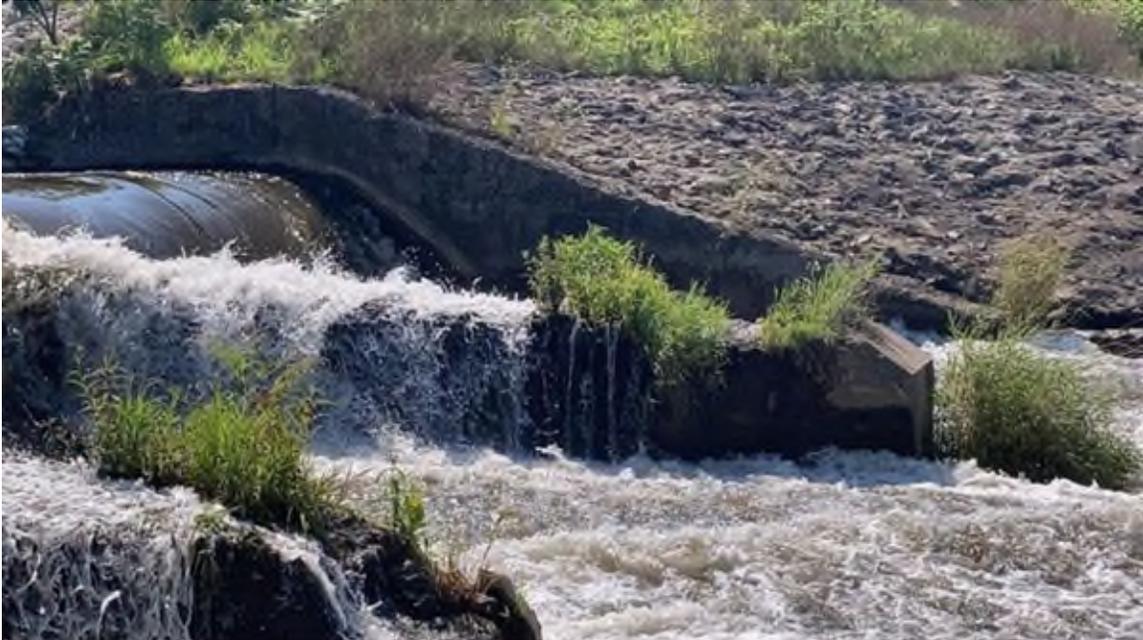
**Photo #63 - Left pier within principal spillway**

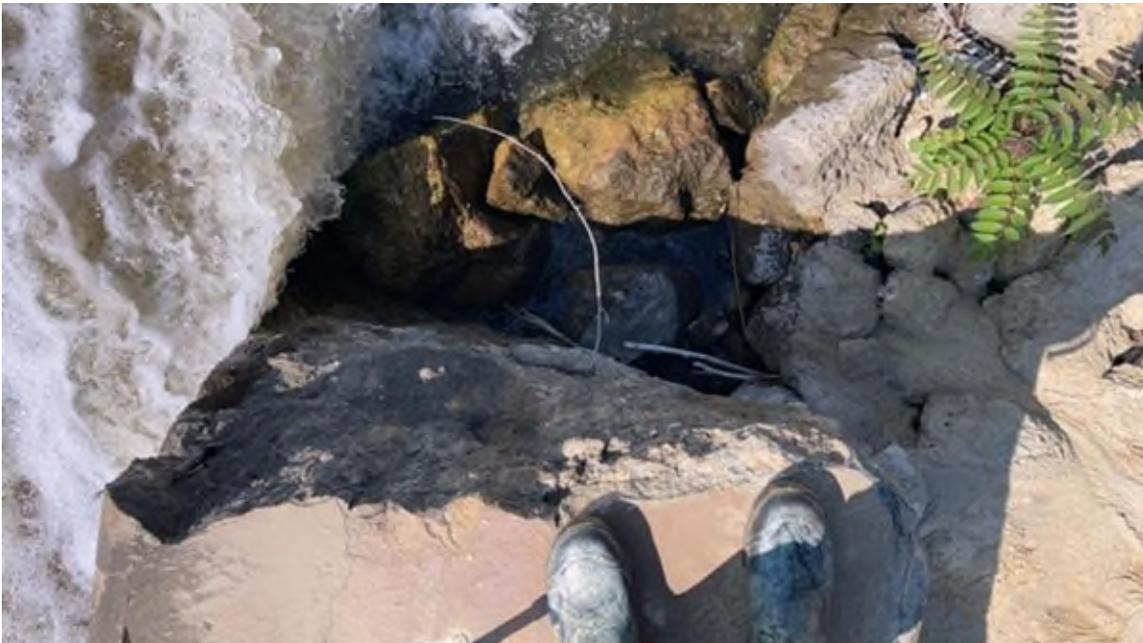
**Photo #64 - Downstream face of pier between principal and auxiliary spillways**

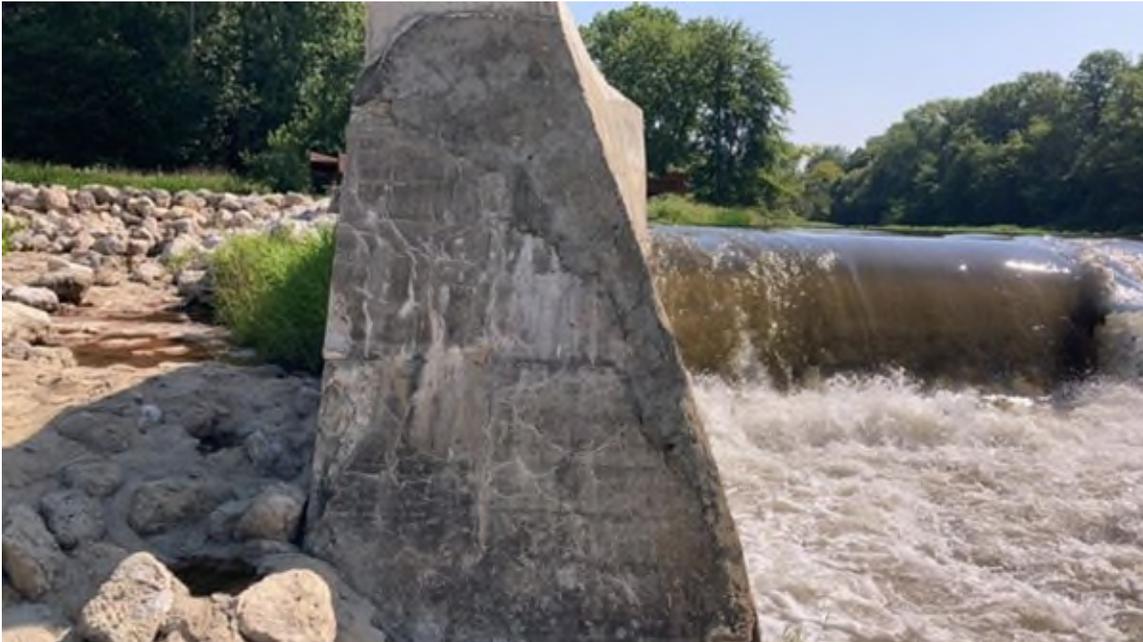
**Photo #65 - Downstream face of pier between principal and auxiliary spillways**

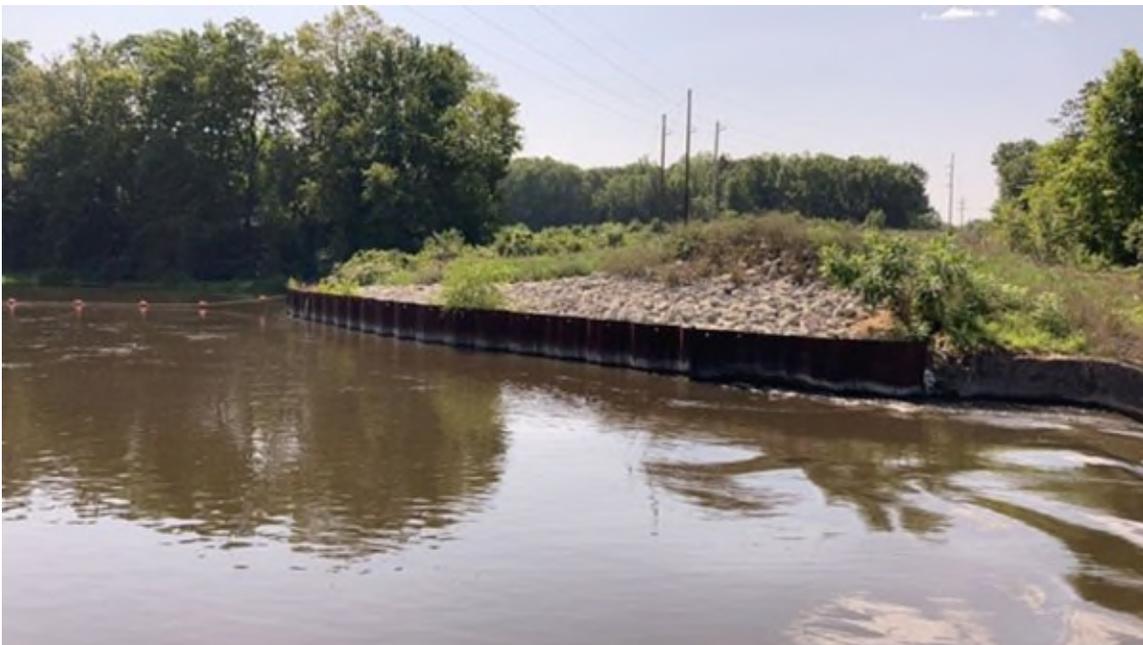
**Photo #66 - Principal spillway left upstream abutment, Phase 1A sheetpile wall**

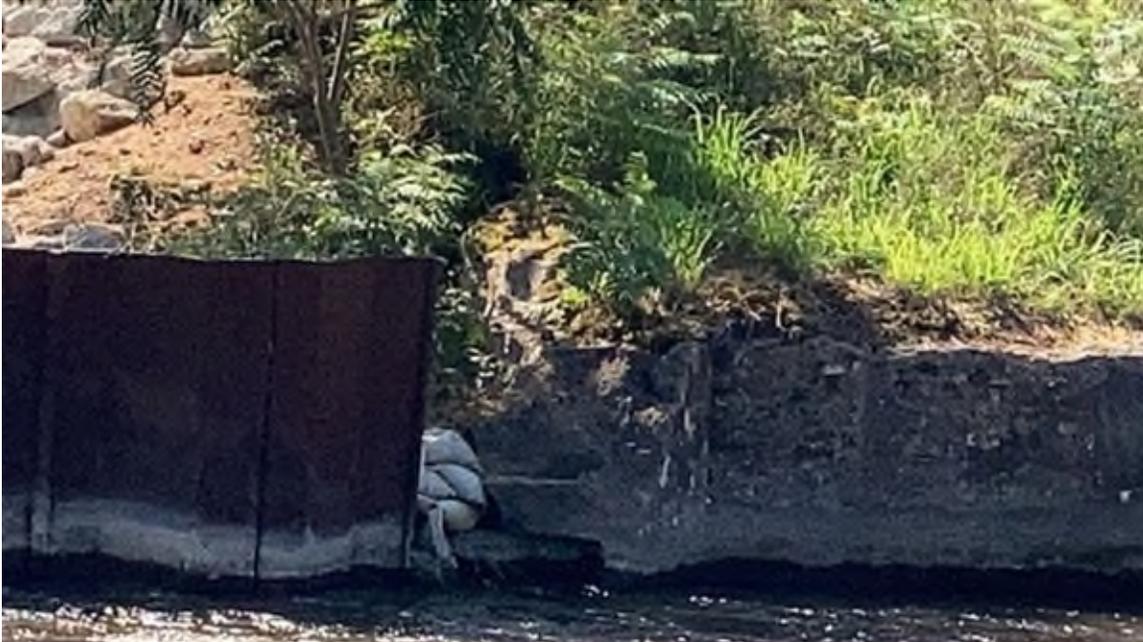
Where are the issues located?	<i>Throughout the spillway piers, left abutment wall</i>
Action required for concrete components of the spillway	<i>Monitor the concrete components of the dam regularly. If dam removal progresses, a more in-depth repair may not be necessary if the concrete shows no further signs of deterioration</i>
<b>Erosion</b>	
Specify issue	<i>At the downstream end of the sheetpiling at the left embankment, there is a gap between the sheetpile and the spillway left upstream abutment</i>

<i>wall. The gap has been filled in with sandbags. If the headwater rises, water would be able to flow through this gap behind the upstream sheetpiling as well as along the backside of the spillway left abutment wall. Due to riprap placement, it is not expected that this overflow would cause significant damage over a short duration behind the sheetpiling. However, it could lead to further erosion behind the left abutment wall that could eventually lead to embankment failure. This is repeated from the "Crest" section. See that section for recommendations</i>
<b>Erosion Control / Energy Dissipation</b>	
What type of erosion control structure is in place?	<i>Apron at outlet and armored embankment toes</i>
<b>Gates / Valves</b>	
Does the spillway include a gate?	<i>No</i>
Additional comments	<i>Add apron for downstream armoring</i>

**Photo #67 - Gap between Phase 1A sheetpile wall and left upstream principal spillway abutment wall viewed from right**

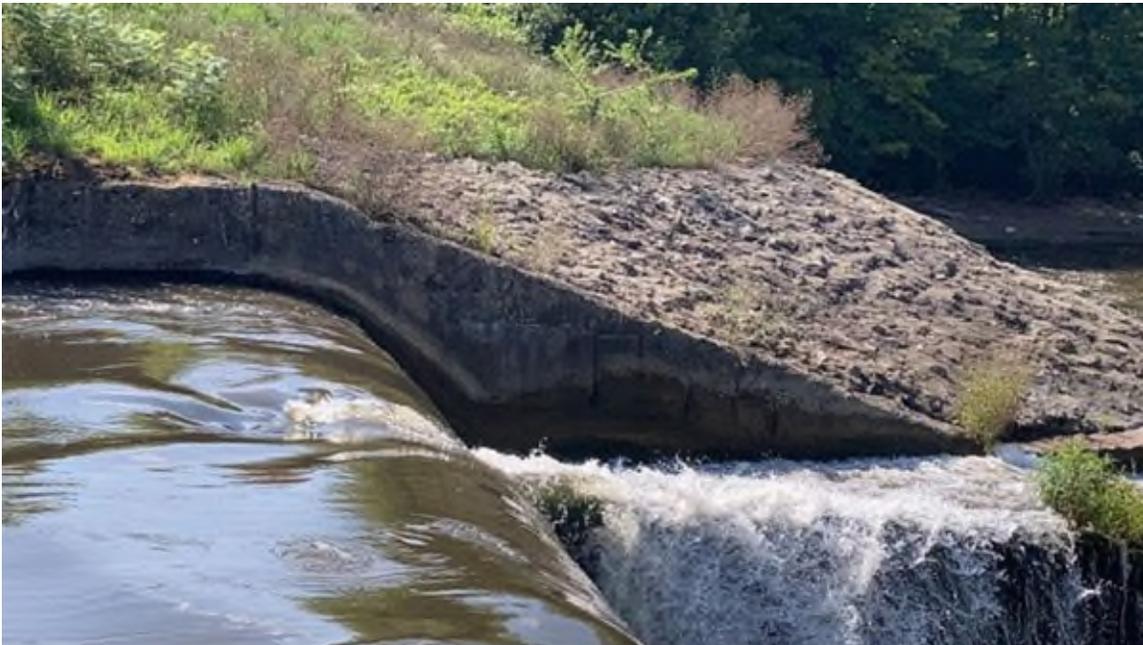
**Photo #68 - Principal spillway left downstream abutment wall**

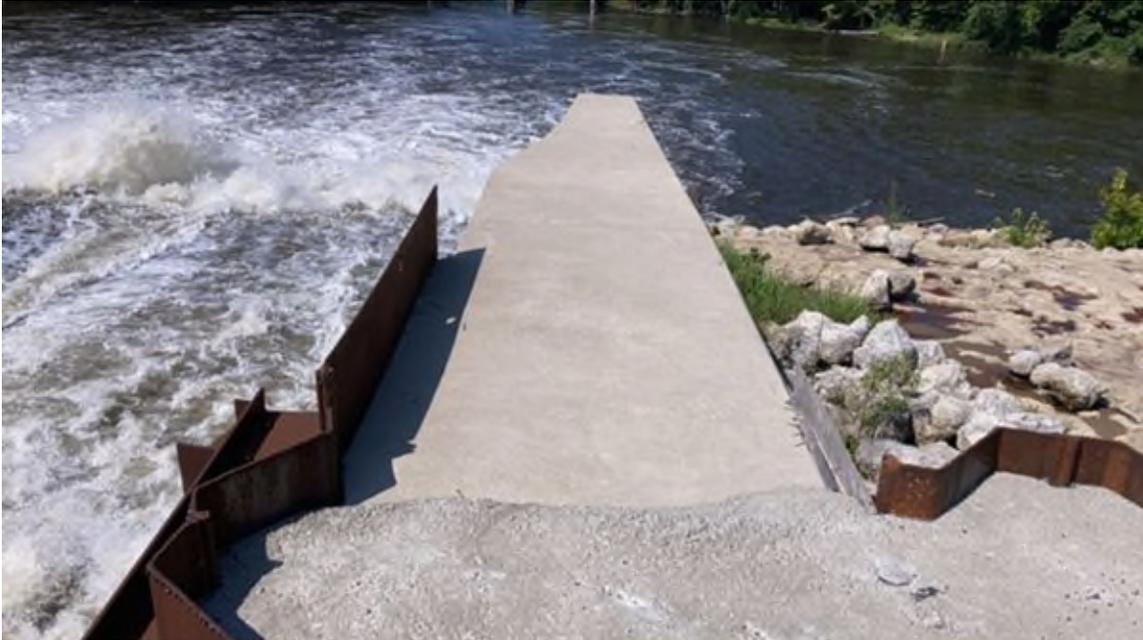
**Photo #69 - Top of pier between principal and auxiliary spillways**

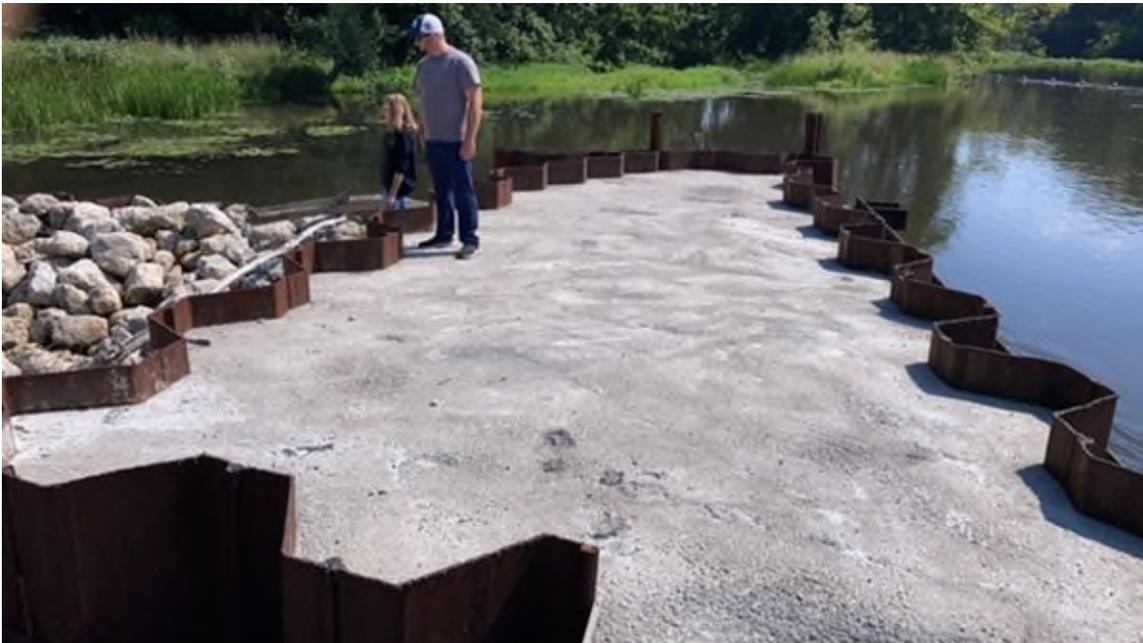
**Photo #70 - Top of pier between principal and auxiliary spillways**

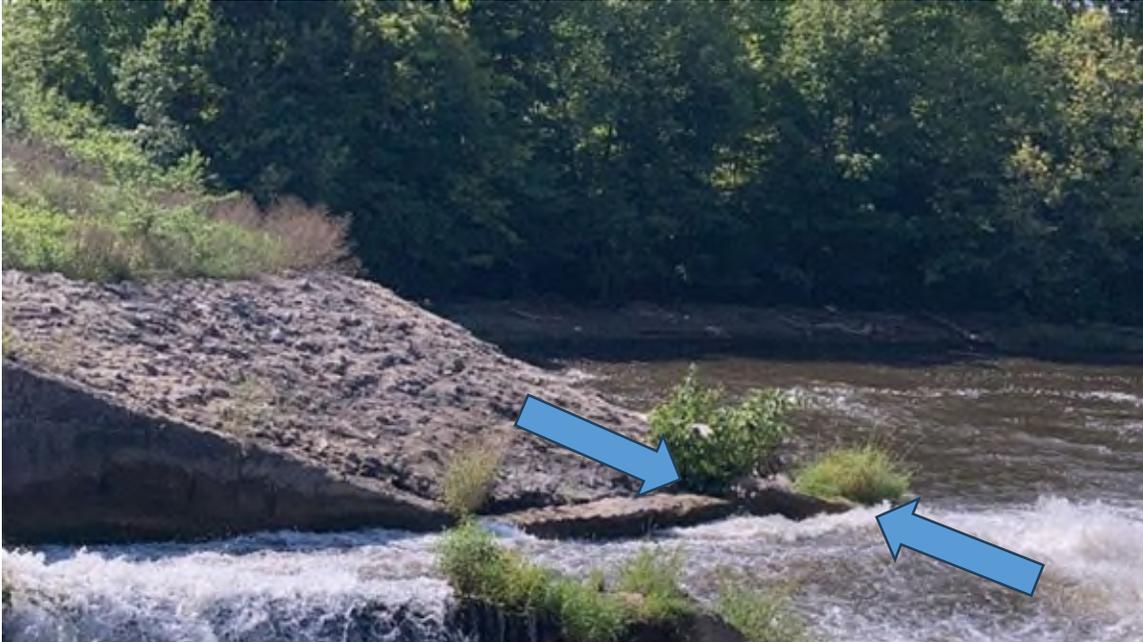
**Photo #71 - Principal spillway left downstream abutment wall, downstream end.  
Note misalignment in wall and vegetation growth**

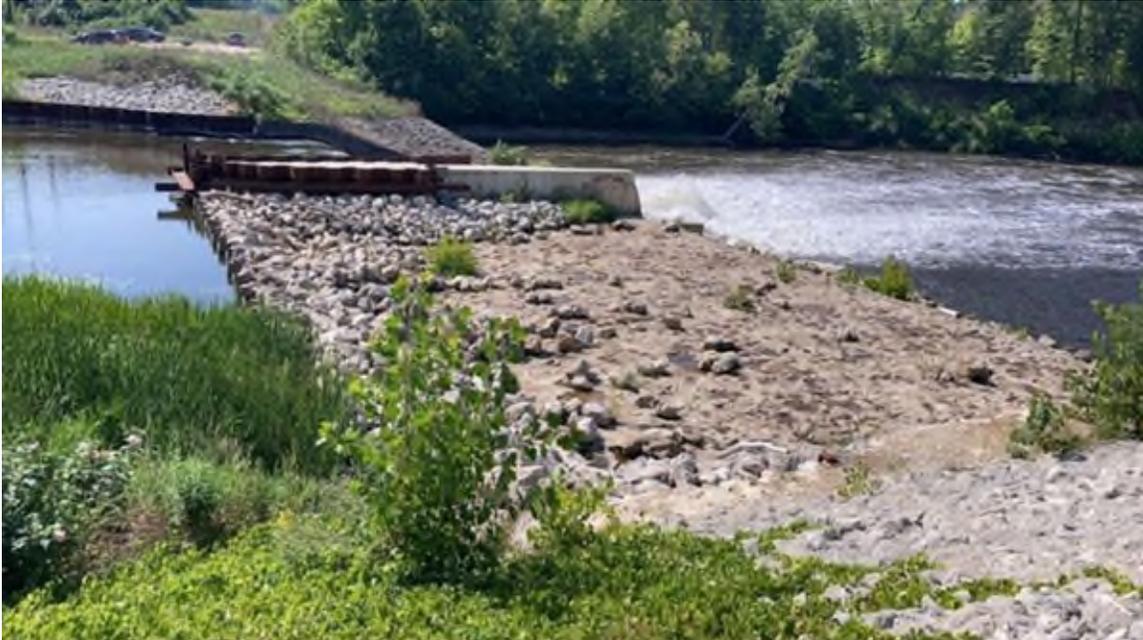
<b>Auxiliary Spillway</b>	
What type of spillway is present?	<i>Steel sheetpile weir upstream with a rock and concrete lined embankment that acts as an overflow chute during overtopping flows.</i>
What is the primary material used in the spillway?	<i>Steel sheetpile, grouted channel and riprap armoring</i>
What type of erosion control structure is in place?	<i>Grout and riprap lined chute, further armoring at chute outlet</i>
Are there any issues with the outlet erosion control structure?	<i>Since the 2022 inspection, riprap immediately downstream of the auxiliary spillway sheetpile weir have moved further downstream in the chute. See photos #75 and #76 for 2022 vs. 2023 comparison.</i>
Where are the issues located?	<i>Chute of auxiliary spillway</i>
Action required for other issues	<i>Maintenance</i>
Describe action required	<i>Add heavier riprap where it has become displaced. Consult with your engineer to determine if the riprap is needed for stability of the sheetpile weir</i>

**Photo #75 - Auxiliary spillway. Note riprap spread throughout spillway. Compare with next photo**

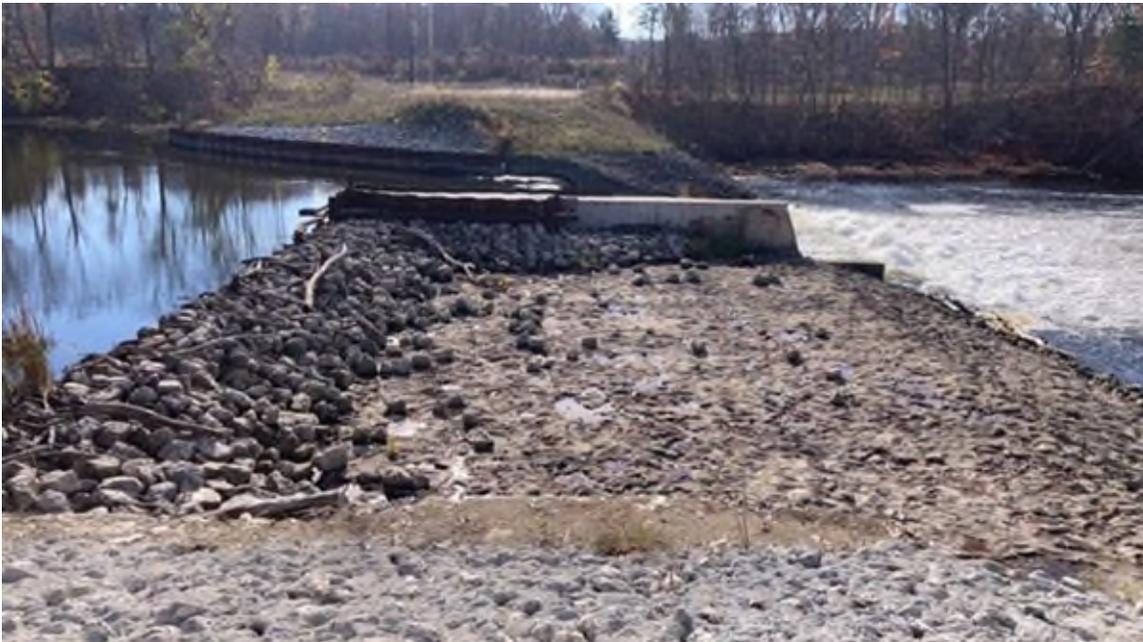
**Photo #76 - Auxiliary spillway from 2022 inspection. Note riprap is less spread out than the current state**

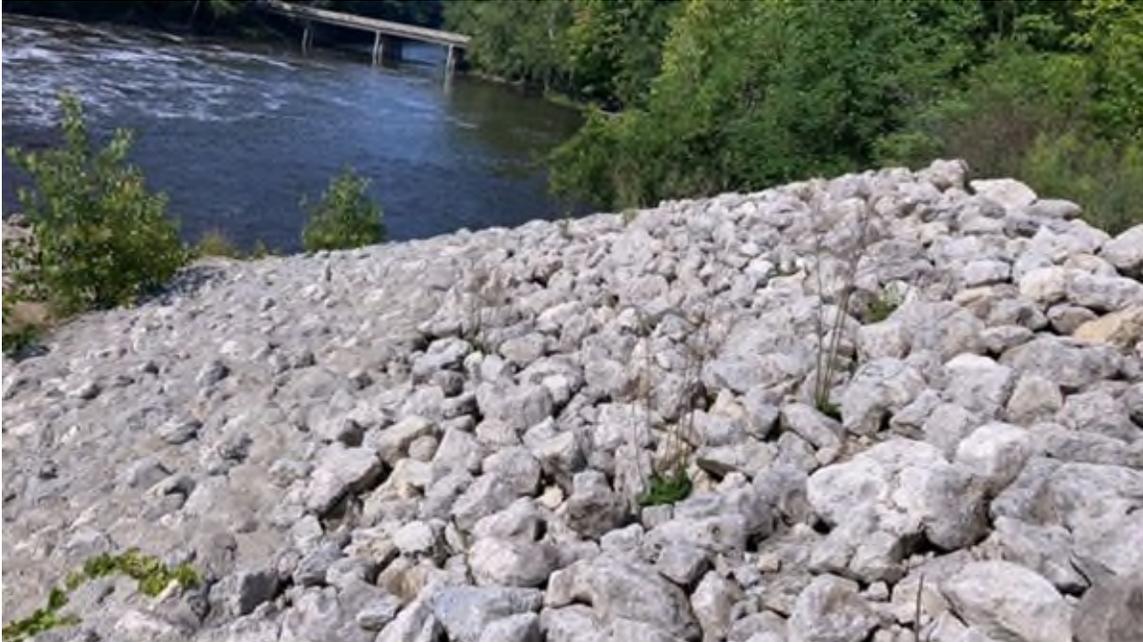
**Photo #77 - Right armored slope of auxiliary spillway**

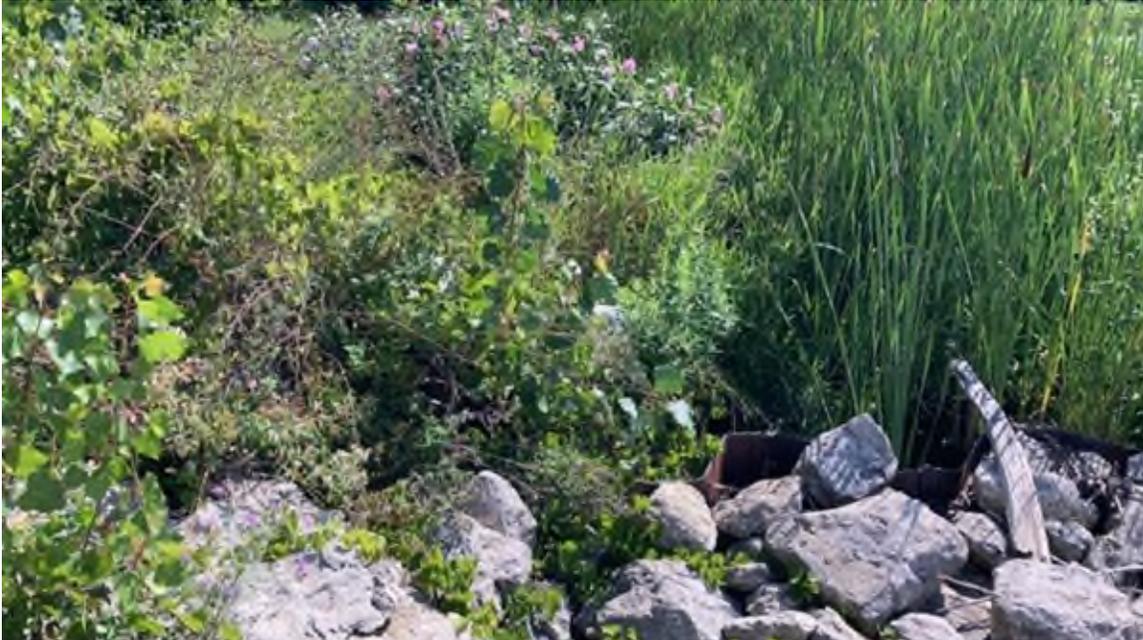
**Photo #79 - Right upstream end of auxiliary spillway sheetpile wall**

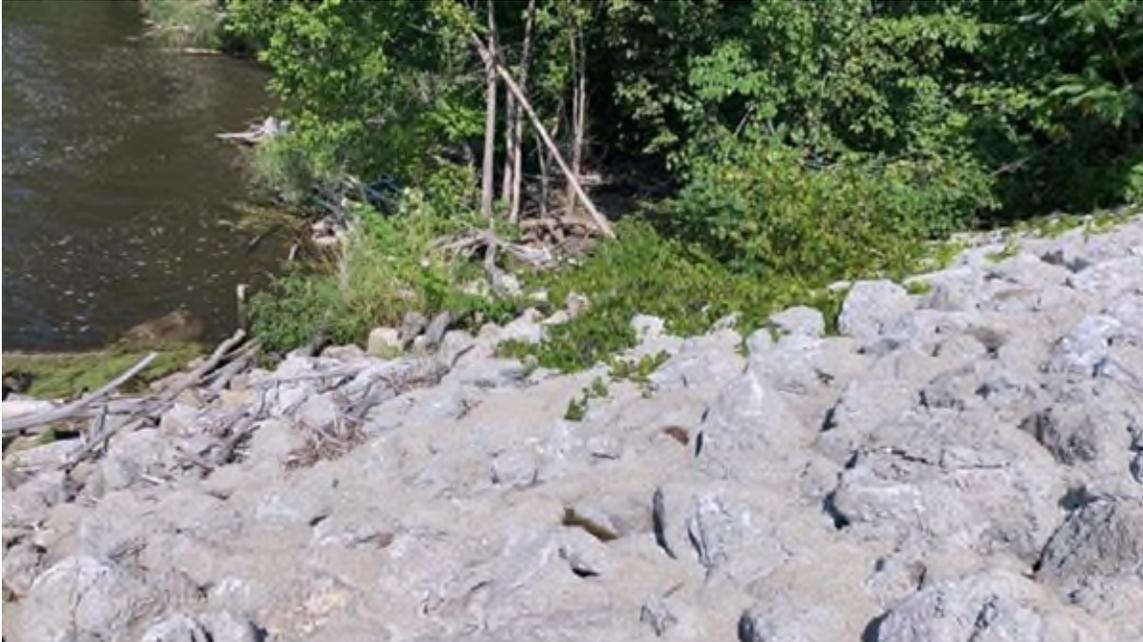
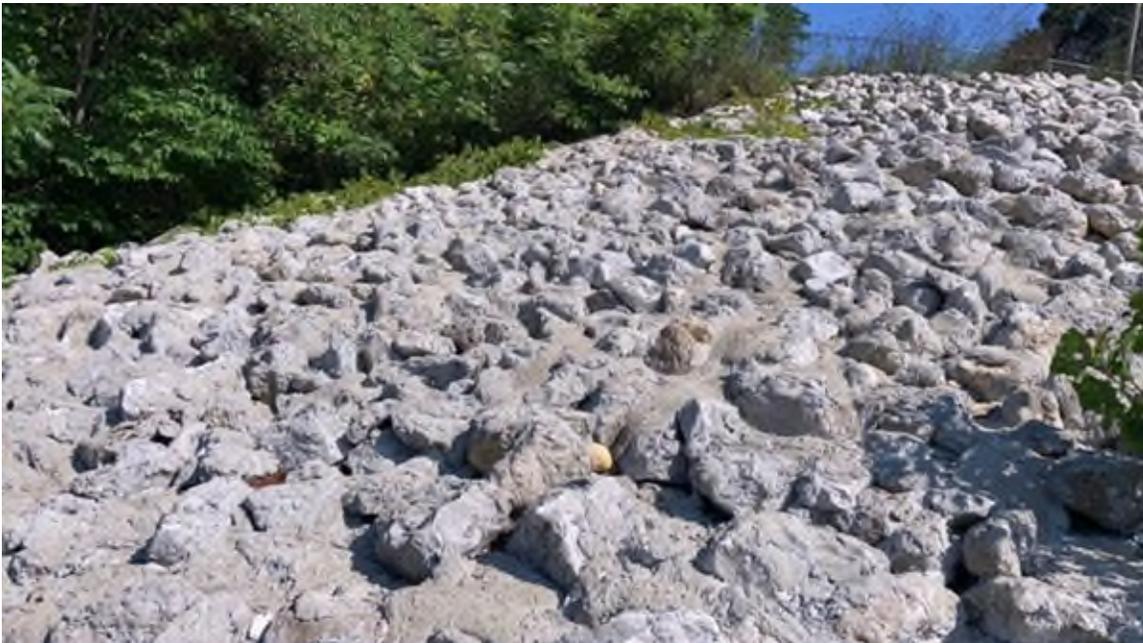
**Photo #81 - Downstream right end of auxiliary spillway, right embankment**

**Photo #82 - Downstream right end of auxiliary spillway, right embankment**

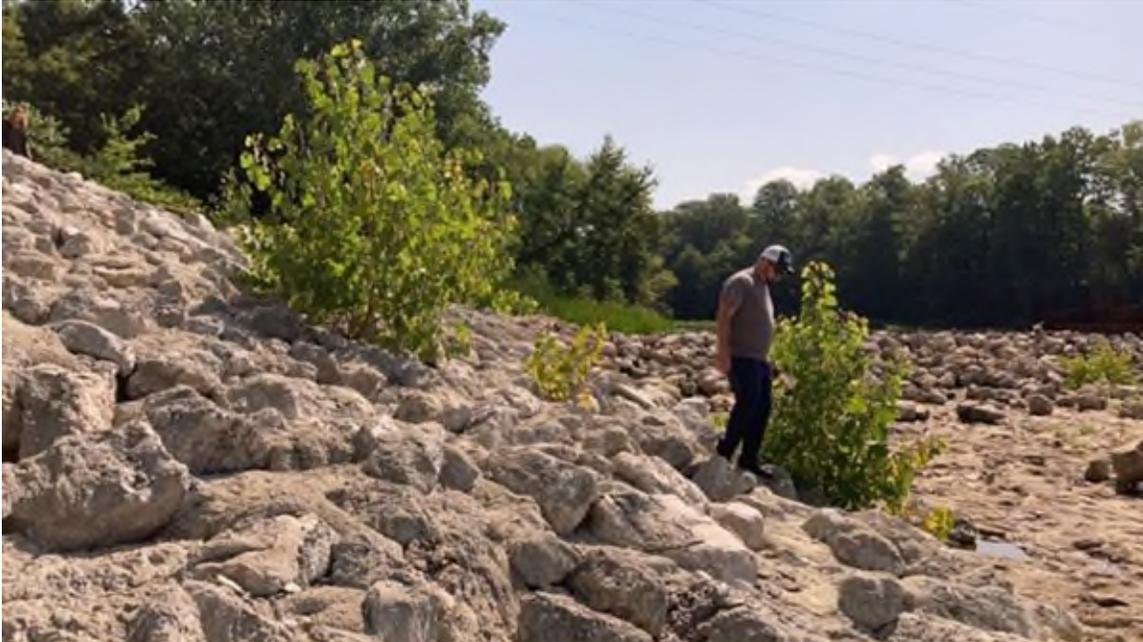
**Photo #83 - Brush growth within auxiliary spillway right armoring**

The MDNR has done a good job of monitoring the dam's condition through frequent dam inspections. Given the deteriorated condition of the dam, it is imperative that this monitoring continue. Incorporate regular brush, tree clearing, and mowing into the plan.

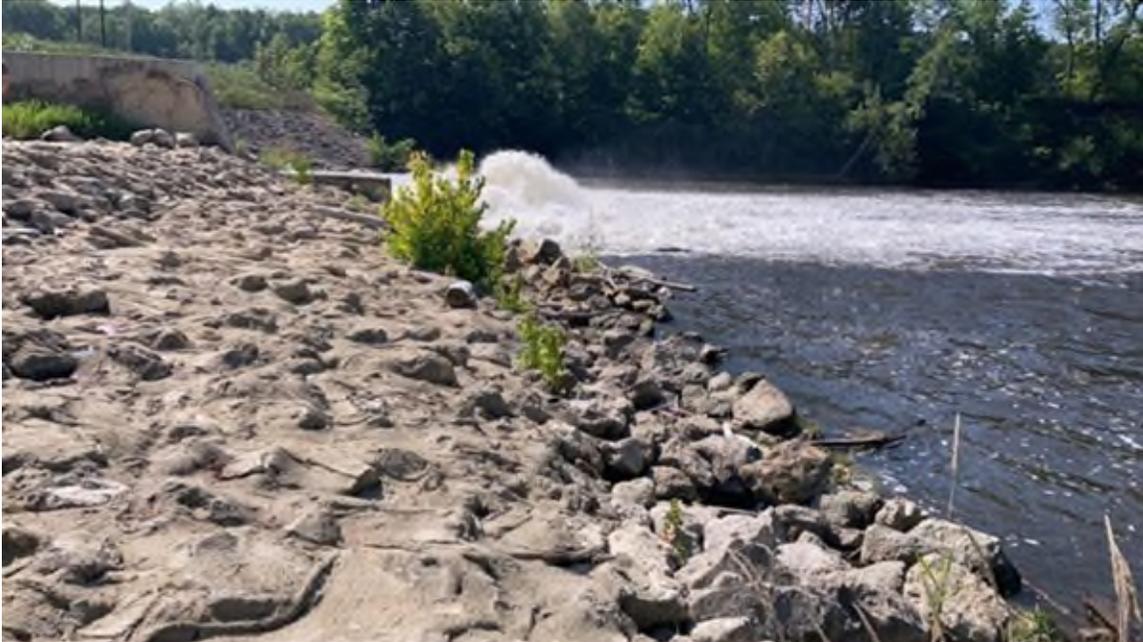
**Photo #85 - Downstream end of auxiliary spillway. Minor vegetation growth starting**
