SUBJECT: Trowbridge Dam, Dam ID No. 604; Allegan County

**DAM SAFETY INSPECTION REPORT  
TROWBRIDGE DAM – DAM ID NO. 604  
KALAMAZOO RIVER  
ALLEGAN COUNTY – SECTION 12, T 01N, R 13W**

**INSPECTION DATE:** August 18, 2023

**REPORT DATE:** September 19, 2023

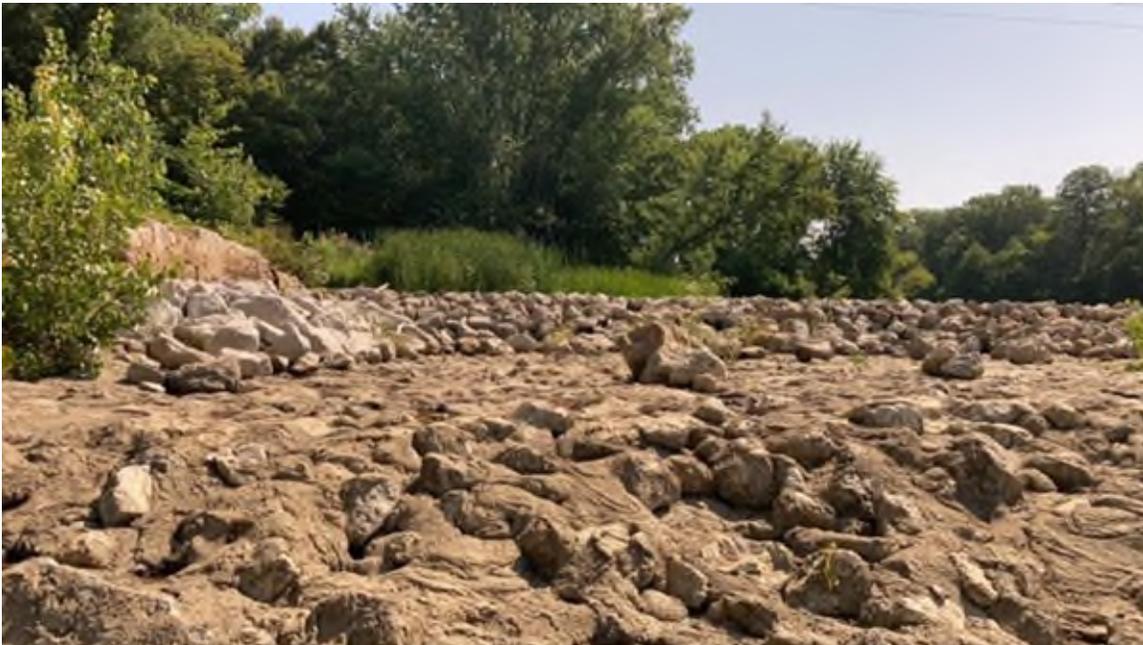
**Photo #86 - Auxiliary spillway viewed from downstream**

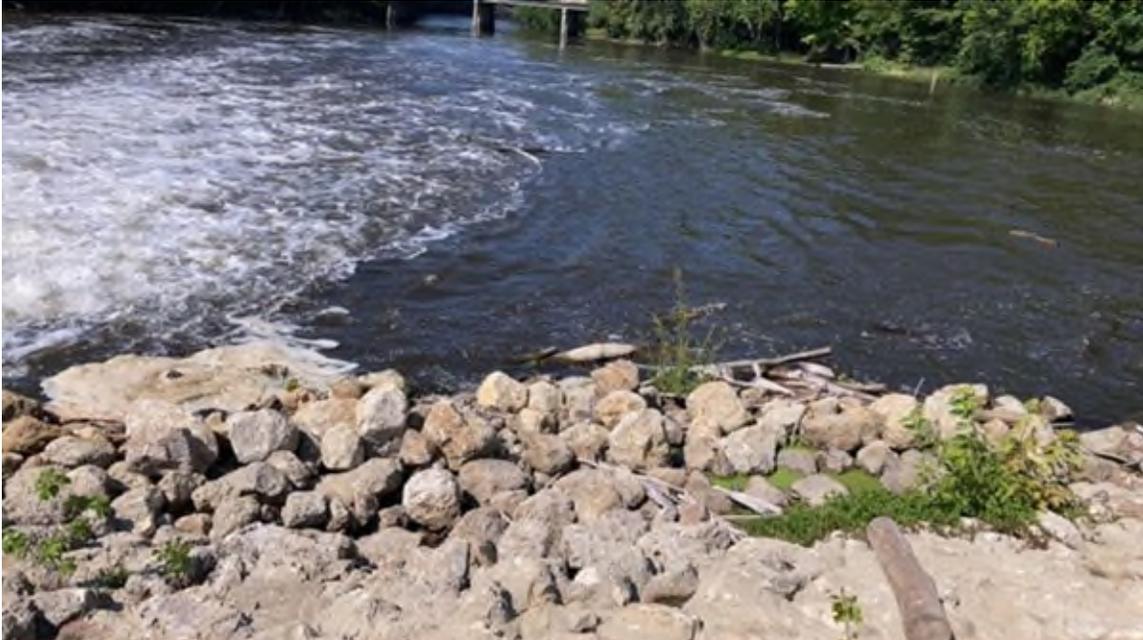
**Photo #87 - Receiving channel downstream of principal spillway**

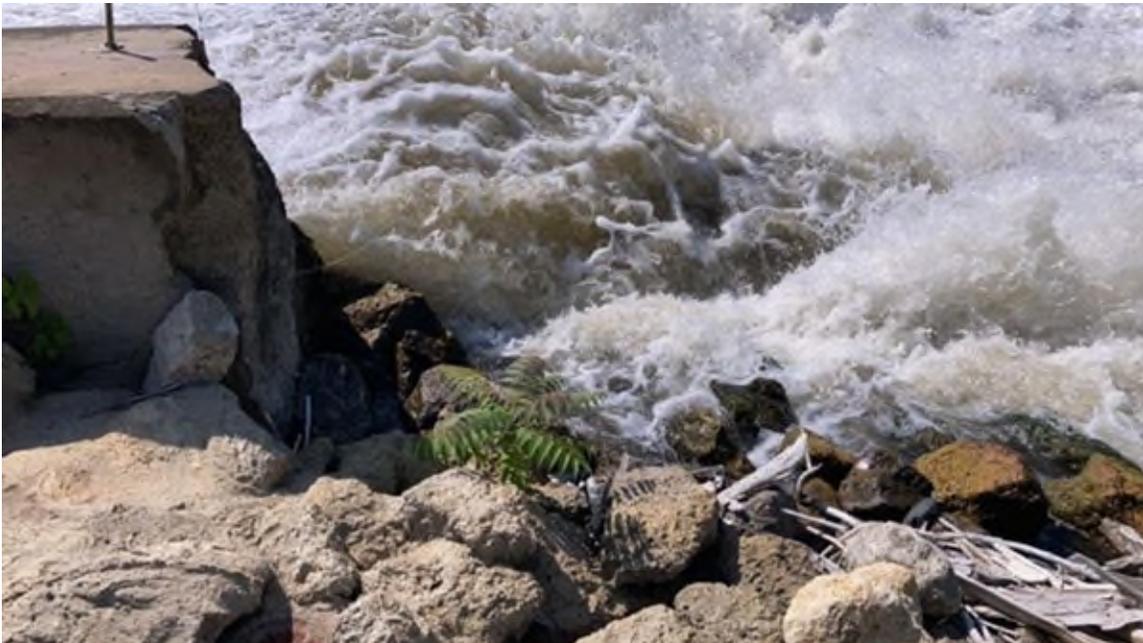
**Photo #88 - Auxiliary spillway left downstream end**

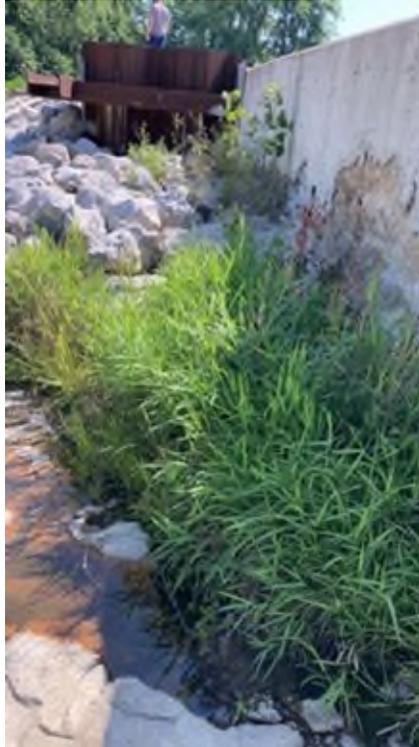
**Photo #89 - Right face of pier between principal and auxiliary spillways. Note vegetation growth**

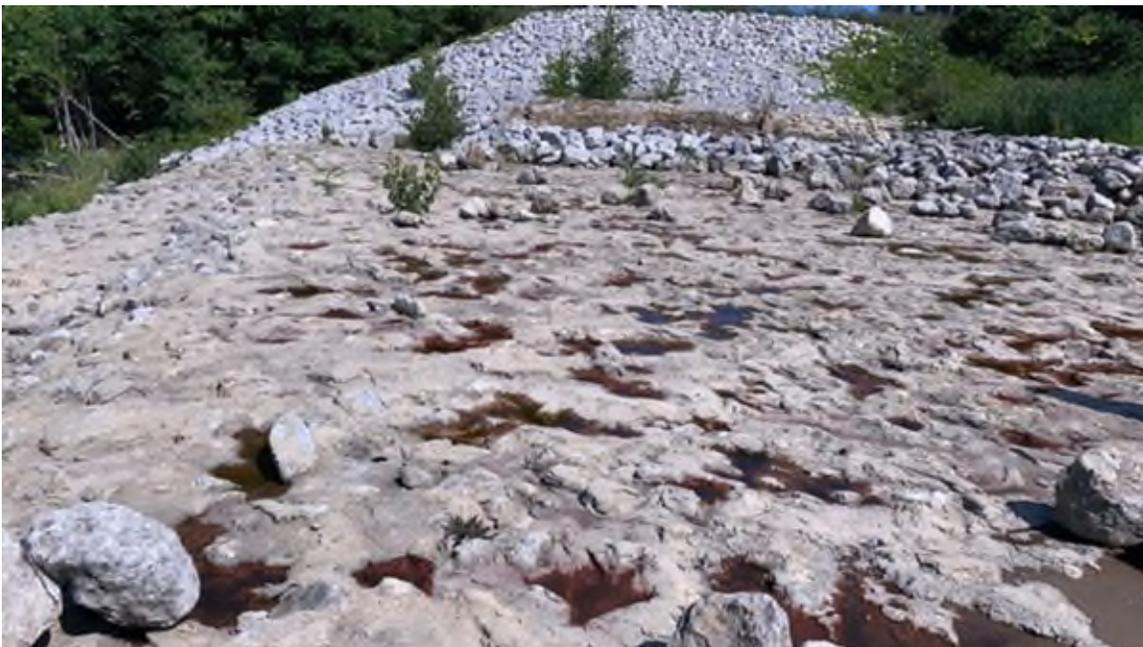
**Photo #90 - Armored surface of auxiliary spillway**

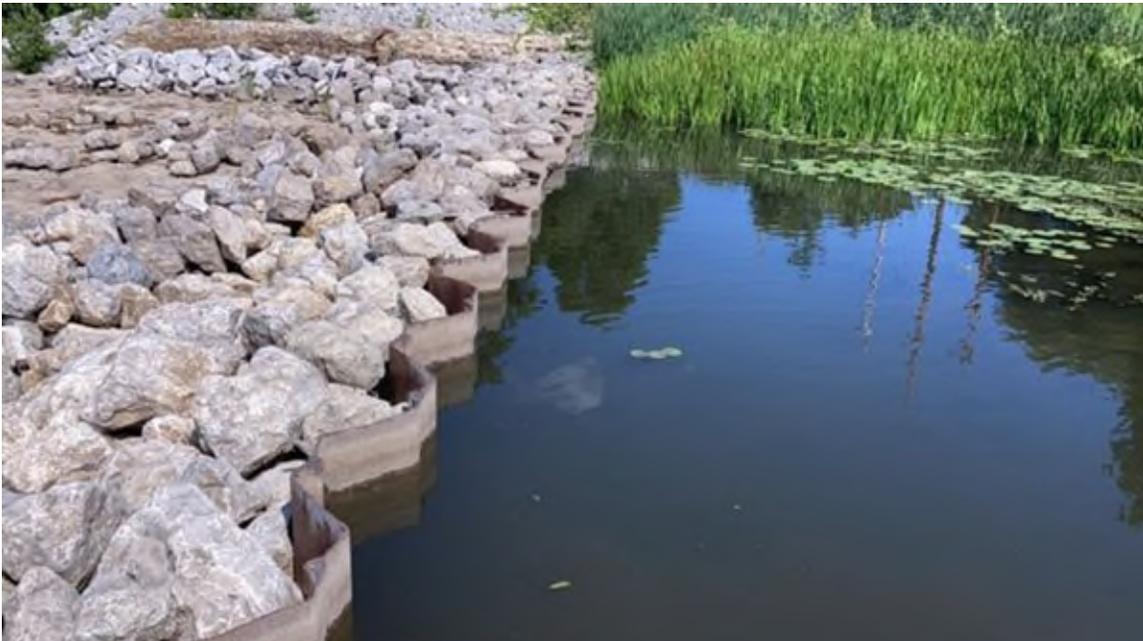
**Photo #92 - Auxiliary spillway crest**

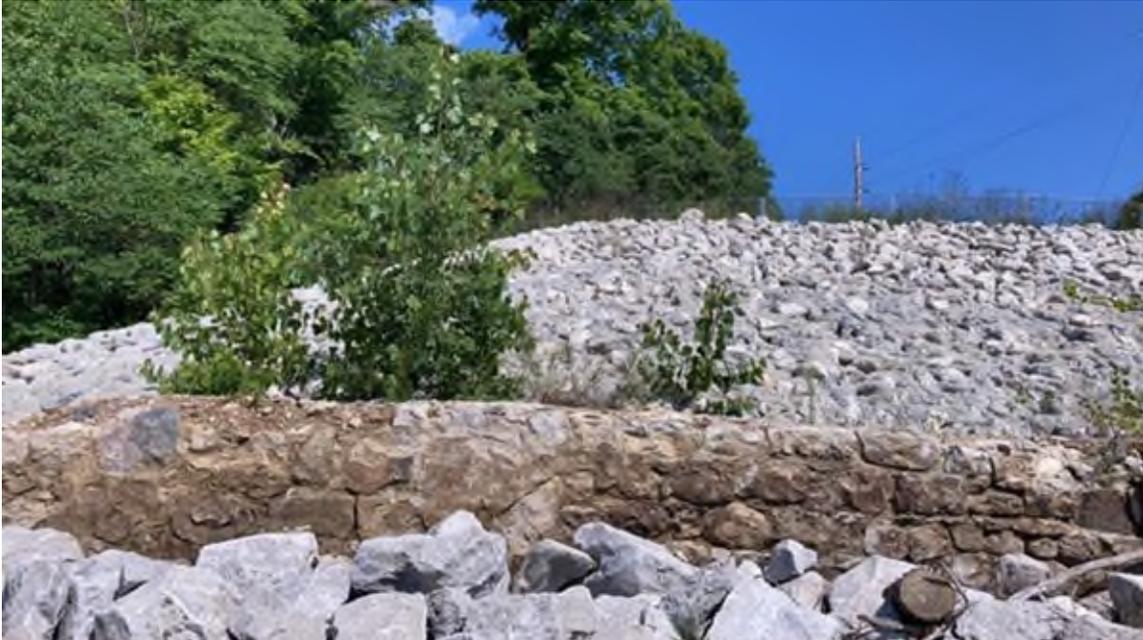
**Photo #93 - Previous powerhouse wall, right side of auxiliary spillway**

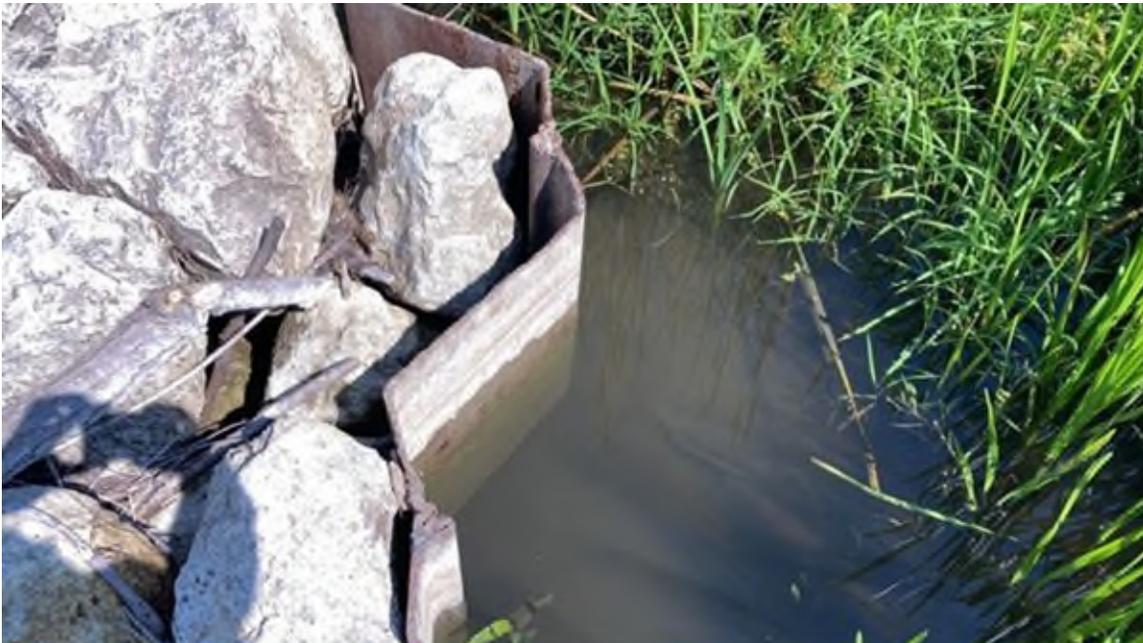
**Photo #94 - Water is approximately 12" below auxiliary spillway sheetpile crest**
